Report: 1723177
Claim:
5345033262PE1108145

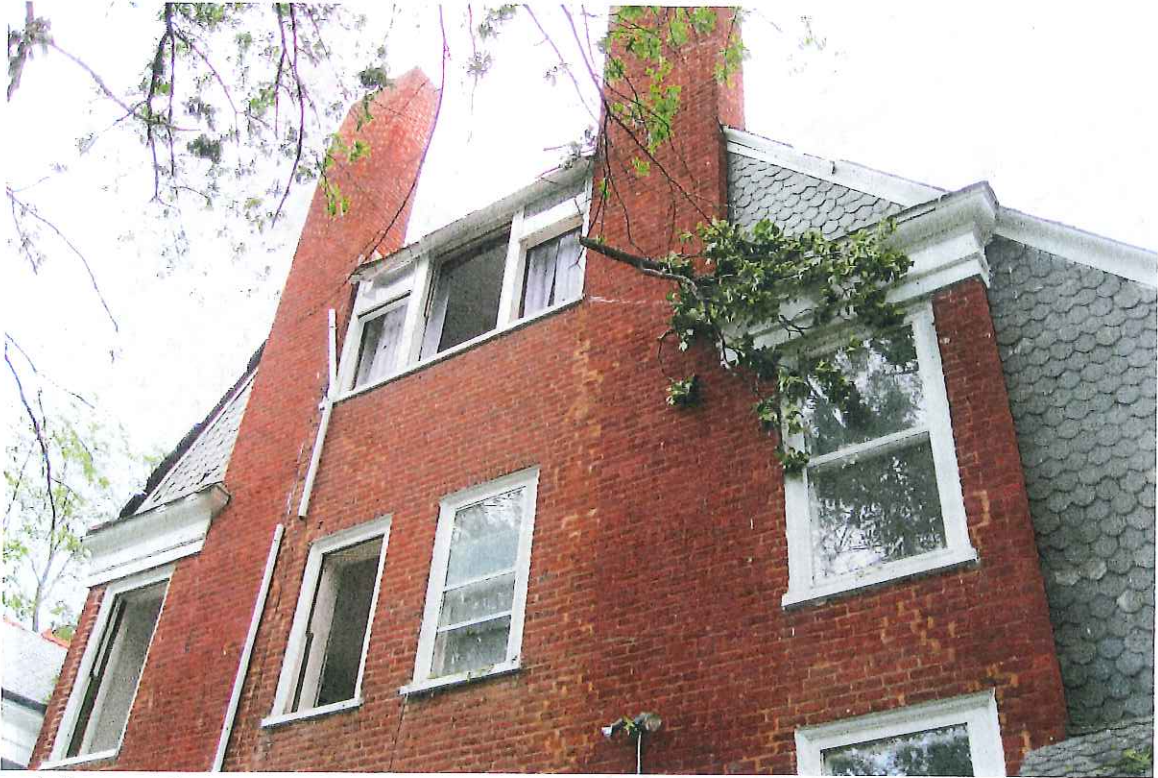
5.

Window and downspout damage; tree limb penetrating roof

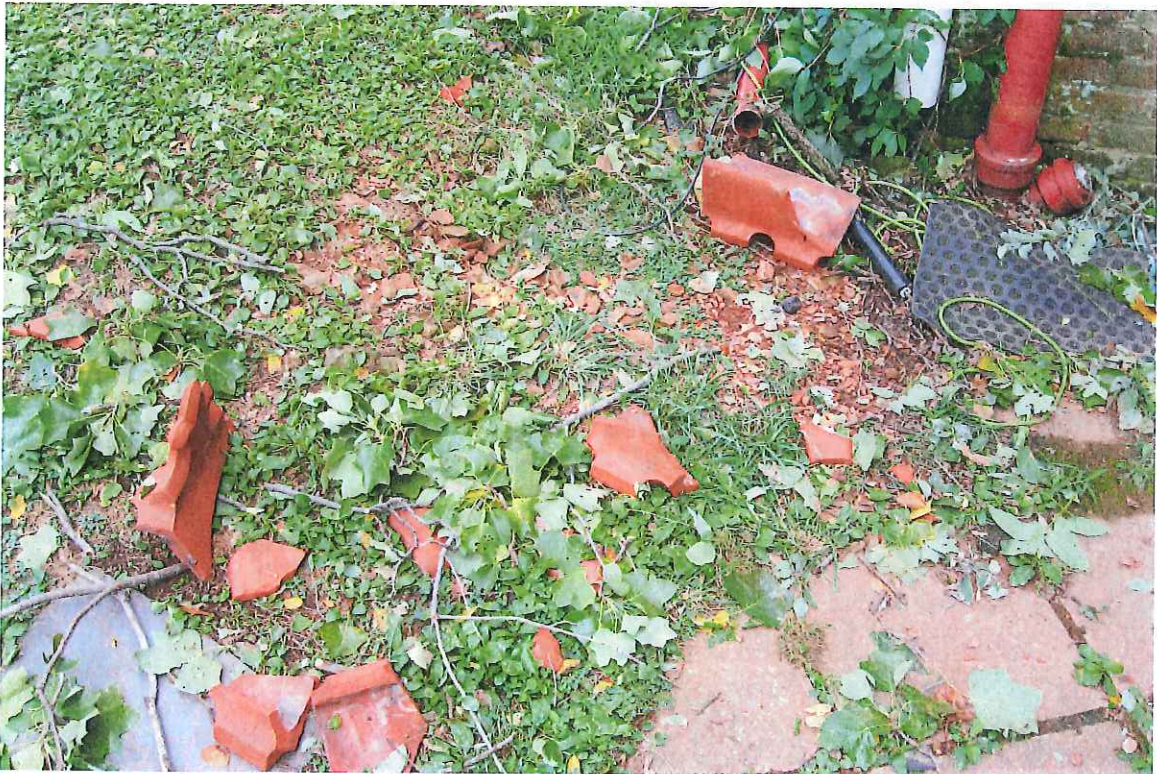
6.

terracotta roof ridge tiles

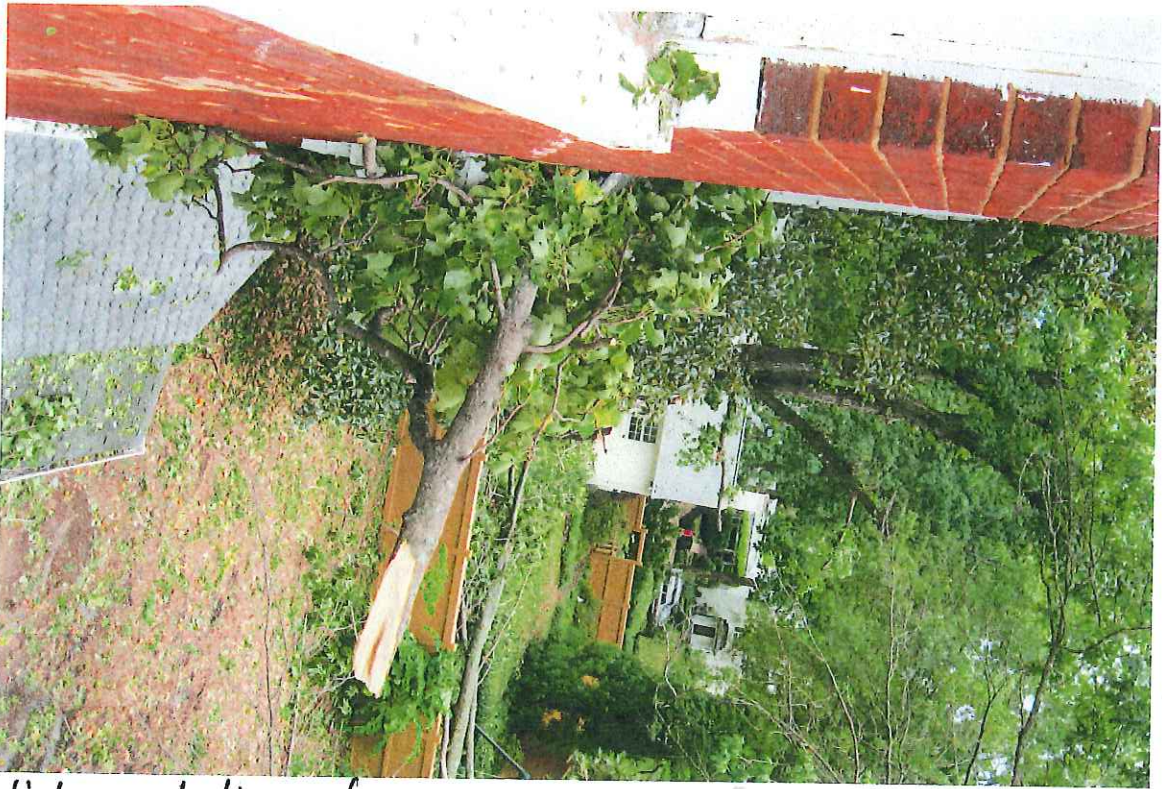
19.

limb penetrating roof

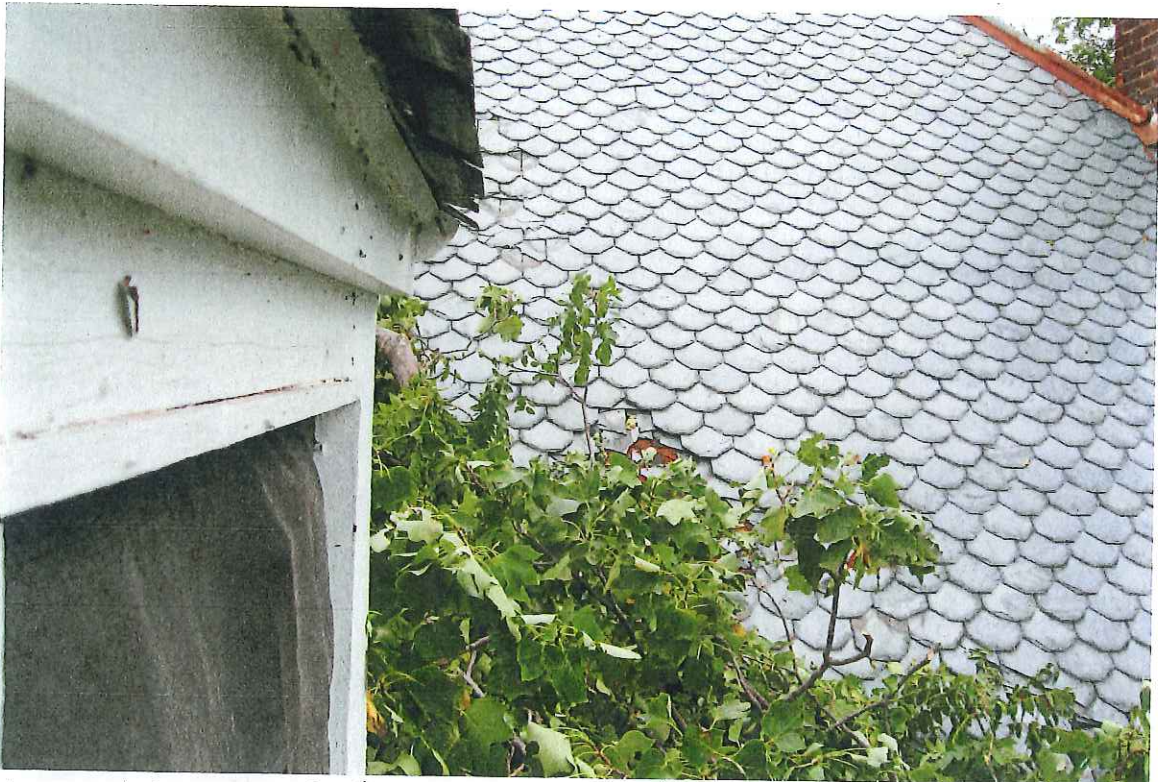
20.

large hole in roof (obscured by limb)
