RECONNAISSANCE LEVEL SURVEY REPORT

DEPARTMENT OF HISTORIC RESOURCE
RECONNAISSANCE SURVEY FORM

DHR Identification Number: 104-5043

Cook Addition Rental House (324 Berring Street)

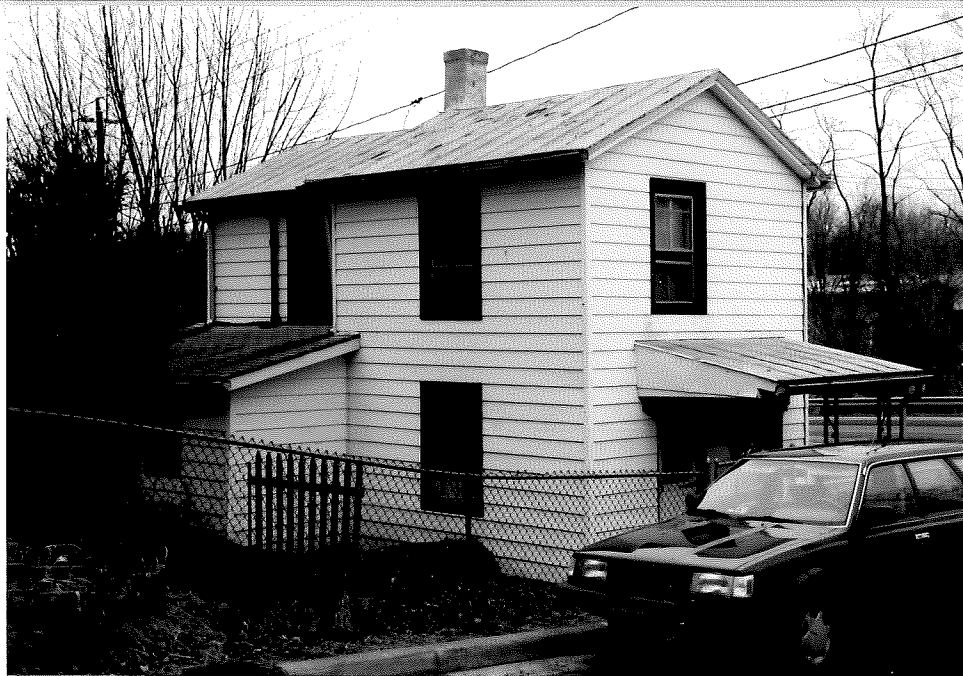
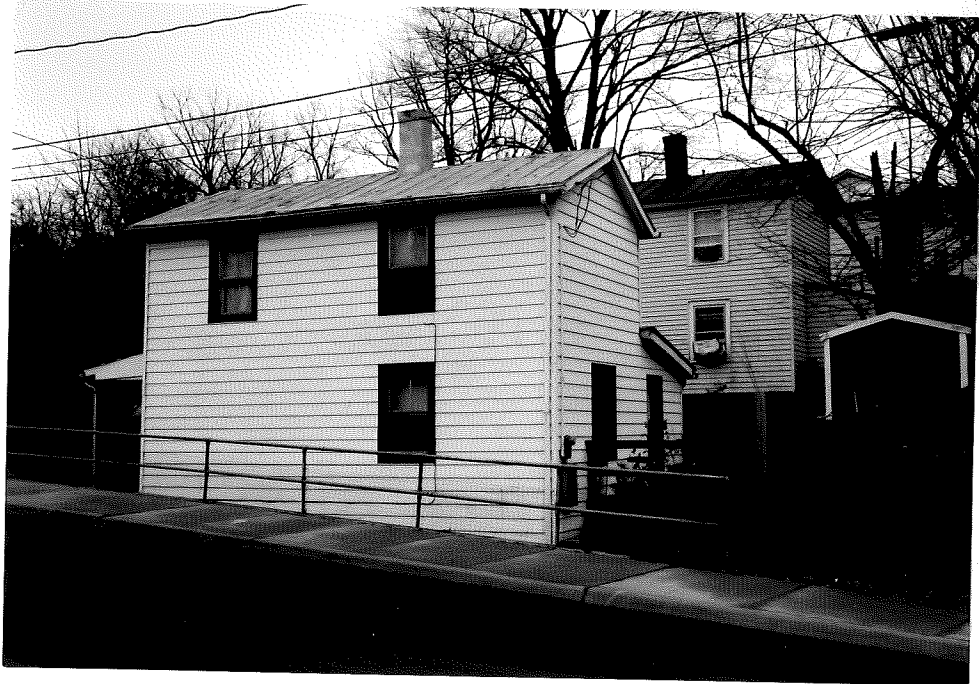
Name Cook Addition Rental House
(324 Barring St.)

Contents 2 exteriors of house
