**ALBEMARLE COUNTY'S
OLD JAIL, YARD WALL, AND JAILER'S HOUSE**

4th Street NE
Charlottesville, Virginia

Prepared September 13, 2006
for
Albemarle County Public Services
401 McIntire Road
Charlottesville, Virginia 22902-4596

Daniel S. Suggs Engineering
Consulting Engineers

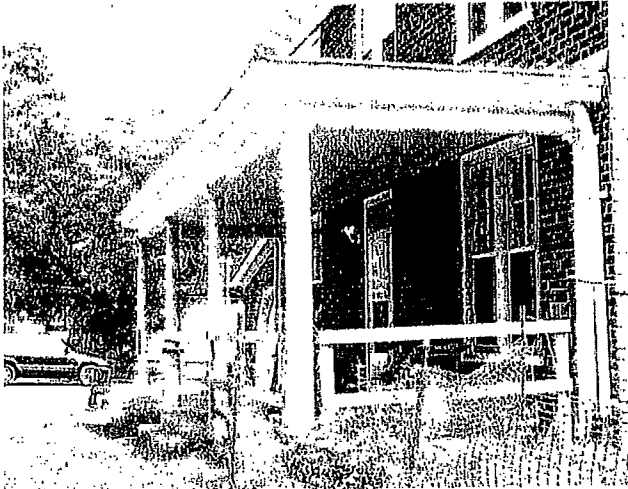
The jailer's house is in relatively good condition. Exterior brick walls are in fair condition with brick rework and re-pointing required in a few places. The porch roof is heavily rusted with flashing at the east end pulling away from the main structure. Cracking of the front porch concrete was noted. The cracking pattern is indicative of foundation settling along the front of the porch. Saturation of the soil under the porch foundation is suspect.

Porch Pulled Away From Structure Due to Movement of Porch Footer (Note Flashing)

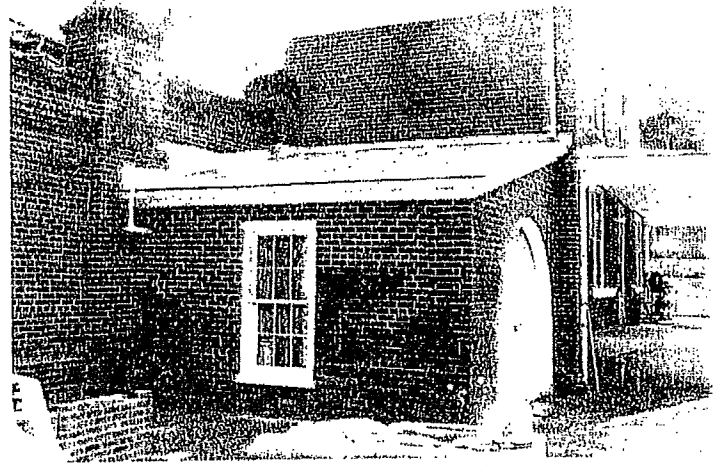
Poor Installation of Roof Flashing at Yard Wall/Foyer; Downspout Missing

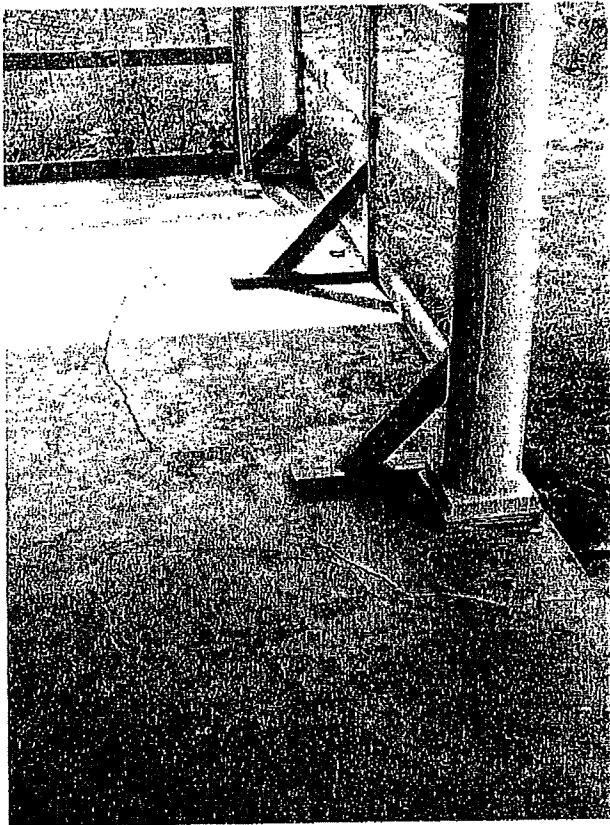
Cracked Porch Deck Due to Differential Movement of Footer

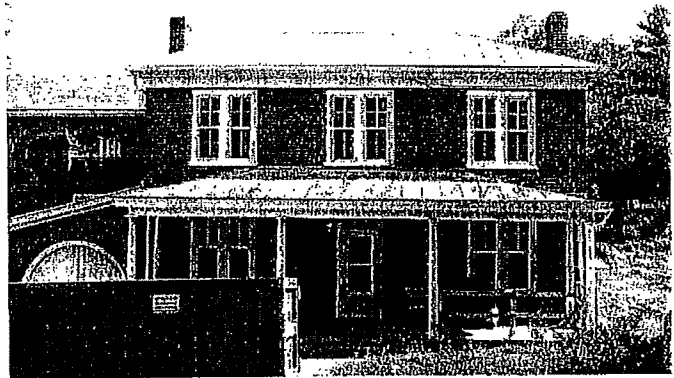
Rusted Porch Roof

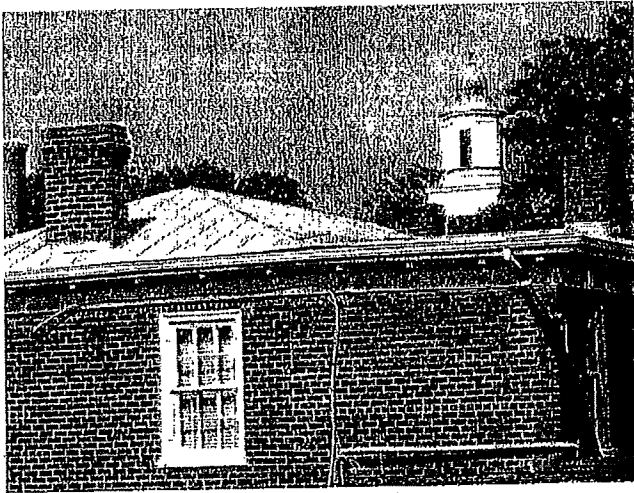
The main roof appears to be in acceptable condition. However, the very low slope above the high addition at the rear may be a source of concern. Similarly, the flat roof on the lower addition at the rear of the building is somewhat concave, thus preventing rainwater from freely running off. Whereas this roof section does not appear to be leaking at this time, its design and execution will inevitably lead to a future leak. The flashing on the west addition (jail foyer) at the intersection of the jail yard wall and the addition was poorly installed and has the potential for water intrusion.

Roof--East Side
Note Flat Roof over High Addition

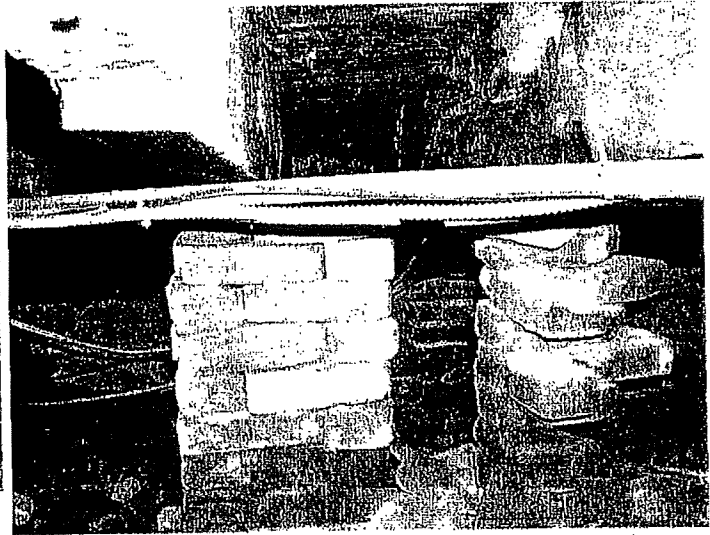
The building foundation appears to be in acceptable condition with limited settling noted. No cracking of exterior walls was noted. Floor joists where visible from crawl space access doors appear to be in good condition. One problem was noted, however, at the access door under the high addition where support for two joists were apparently removed and replaced with stacked brick piers. The brick piers, as constructed, are inadequate and need to be replaced.

Inadequate Brick Piers under High Addition

9	Replace stacked brick piers under high addition at crawl space access door. Provide proper footers.	1500
10	Backfill foundation excavation for low addition inside crawl space.	200
11	Repaint all windows and trim.	1500
12	Remove original ceiling for all rooms with suspended ceilings. If immediate occupancy is not expected, do not replace suspended ceiling panels. This will provide easy inspection for early detection of water entry.	2000
	Total	\$26,400
13	Provide minimum year round heat and dehumidification. Drain water from entire plumbing system if immediate occupancy is not expected.	
14	Provide semi-annual inspection.

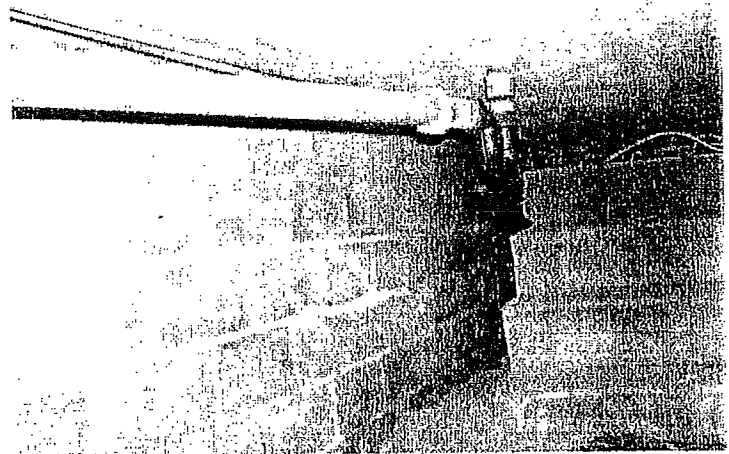
Foundation under Low Addition

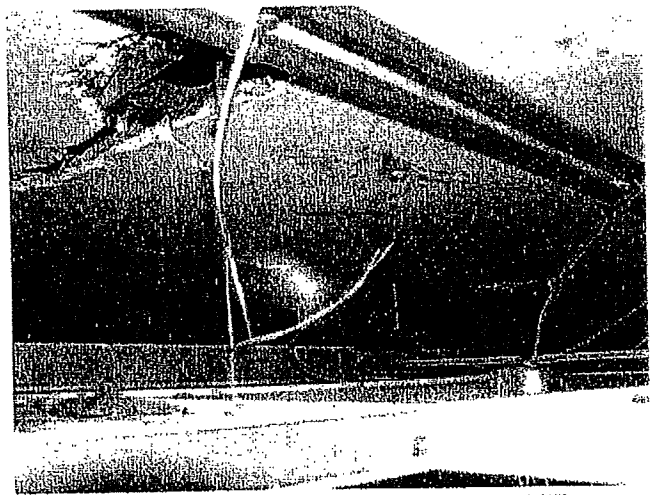
Above Suspended Ceiling, Second Floor
Southeast Room

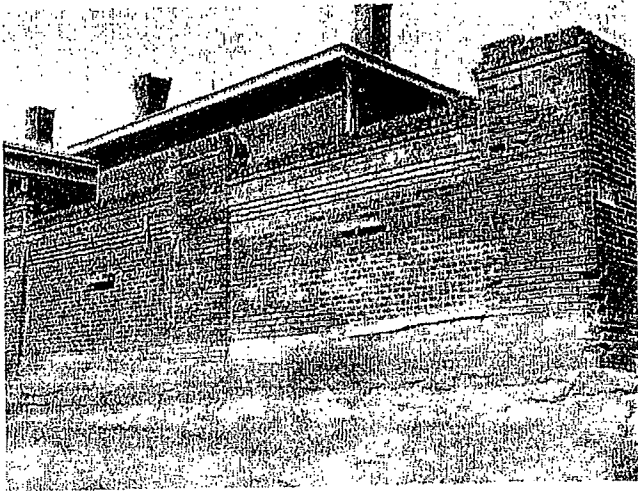
3. Cracking at the northwest corner caused by the growth of an existing tree at that location
4. Cracking at the northeast corner; and
5. Cracking near the center of the east wall at the top of the foundation.

The latter cracking is indicative of differential movement of the wall foundation. Such movement may be the result of mortar deterioration within the rubble foundation, or a result of the recent excavation.

East Yard Wall

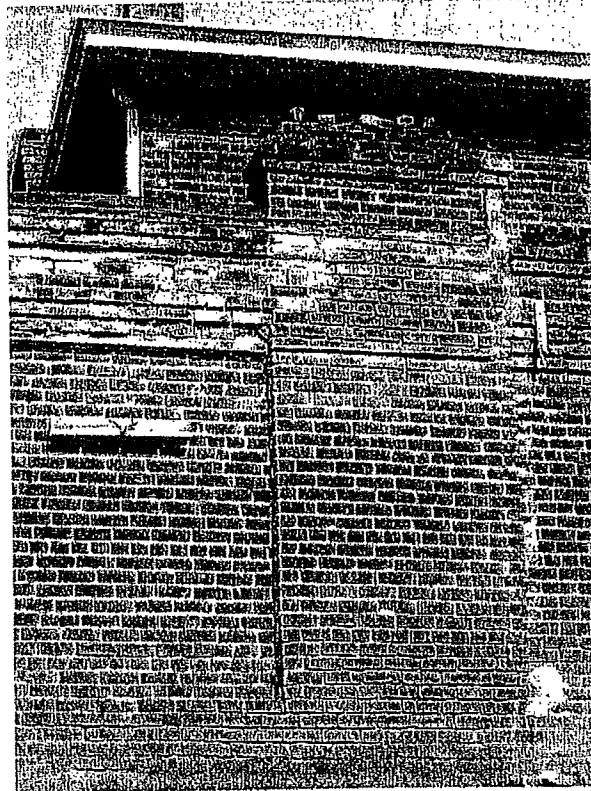
Close Up View of Center Pilaster, East Yard Wall

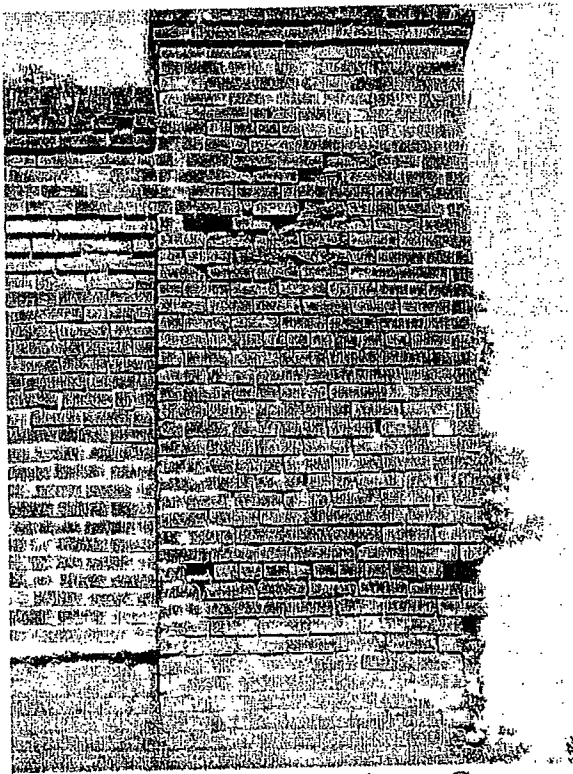
Close Up View of Northeast Corner

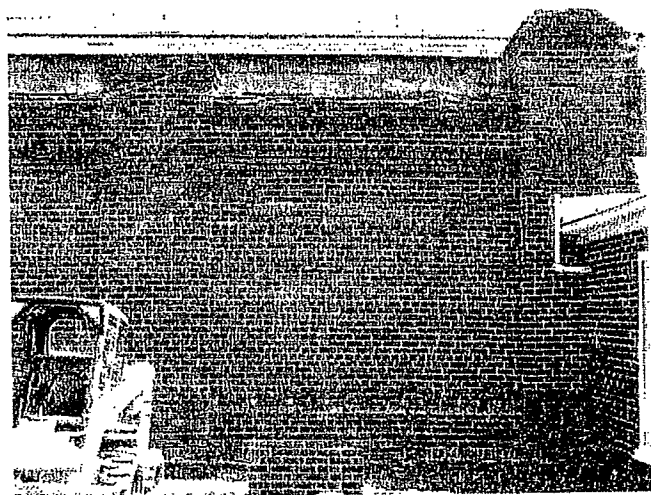
South Wall--Typical of Wall Condition
(Note Lime Leachate Caused by Water Penetration from Top of Wall)

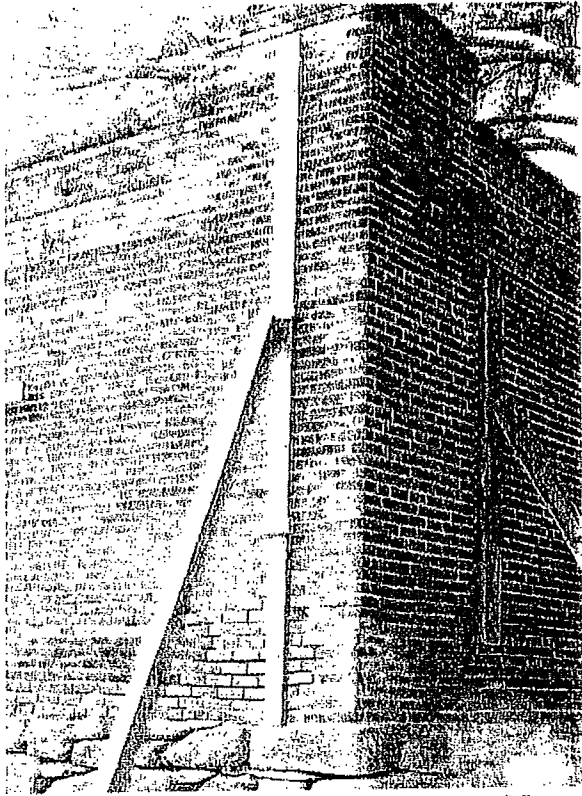
North View of Northwest Pilaster--Note
Mortar Deterioration in Foundation and Wall

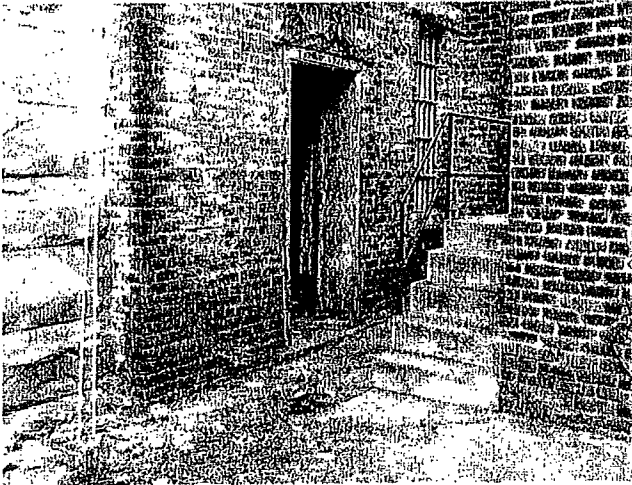
Entrance to Brick Section of Jail
(Note Rusted Door Frame)

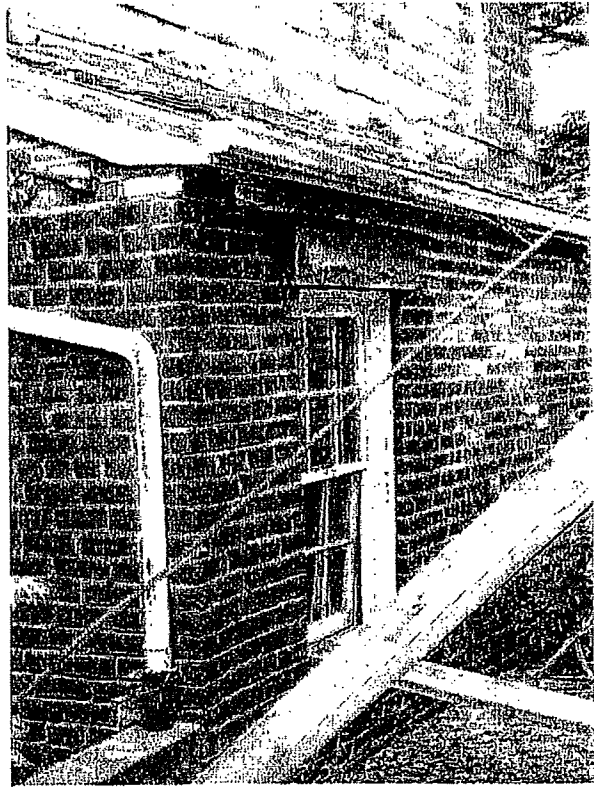
Mechanical Room (Note Cracked Wall
Around Window and Roof Condition)

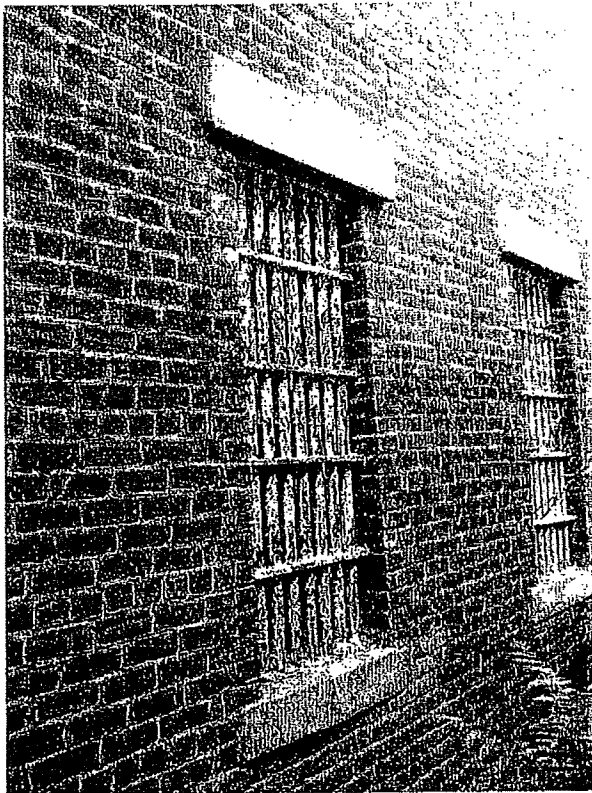
Added Windows, Ground Level, East Wall
(Note Cracks in Headers and Sills)

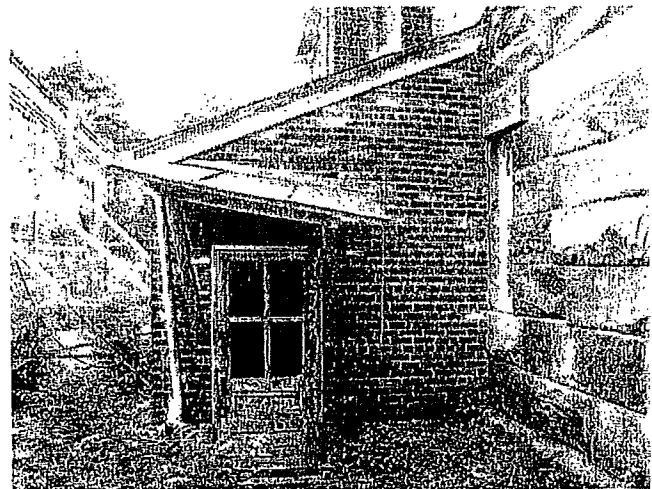
Mechanical Room Outside Entrance (Note
Gap between Brick and Granite Blocks Due
to Movement of Wall Foundation)

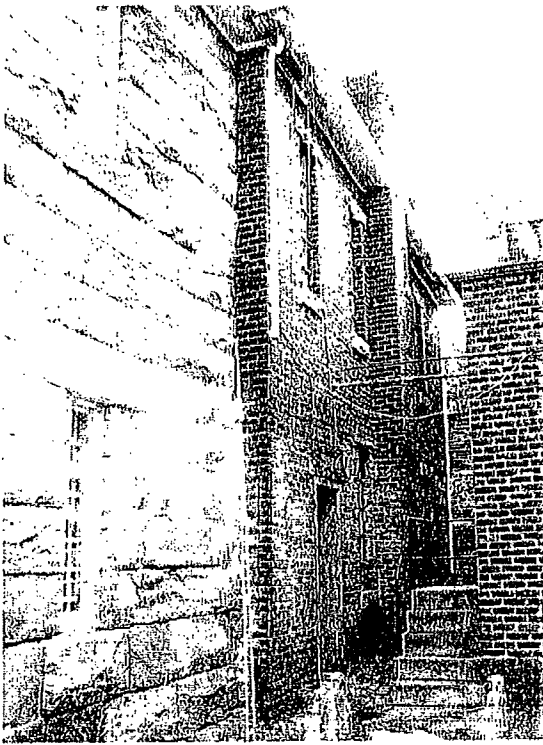
Rotting Soffits, Southeast Side

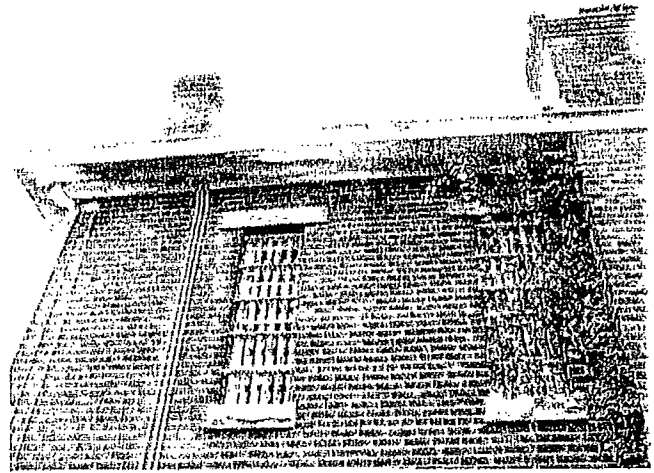
Rotting Soffits, North Side

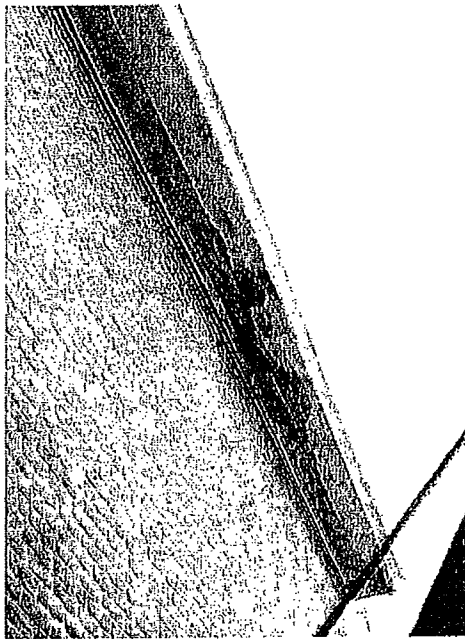
Rotting Soffits, East Side

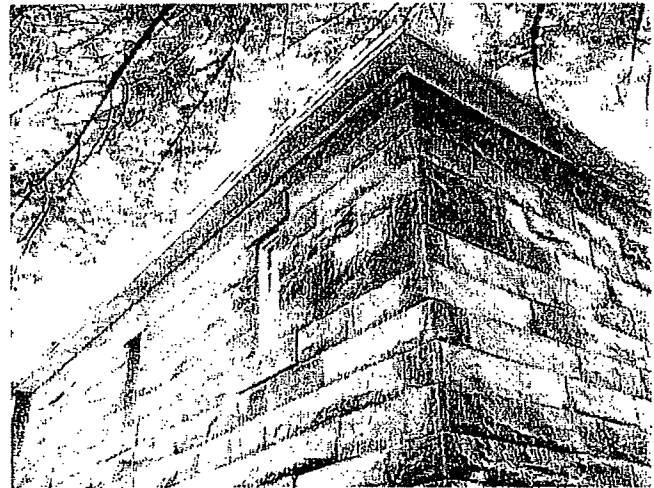
Rotting Soffits, Northwest Corner

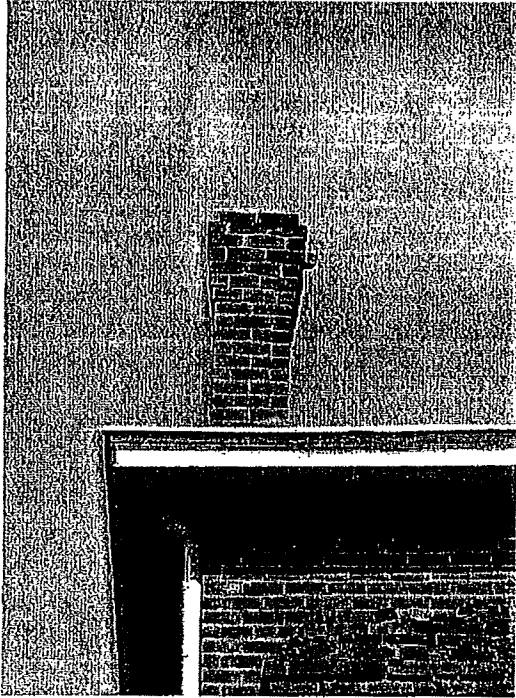
Tilting South Chimney

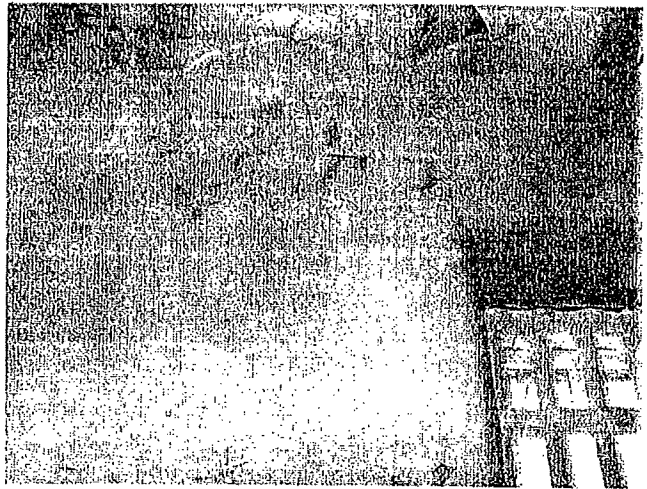
Settlement Crack in Granite Section

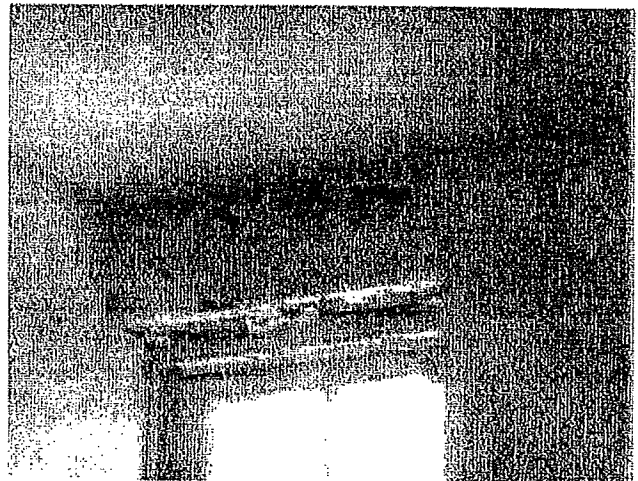
Settlement Crack in Brick Section

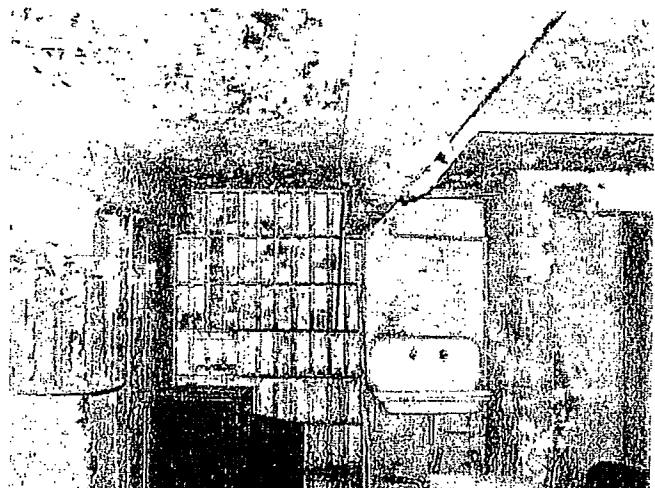
Peeling Paint, First Floor, Brick Section

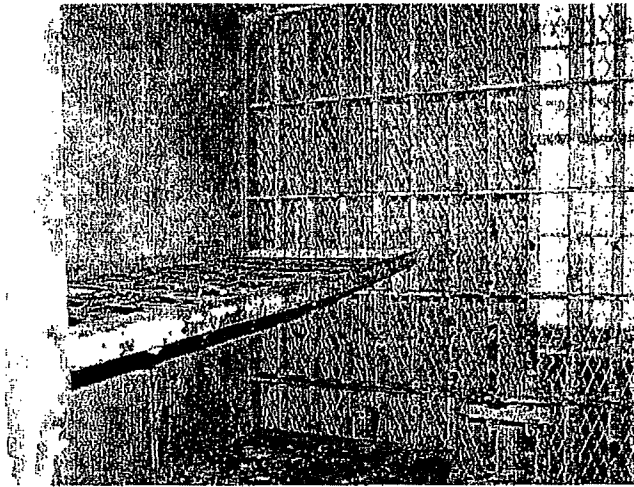
Rusting Jail Cell, Brick Section

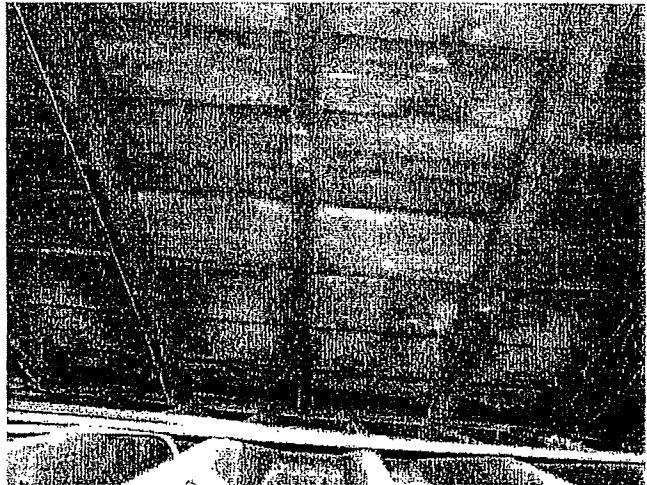
Attic, Brick Section, Looking South (Note
Water Discoloration)
