**OLD ALBEMARLE COUNTY JAIL  
PERIMETER WALL STUDY**

**4<sup>th</sup> Street NE  
Charlottesville, Virginia**

Prepared May 28, 2014  
for  
Albemarle County Public Services  
401 McIntire Road  
Charlottesville, Virginia 22902-4596

**Daniel S. Suggs Engineering**  
*Consulting Engineers*

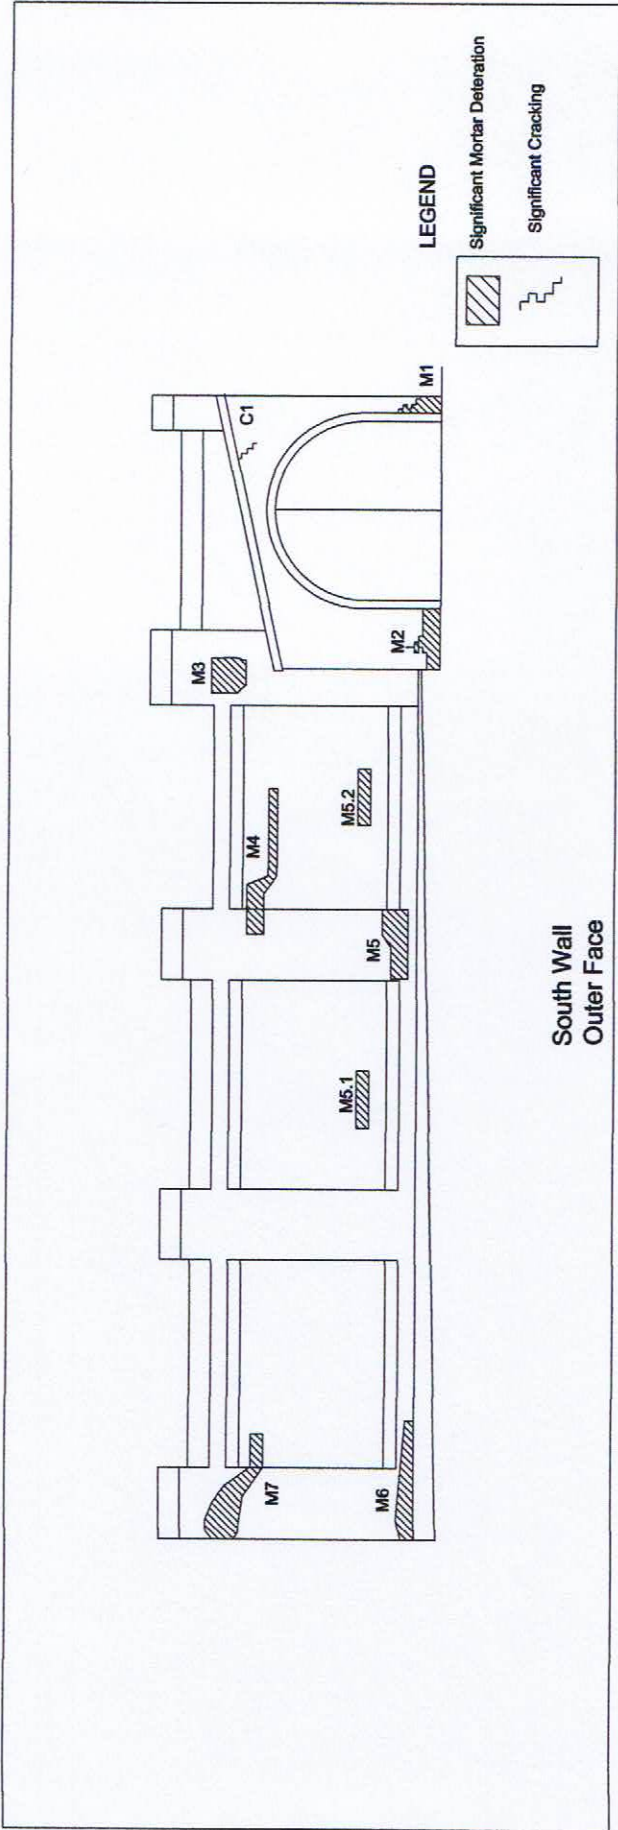
South Wall  
Outer Face

South Wall—Outer Face Significant Cracking							
Significant Crack ID	Crack Width (Inches)	Crack Width (Inches)	Crack Width (Inches)	Crack Width (Inches)	Photo Reference No.		
C1	0.247	0.221	0.251	0.23	0.23	6/12/2013	C1_XXX

South Wall—Outer Face Significant Mortar Loss						
Significant Mortar Loss ID	Photo Reference	Photo Reference	Photo Reference	Photo Reference	Photo Reference	Photo Reference
M1	5/21/2011	9/21/2011	5/30/2012	11/9/2012	6/12/2013	
M2	M1_511	M1_1011	M1_512	M1_1112	M1_613	
M3	M2_511	M2_1011	M2_512	M2_1112	M2_613	
M4	M3_511	M3_1011	M3_512	M3_1112	M3_613	
M5	M4_511	M4_1011	M4_512	M4_1112	M4_613	
M5.1	M5_511	M5_1011	M5_512	M5_1112	M5_613	
M5.2	M5.1_1011	M5.1_512	M5.1_1112	M5.2_1112	M5.2_613	
M6	M6_511	M6_1011	M6_512	M6_1112	M6_613	
M7	M7_511	M7_1011	M7_512	M7_1112	M7_613

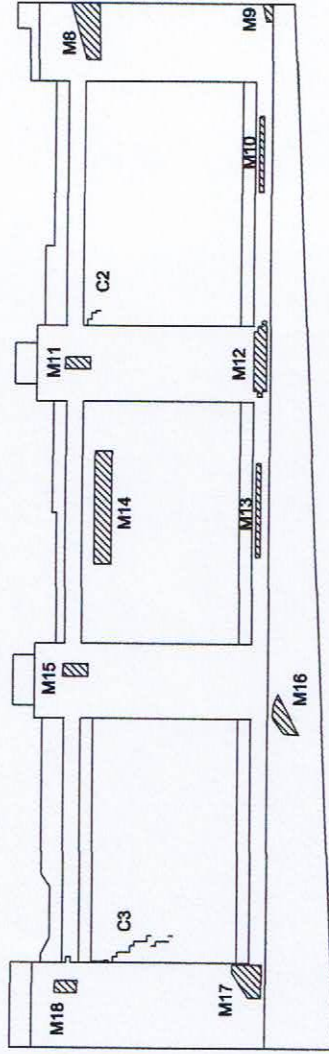
West Wall  
Outer Face

West Wall—Outer Face Significant Cracking				
Crack ID	Crack Width (Inches)	Crack Width (Inches)	Crack Width (Inches)	Photo Reference No.
C2	0.251	0.292	0.288	C2_XXX
C3A	0.649	0.627	0.691	C3_XXX
C3B	0.315	0.41	0.427	C3_XXX

West Wall—Outer Face Significant Mortar Loss					
Significant Mortar Loss ID	Photo Reference	Photo Reference	Photo Reference	Photo Reference	Photo Reference
M8	M8_511	M8_1011	M8_512	M8_1112	M8_613
M9	M9_511	M9_1011	M9_512	M9_1112	M9_613
M10	M10_511	M10_1011	M10_512	M10_1112	M10_613
M11	M11_511	M11_1011	M11_512	M11_1112	M11_613
M12	M12_511	M12_1011	M12_512	M12_1112	M12_613
M13	M13_511	M13_1011	M13_512	M13_1112	M13_613
M14	M14_511	M14_1011	M14_512	M14_1112	M14_613
M15	M15_511	M15_1011	M15_512	M15_1112	M15_613
M16	M16_511	M16_1011	M16_512	M16_1112	M16_613
M17	M17_511	M17_1011	M17_512	M17_1112	M17_613
M18	M18_511	M18_1011	M18_512	M18_1112	M18_613

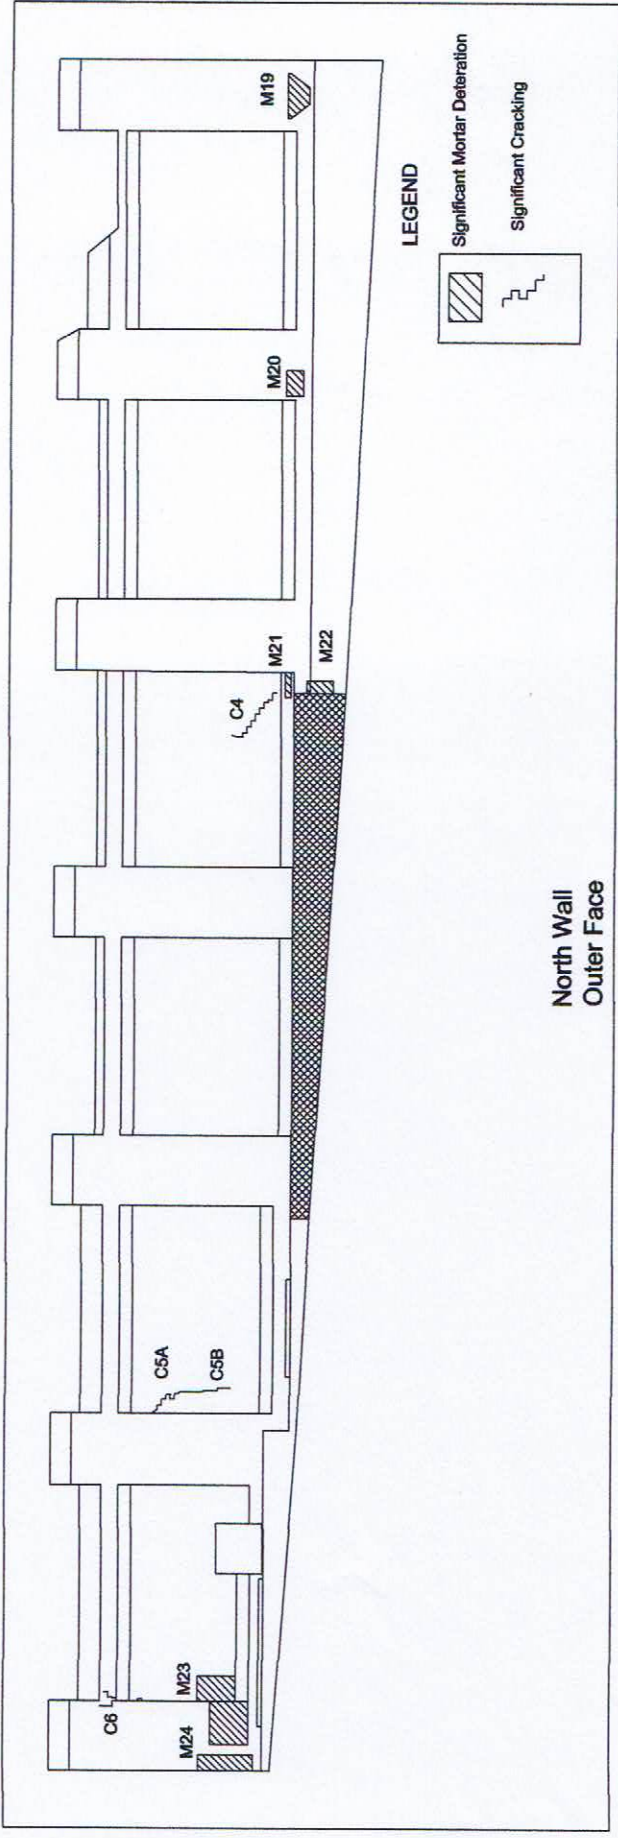
**North Wall  
Outer Face**

**North Wall-Outer Face  
Significant Cracking**

Significant Crack ID	Crack Width (Inches) 5/21/2011	Crack Width (Inches) 9/29/2011	Crack Width (Inches) 5/30/2012	Crack Width (Inches) 11/10/2012	Crack Width (Inches) 6/12/2013	Photo Reference No.
C4	0.029	0.066	0.095	0.124	0.102	C4_XXX
C5A	0.179	0.038	0.213	0.224	0.231	C5_XXX
C5B	0.047	0.23	0.278	0.238	0.243	C5_XXX
C6	0.103	0.019	0.122	0.123	0.111	C6_XXX

**North Wall-Outer Face  
Significant Mortar Loss**

Significant Mortar Loss ID	Photo Reference 5/21/2011	Photo Reference 9/21/2011	Photo Reference 5/30/2012	Photo Reference 11/9/2012	Photo Reference 6/12/2013
M19	M19_511	M19_1011	M19_512	M19_1112	M19_613
M20	M20_511	M20_1011	M20_512	M20_1112	M20_613
M21	M21_511	M21_1011	M21_512	M21_1112	M21_613
M22	M22_511	M22_1011	M22_512	M22_1112	M22_613
M23	M23_511	M23_1011	M23_512	M23_1112	M23_613
M24	M24_511	M24_1011	M24_512	M24_1112	M24_613

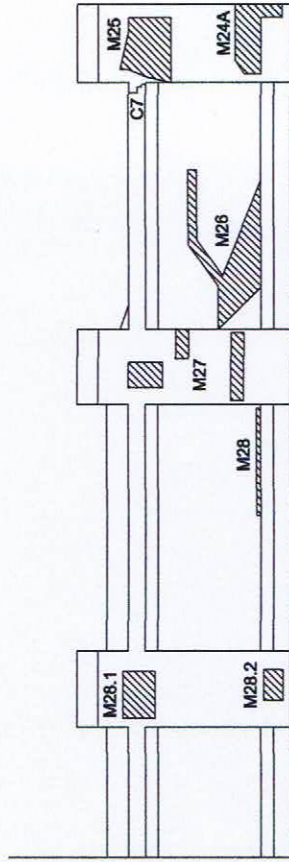
**East Wall  
Outer Face**

East Wall-Outer Face Significant Cracking				
Significant Crack ID	Crack Width (Inches)	Crack Width (Inches)	Crack Width (Inches)	Photo Reference No.
C7	0.276	0.254	0.264	C7_XXX
			0.254	
			0.272

East Wall-Outer Face Significant Mortar Loss				
Significant Mortar Loss ID	Photo Reference	Photo Reference	Photo Reference	Photo Reference
M24A	M24A_511	M24A_1011	M24A_512	M24A_1112
M25	M25_511	M25_1011	M25_512	M25_1112
M26	M26_511	M26_1011	M26_512	M26_1112
M27	M27_511	M27_1011	M27_512	M27_1112
M28	M28_511	M28_1011	M28_512	M28_1112
M28.1		M28.1_1011		
M28.2		M28.2_1011

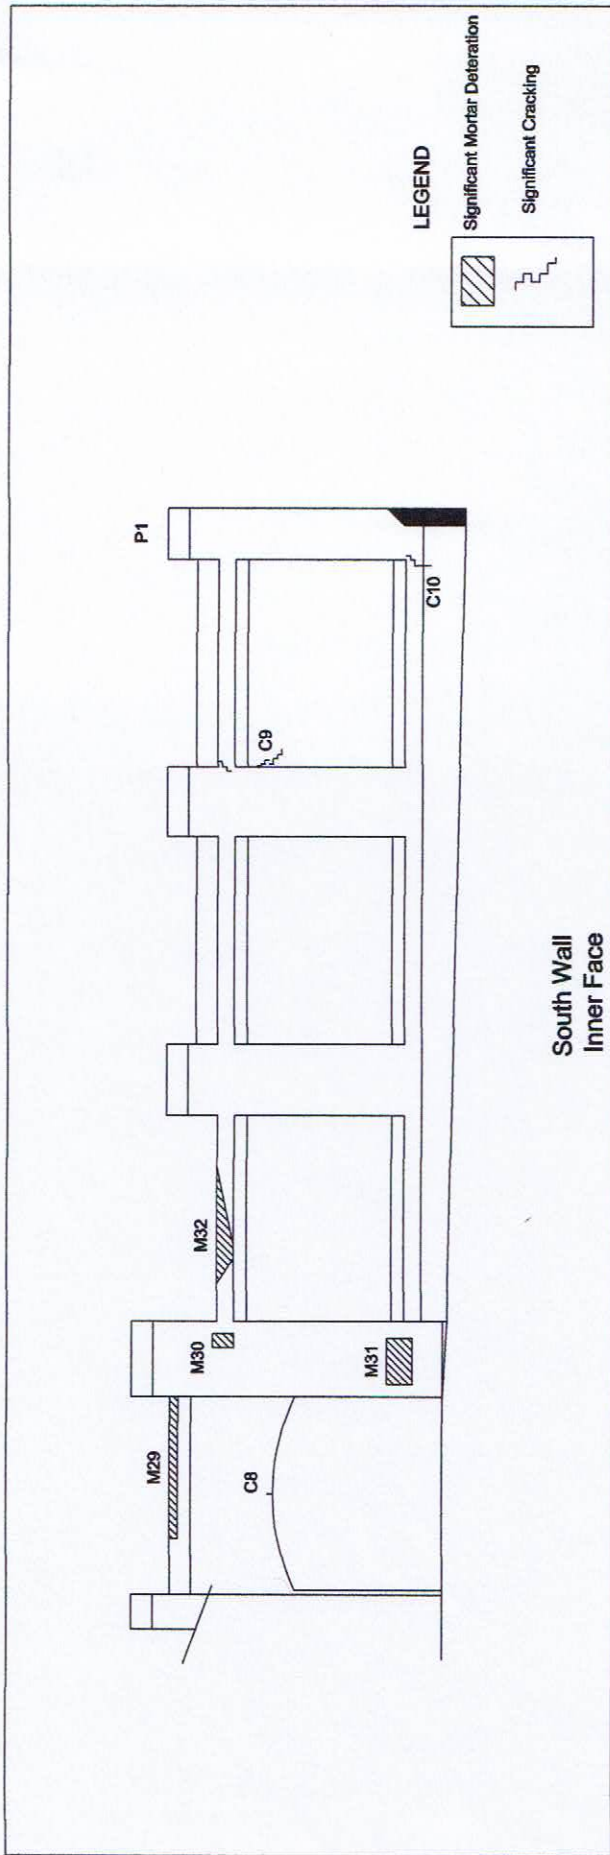
**South Wall  
Inner Face**

South Wall—Inner Face Significant Cracking						
Significant Crack ID	Crack Width (Inches)	Crack Width (Inches)	Crack Width (Inches)	Crack Width (Inches)	Crack Width (Inches)	Photo Reference No.
C8	0.106	0.089	0.111	0.12	0.105	C8_XXX
C9	0.074	0.086	0.086	0.095	0.124	C9_XXX
C10	0.152	0.168	0.159	0.195	0.196	C10_XXX

South Wall—Inner Face Significant Mortar Loss						
Significant Mortar ID	Photo Reference	Photo Reference	Photo Reference	Photo Reference	Photo Reference	Photo Reference
M29	5/21/2011	9/30/2011	5/30/2012	11/9/2012	6/11/2013	
M30	M29_511	M29_1011	M29_512	M29_1112	M29_613	
M31	M30_511	M30_1011	M30_512	M30_1112	M30_613	
M32	M31_511	M31_1011	M31_512	M31_1112	M31_613	
	M32A,B,C_511	M32_1011	M32_512	M32_1112	M32_613

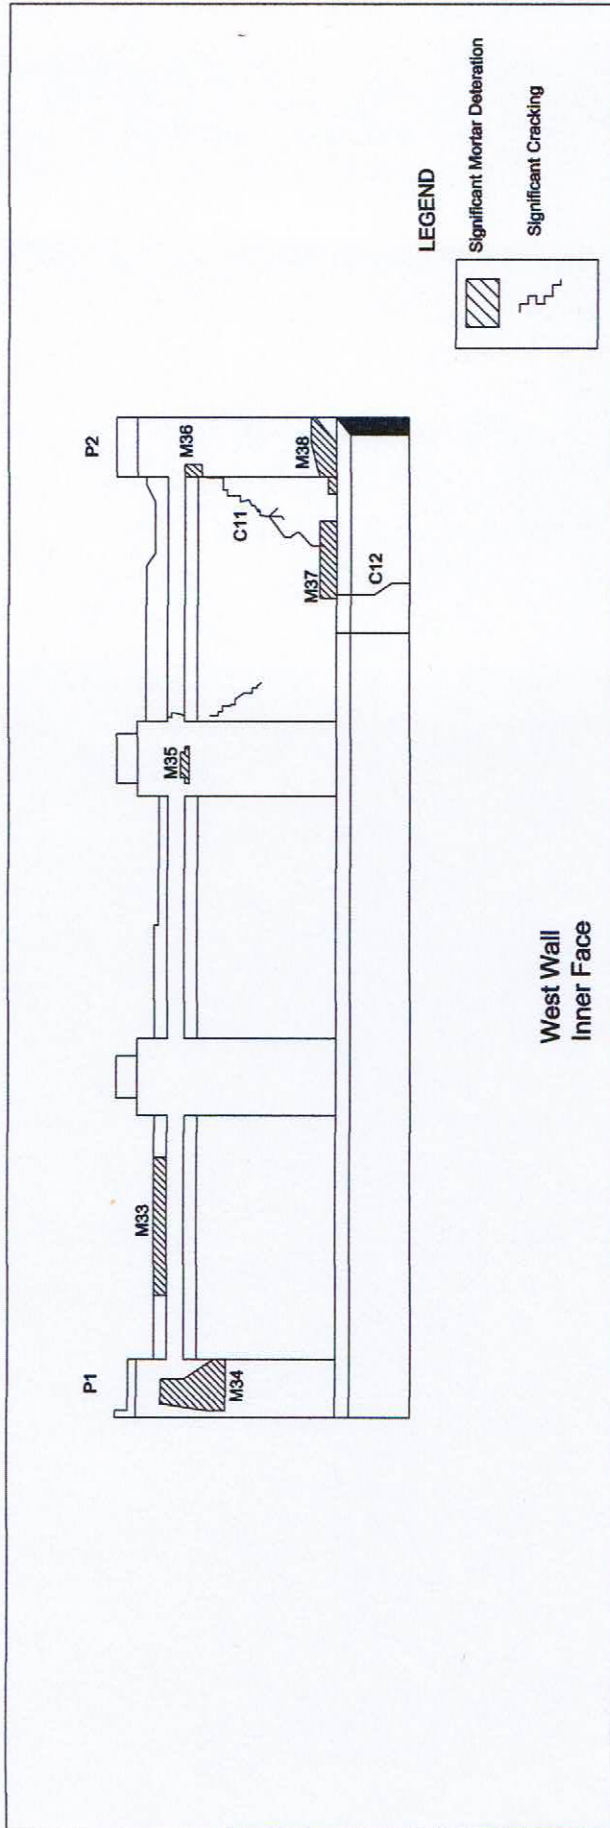
**West Wall  
Inner Face**

West Wall—Inner Face Significant Cracking						
Significant Crack ID	Crack Width (Inches) 5/21/2011	Crack Width (Inches) 9/29/2011	Crack Width (Inches) 5/30/2012	Crack Width (Inches) 11/10/2012	Crack Width (Inches) 6/11/2013	Photo Reference No.
C11A	0.579	0.602	0.608	0.567	0.575	C11_XXX
C11B	0.141	0.152	0.156	0.135	0.16	C11_XXX
C12	0.093	0.075	0.072	0.073	0.108	C12_XXX

West Wall—Inner Face Significant Mortar Loss					
Significant Mortar Loss ID	Photo Reference 5/21/2011	Photo Reference 9/30/2011	Photo Reference 5/30/2012	Photo Reference 11/9/2012	Photo Reference 6/11/2013
M33	M33_511	M33_1011	M33_512	M33_1112	M33_613
M34	M34_511	M34_1011	M34_512	M34_1112	M34_613
M35	M35_511	M35_1011	M35_512	M35_1112	M35_613
M36	M36_511	M36_1011	M36_512	M36_1112	M36_613
M37	M37_511	M37_1011	M37_512	M37_1112	M37_613
M38	M38_511	M38_1011	M38_512	M38_1112	M38_613

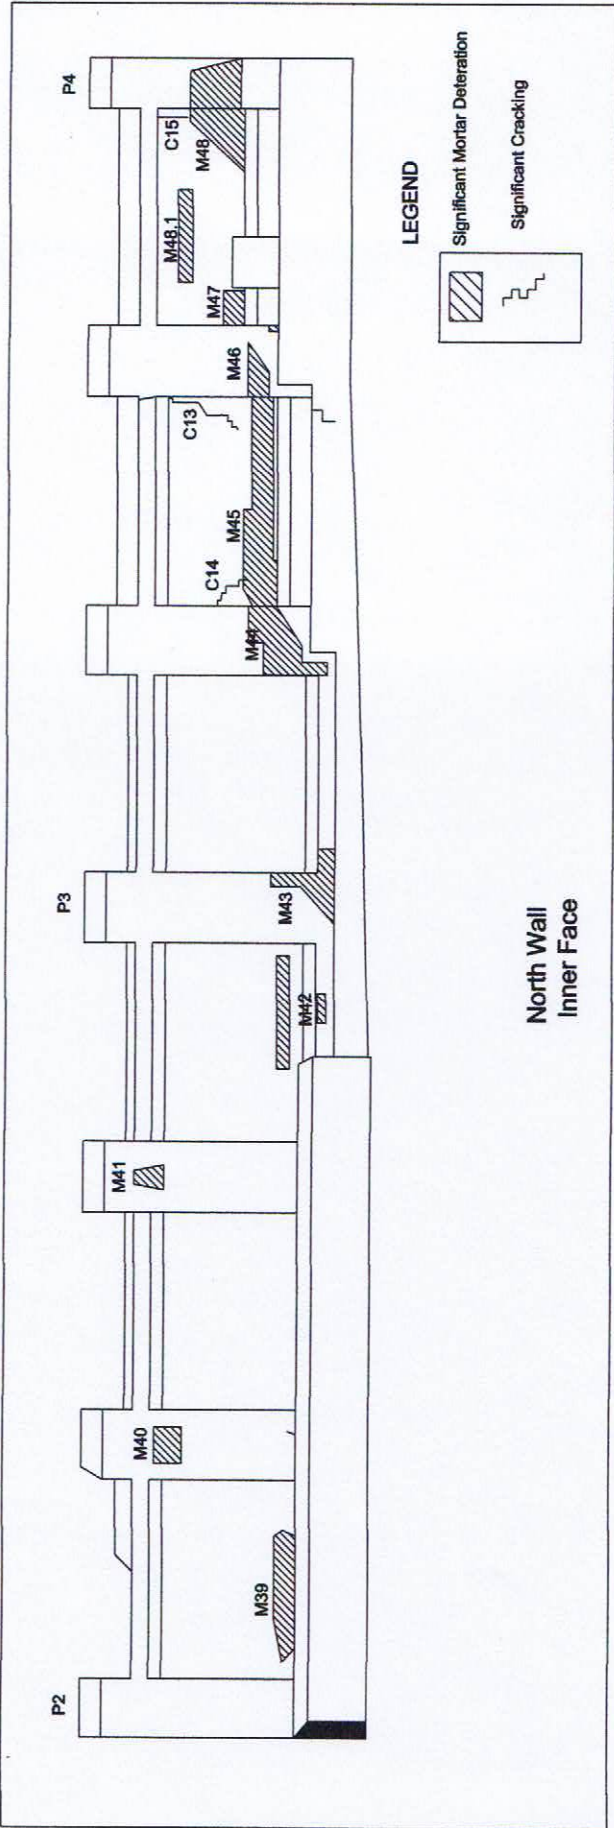
North Wall  
Inner Face

North Wall-Inner Face Significant Cracking						
Significant Crack ID	Crack Width (Inches)	Crack Width (Inches)	Crack Width (Inches)	Crack Width (Inches)	Photo Reference No.	
C13	0.175	0.134	0.293	0.155	0.147	C13_XXX
C14	0.16	0.15	0.181	0.16	0.164	C14_XXX
C15	0.395	0.254	0.144	0.3	0.295	C15_XXX

North Wall-Inner Face Significant Mortar Loss					
Significant Mortar Loss ID	Photo Reference	Photo Reference	Photo Reference	Photo Reference	Photo Reference
M39	M39_511	M39_1011	M39_512	M39_1112	M39_613
M40	M40_511	M40_1011	M40_512	M40_1112	M40_613
M41	M41_511	M41_1011	M41_512	M41_1112	M41_613
M42	M42_511	M42_1011	M42_512	M42_1112	M42_613
M43	M43_511	M43_1011	M43_512	M43_1112	M43_613
M44	M44_511	M44_1011	M44_512	M44_1112	M44_613
M45	M45_511	M45_1011	M45_512	M45_1112	M45_613
M46	M46_511	M46_1011	M46_512	M46_1112	M46_613
M47	M47_511	M47_1011	M47_512	M47_1112	M47_613
M48	M48_511	M48_1011	M48_512	M48_1112	M48_613
M48.1	M48.1_1011	M48.1_1011	M48.1_1011	M48.1_1112	M48.1_1112

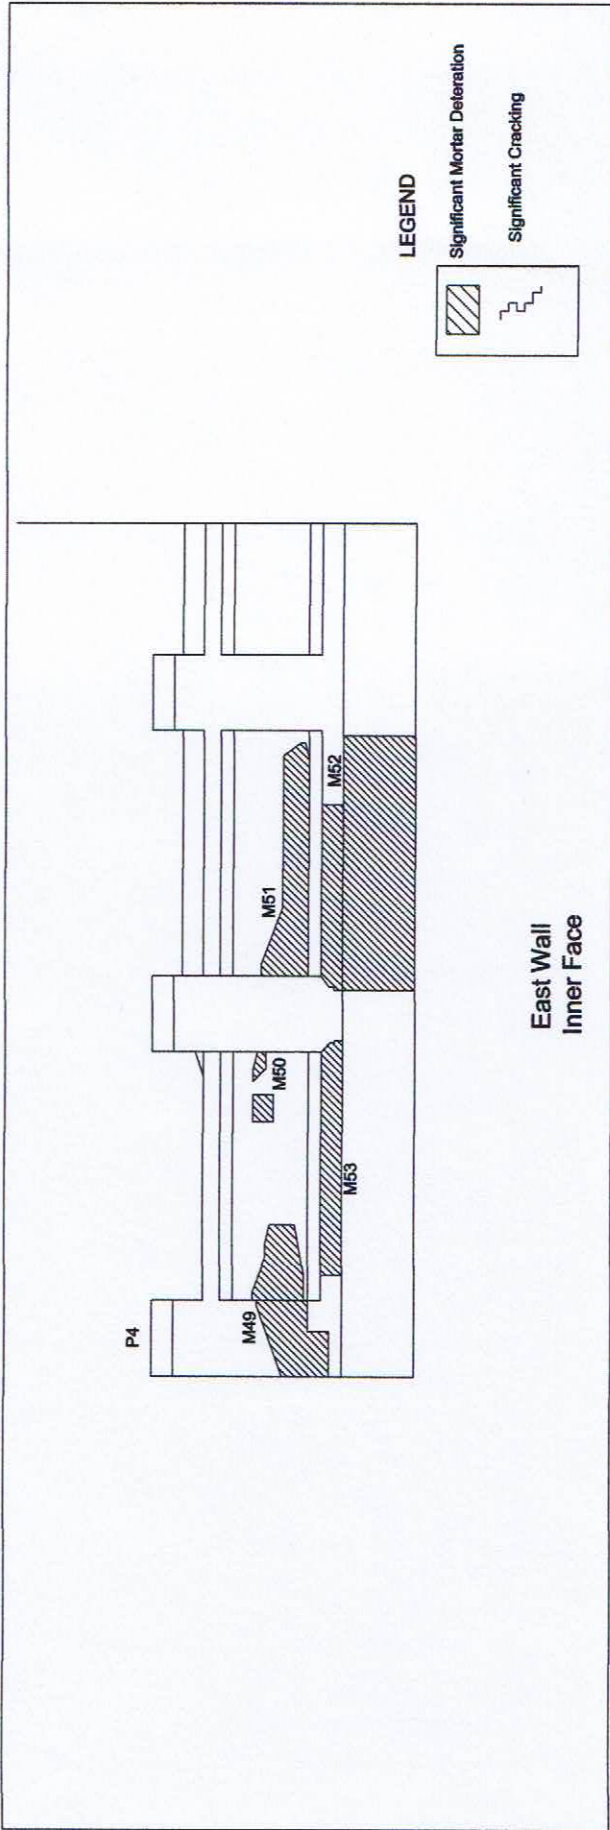
East Wall  
Inner Face

East Wall—Inner Face					
Significant Mortar Loss					
Significant Mortar Loss ID	Photo Reference	Photo Reference	Photo Reference	Photo Reference	Photo Reference
M49	M49_511	M49_1011	M49_512	M49_1112	M49_613
M50	M50_511	M50_1011	M50_512	M50_1112	M50_613
M51	M51A, B_511	M51_1011	M51_512	M51_1112	M51_613
M52	M52_511	M52_511, B	M52_512	M52_1112	M52_613
M53	M53_511		M49-50_512	M49-50_1112	M49-50_613

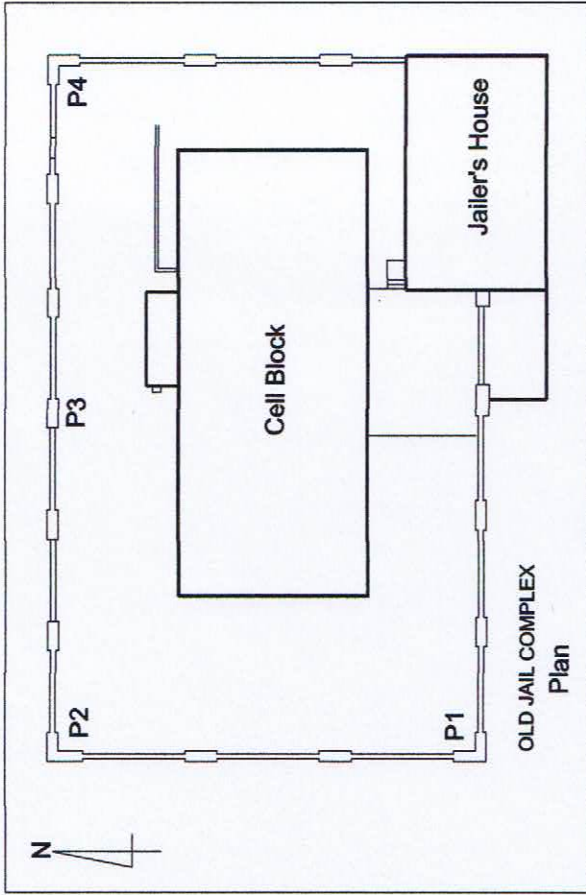
Pilaster P1

Pilaster 1—Inner Face Normalized Measurements						
Weather Conditions		Overcast to Sunny 82-87 F	Mostly Sunny 60 F	Partly Cloudy to Sunny 83-87 F	Partly Cloudy to Sunny 72 F	Mostly Sunny 83 F
	Vertical Distance Above Foundation	Measurement (Inches) 5/22/2011	Measurement (Inches) 10/1/2011	Measurement (Inches) 5/30/2012	Measurement (Inches) 11/11/2012	Measurement (Inches) 6/11/2013
Pilaster 1 Face South Wall	10'-11"	0	0	0	0	0
	8'-11"	-0.104	-0.081	-0.082	-0.057	-0.083
	6'-11"	-0.219	-0.221	-0.243	-0.211	-0.217
	4'-11"	-0.194	-0.277	-0.303	-0.169	-0.293
	2'-11"	-0.194	-0.339	-0.35	-0.289	-0.409
West Wall	9'-2"	0	0	0	0	0
	7'-2"	0.051	0.164	0.202	0.199	0.231
	5'-2"	0.24	0.356	0.431	0.31	0.376
	3'-2"	0.062	0.318	0.18	0.176	0.262

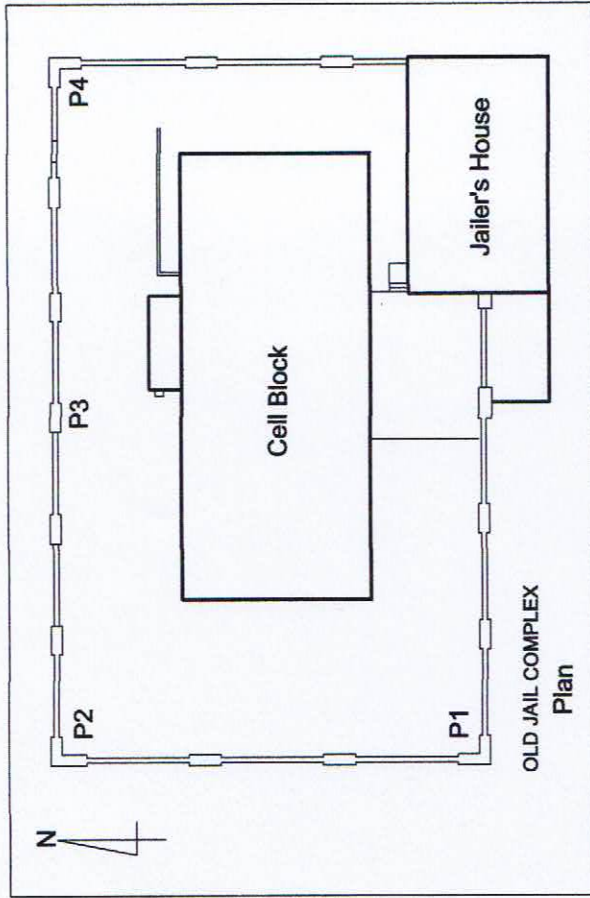
Pilaster P2 is unique in that it appears to be stabilizing and only showing effects of mortar and brick degradation in the upper reaches of the north wall component. This is likely the result of separation of the west wall from the pilaster due to cracking, and repairs previously made to the

outer wythe brick at the pilaster base. Even though the pilaster appears to be stabilizing, it is not as structurally stable as it once was due to the loss of the west wall “bracing” effect.

Pilaster 2--Inner Face Normalized Measurements						
Weather Conditions	Overcast to Sunny 82-87 F	Overcast to Sunny 75-79 F	Partly Cloudy to Sunny 83-87 F	Partly Cloudy to Sunny 66 F, 72F	Sunny 83F	Measurement (Inches) 6/11/2013
	Measurement (Inches) 5/22/2011	Measurement (Inches) 9/30/2011	Measurement (Inches) 5/30/2012	Measurement (Inches) 11/10-11/2012	Measurement (Inches) 11/10-11/2012	Measurement (Inches) 6/11/2013
<b>Pilaster 2 Face West Wall</b>	Vertical Distance Above Foundation	9'-1"	0	0	0	0
	7'-1"	-0.848	-0.233	-0.172	-0.207	-0.271
	5'-1"	-0.962	-0.309	-0.159	-0.27	-0.258
	3'-1"	-1.009	-0.412	-0.246	-0.338	-0.345
<b>North Wall</b>	8'-10 1/2"	0	0	0	0	0
	6'-10 1/2"	0.123	0.091	0.069	0.086	0.042
	4'-10 1/2"	0.338	0.319	0.374	0.252	0.266
	2'-10 1/2"	0.413	0.359	0.313	0.255	0.276

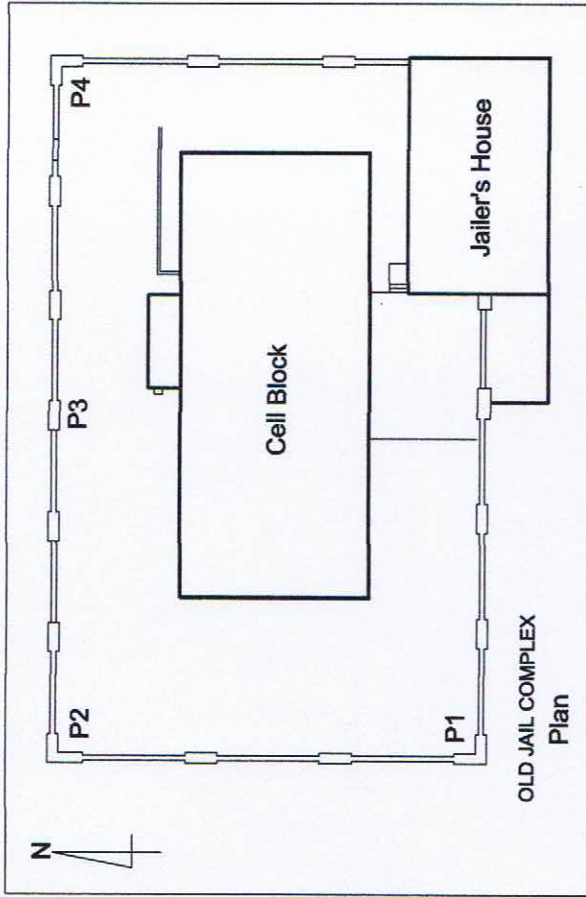
Pilaster P3

From a review of the photo logs it is obvious that considerable mortar and brick deterioration has occurred on the inner and outer wythes in the northeast corner of the perimeter wall. Less prominent is the deterioration that has occurred in the southwest corner. A review of the regression curves for pilaster P1 in the southwest corner suggests that deterioration/mortar loss in the outer wythe is impacting the movement and slope of the pilaster. The indication is that the southwest corner and pilaster P1 are in the early stages of brick and mortar deterioration. Similarly, the regression curves for pilaster P3, mid-reach of the north wall, also suggest that mortar loss and deterioration near the wall base is impacting pilaster P3 movement.

Pillar 3—Inner Face Normalized Measurements					
Weather Conditions	Overcast to Sunny 82-87F	Overcast to Sunny 75-80F	Partly Cloudy to Sunny 83-87F	Partly Cloudy to Sunny 72F	Sunny 83F
Pillar 3 Face	Measurement (Inches) 5/22/2011	Measurement (Inches) 9/30/2011	Measurement (Inches) 5/30/2012	Measurement (Inches) 11/11/2012 *	Measurement (Inches) 6/11/2013
North Wall	0	0	0	0	0
Vertical Distance Above Foundation 11'-10 1/2"	0.292	0.318	0.316	0.277	0.362
9'-10 1/2"	0.527	0.616	0.556	0.364	0.655
7'-10 1/2"	0.613	0.66	0.587	0.549	0.84
3'-10 1/2"	0.627	0.685	0.694	0.609	0.87

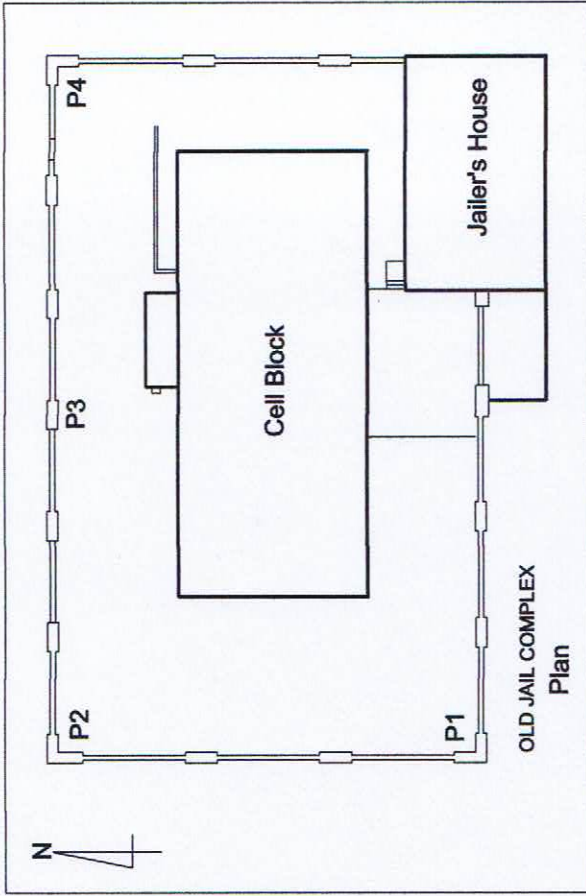
Pilaster P4

Pilaster 4—Inner Face Normalized Measurements						
Weather Conditions	Overcast to Sunny 82-87F	Sunny 75-80F	Overcast to Sunny 83-87F	Sunny 66F	Sunny 83F	
Pilaster 4 Face	Measurement (Inches) 5/22/2011	Measurement (Inches) 9/29/2011	Measurement (Inches) 5/30/2012	Measurement (Inches) 11/10/2012	Measurement (Inches) 6/11/2013	
Vertical Distance Above Foundation						
North Wall						
8'-0"	0.000	0.000	0.000	0.000	0.000	
6'-0"	-0.110	0.043	0.032	-0.031	0.130	
4'-0"	-0.076	-0.010	0.057	-0.022	0.191	
2'-0"	-0.049	0.035	-0.131	-0.005	0.244	
East Wall						
8'-0"	0	0	0	0	0	
6'-0"	0.034	-0.113	0.031	0.137	0.14	
4'-0"	0.175	-0.029	-0.045	0.006	-0.125	
2'-0"	0.213	0.164	0.005	0.199	0.197
