Subject: BAR Action - Lee Park 101 E Market Street - October 20, 2015

CITY OF CHARLOTTESVILLE BOARD OF ARCHITECTURAL REVIEW STAFF REPORT October 20, 2015

# City of Charlottesville, VA Repairs at Lee Park Feasibility Study

October 20, 2014 FINAL DRAFT

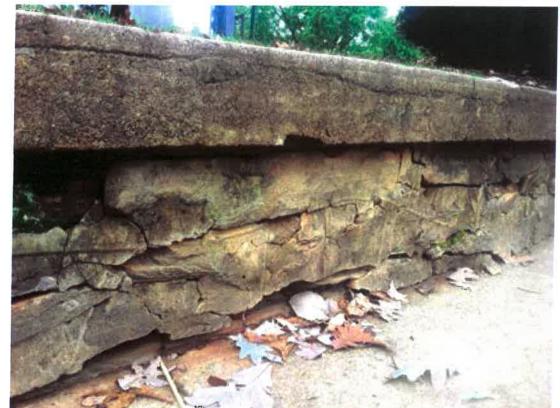
Photograph 2 - Remaining Parge Coating Along East Elevation (note raised read tooling marks)

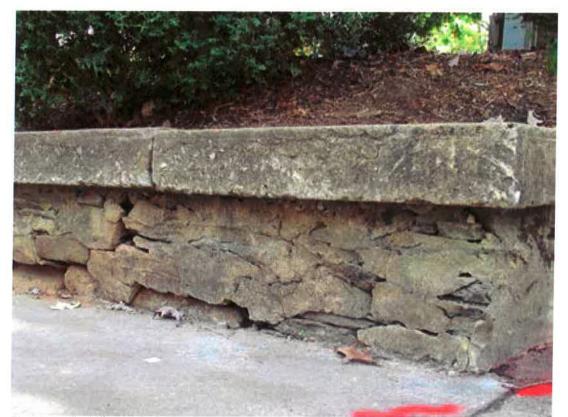
Photograph 4 - Parge Coating along East Elevation near 2nd Street Stairway

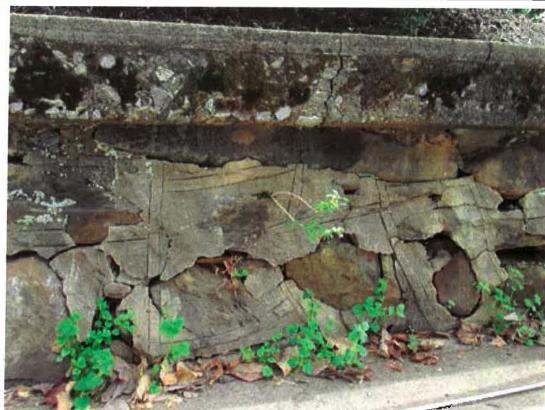
Photograph 3 - Remaining Parge Coating Along West Elevation (note double struck tooling marks)

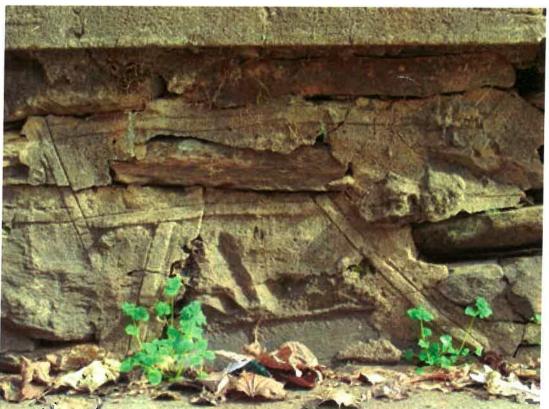
Photograph 5 - Remaining Parge Coating Along West Elevation

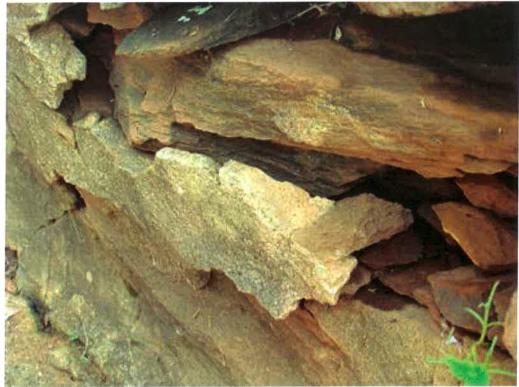
Photograph 10 - Stacked Stone + Parge Coating

the only location where the parge coat remained corresponded with the joints between stones, see Photograph 10. This may be due to the porous nature of the stone, "Every kind of stone is more or less porous; it absorbs moisture from a damp atmosphere, from rain, from groundwater [...] the action [water migration] may cause the surface to break off..."<sup>11</sup>

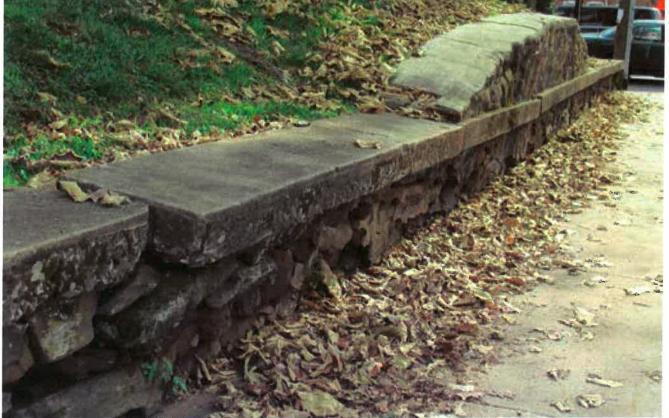
Photograph 11 - Existing Wall Showing Concrete Cap Dislocation

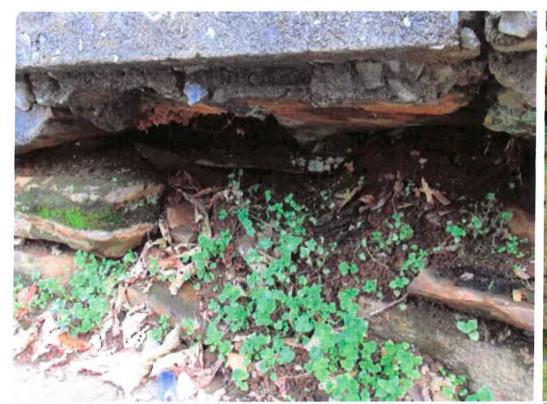
Photograph 12 - Erosion of Retained Earth

was the apparent erosion of the earth fill from behind the wall into the wall cavity. The most reliable field measurements from various locations around the project site indicated the stone retaining walls to be roughly 14 to 16 inches thick at midheight of the wall.

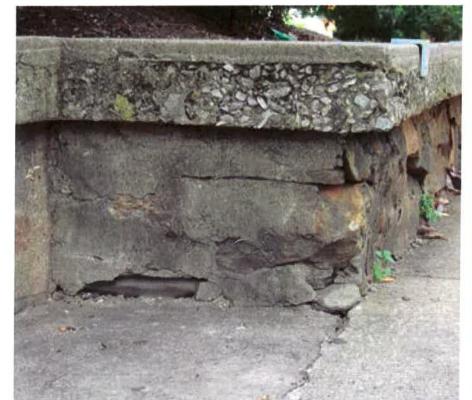
Photograph 14 - Concrete Cap Revealing Exposed Aggregate

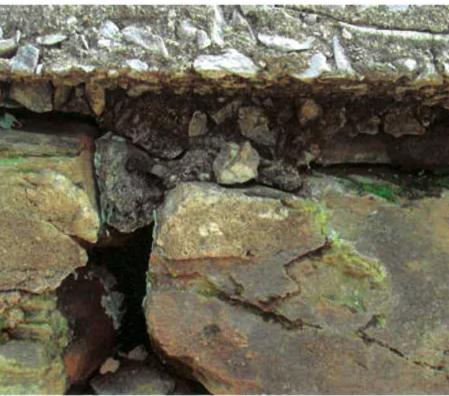
Photograph 13 - Concrete Cap Cast Atop of Stone Wall

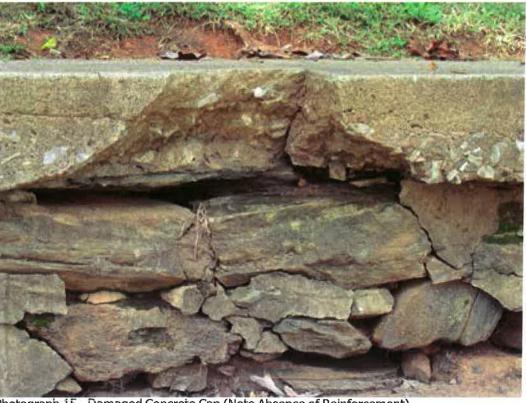
Photograph 15 - Damaged Concrete Cap (Note Absence of Reinforcement)

In isolated locations throughout the project vicinity, the concrete cap has been chipped or broken, see Photograph 15. These locations have been recorded on the field notes provided in Appendix A.

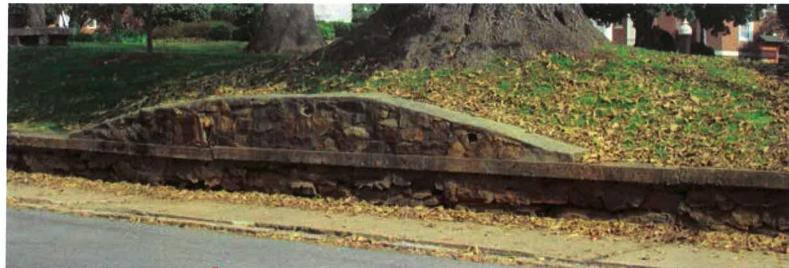
Photograph 16 - Retaining Wall Extension at the American Linden Tree

The existing stone masonry wall(s) adjacent to the American Linden tree will need to be replaced with a structural system capable to resist the anticipated loadings.

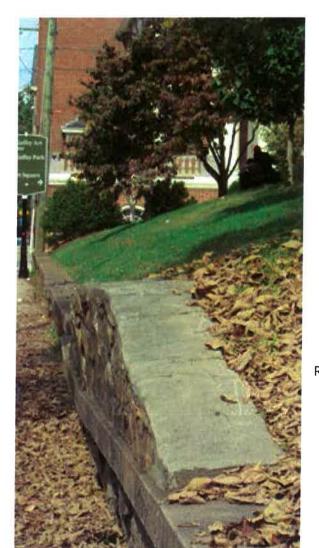
Photograph 17 - Retaining Wall Extension

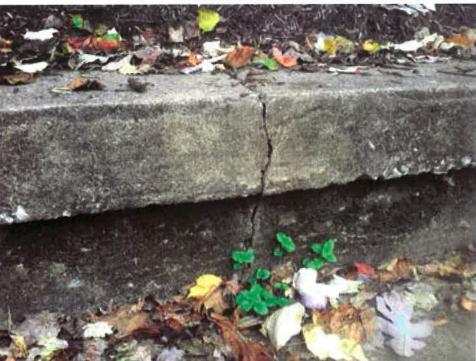
Photograph 19 - Transverse Crack in Concrete Retaining Wall

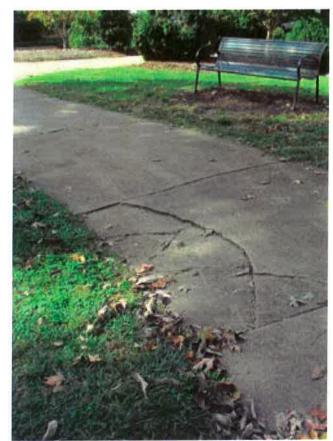
Photograph 19 - Typical Concrete Sidwalk Damage

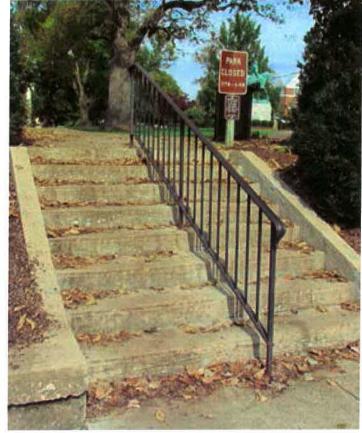
Photograph 21 - Metal Handrail

The current handrails do not comply with the full extent of the ADAAG recommendations for grab bars and handrails.<sup>18</sup>
