Certificate of Appropriateness
BAR # HST25-0112
159 Madison Lane, TMP 090145000
The Corner ADC District (contributing structure)
Owner: Montalto Corporation
Applicant: Paul Tassell / The Gaines Group
Project: Misc. repairs/improvements to south porch

**City of Charlottesville
Board of Architectural Review
Staff Report
November 18, 2025**

Project: Masonry repairs and rehabilitation work at south elevation

PHI KAPPA PSI FRATERNITY HOUSE - BAR SUBMITTAL

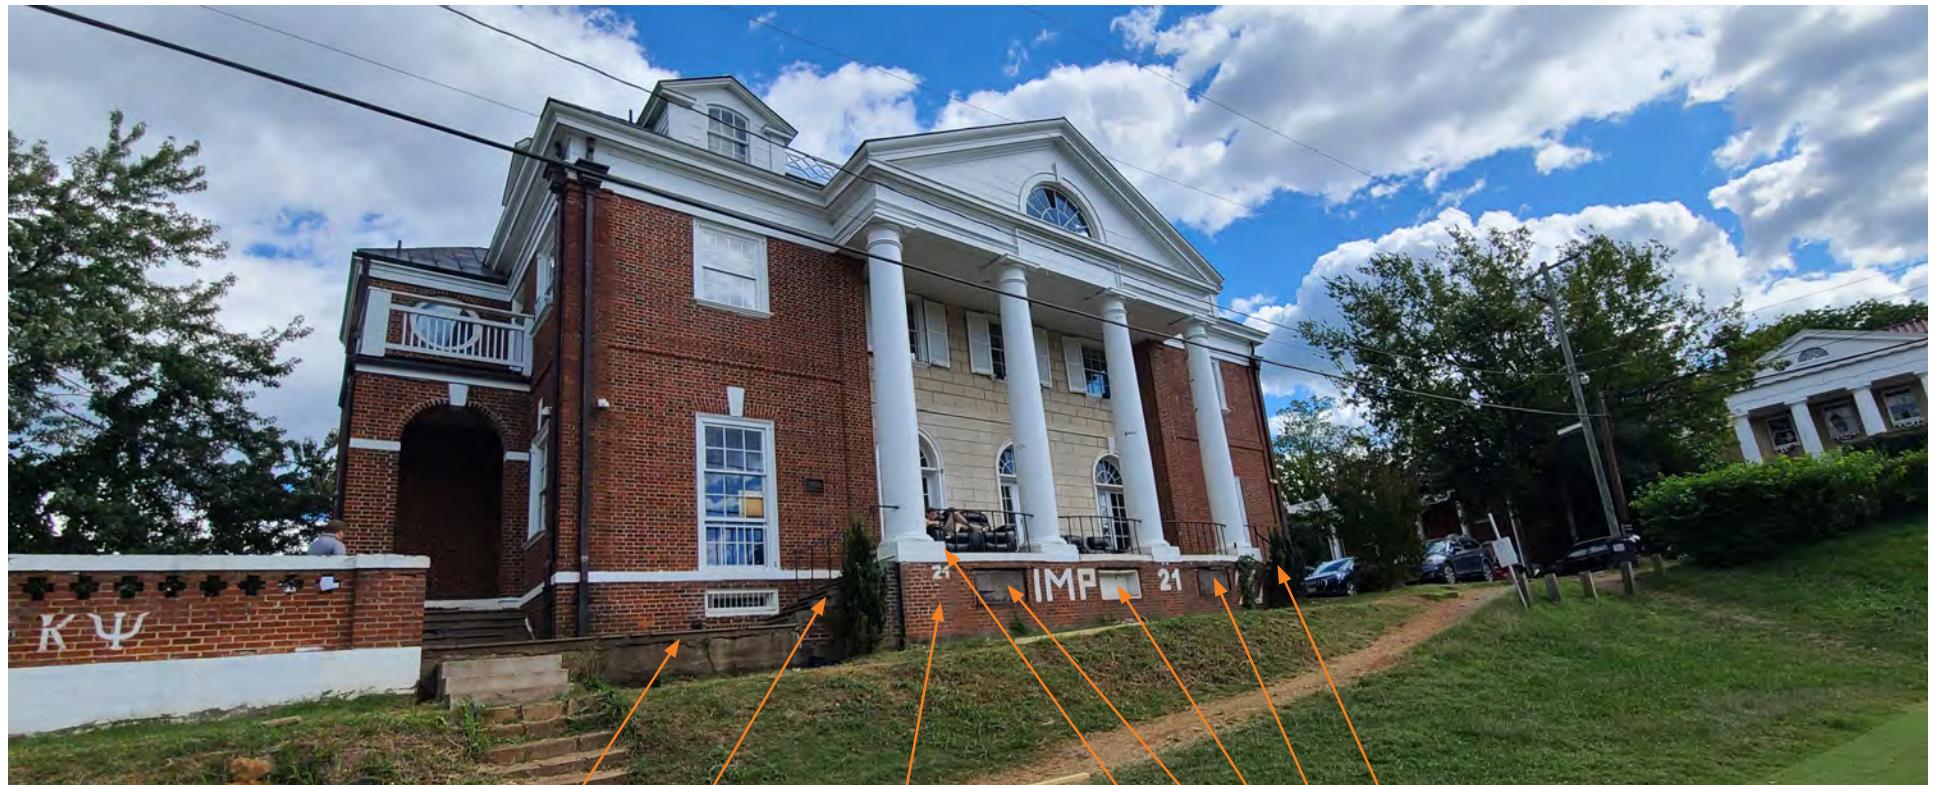
EXISTING CONDITIONS - SOUTH ELEVATION

Elevated slab has experienced deterioration over time due to water infiltration causing cracking, spalling, corrosion of reinforcement, discoloration & staining, and overall weakening.

Left side exterior stair has experienced deterioration to the brick and slab due to water infiltration and winter salts causing cracking, spalling, corrosion to railing, discoloration & staining, and overall weakening.

Face brick has experienced deterioration over time due to water infiltration causing cracking, bowing, efflorescence, discoloration & staining, and overall weakening.

Right side exterior stair has experienced deterioration to the brick and slab due to water infiltration and winter salts causing cracking, spalling, corrosion to railing, discoloration & staining, and overall weakening.

In response to constant vandalism, plywood was used to infill window openings.

Portico surface has experienced deterioration over time due to water infiltration causing cracking, spalling, corrosion of reinforcement, discoloration & staining, and overall weakening.

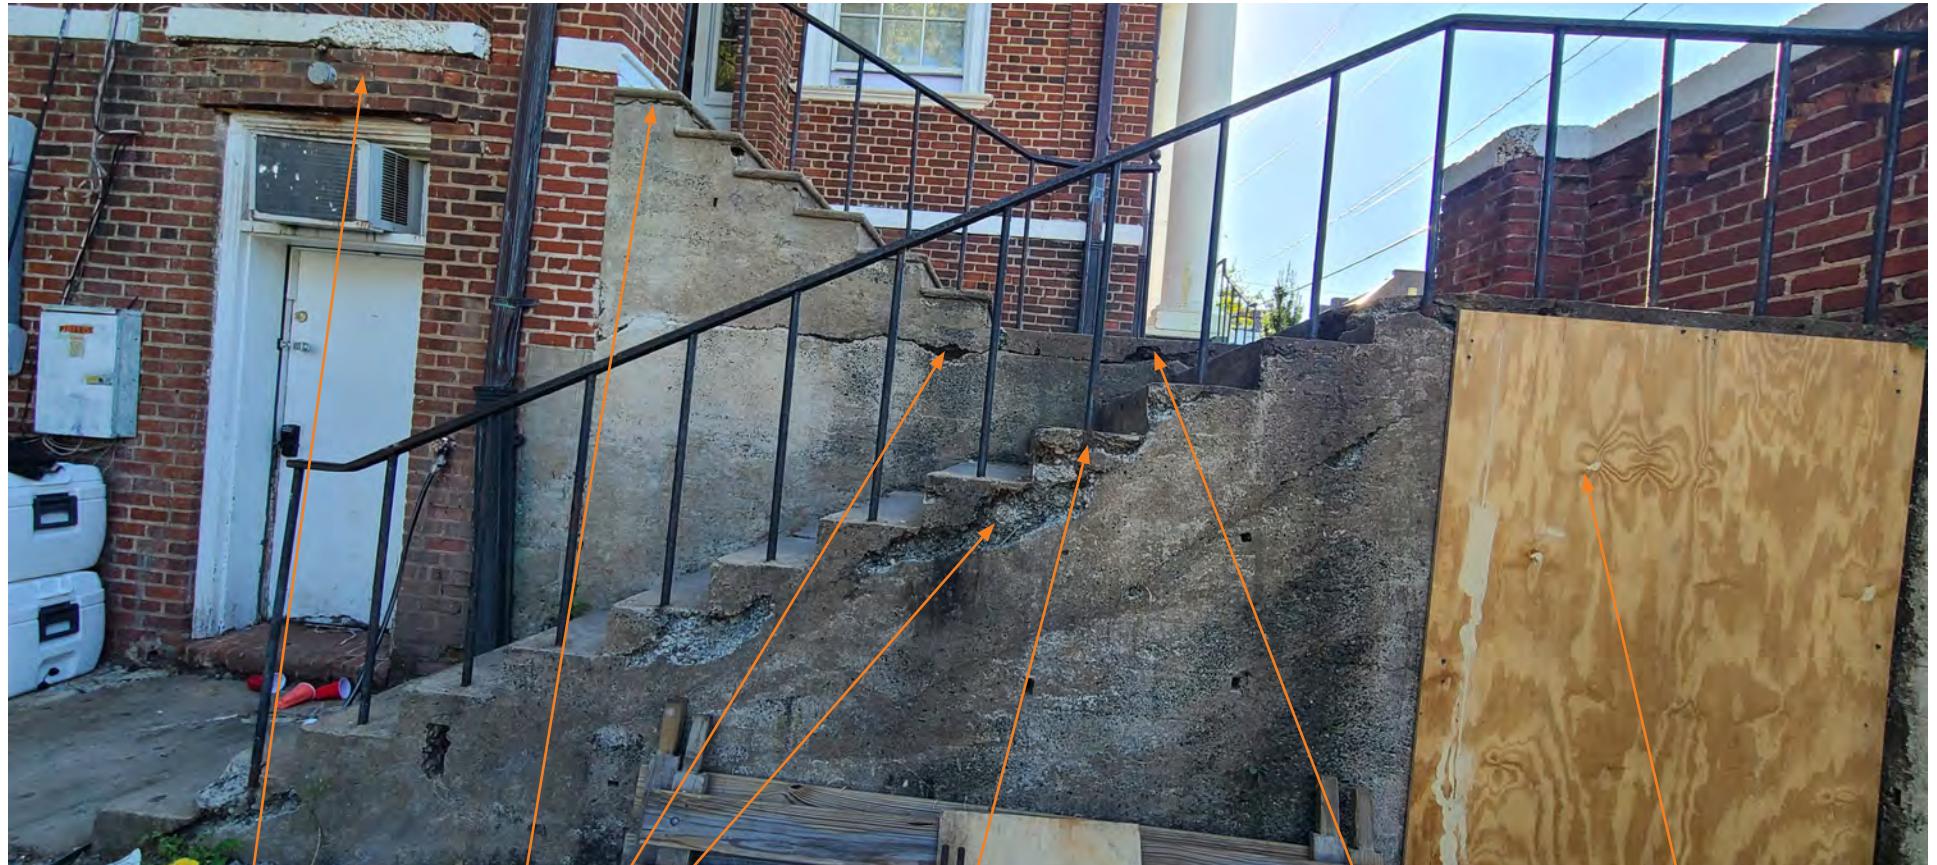
EXISTING CONDITIONS - WEST ELEVATION

Face brick has experienced deterioration over time due to water infiltration causing cracking, bowing, efflorescence, discoloration & staining, and overall weakening.

Exterior stair has experienced deterioration to the brick and slab due to water infiltration and winter salts causing cracking, spalling, corrosion to railing, discoloration & staining, and overall weakening.

Metal railing attachment to staircase is compromised due to water infiltration.

In response to constant vandalism, plywood was used to infill opening below elevated slab.

Elevated slab has experienced deterioration over time due to water infiltration causing cracking, spalling, corrosion of reinforcement, discoloration & staining, and overall weakening.

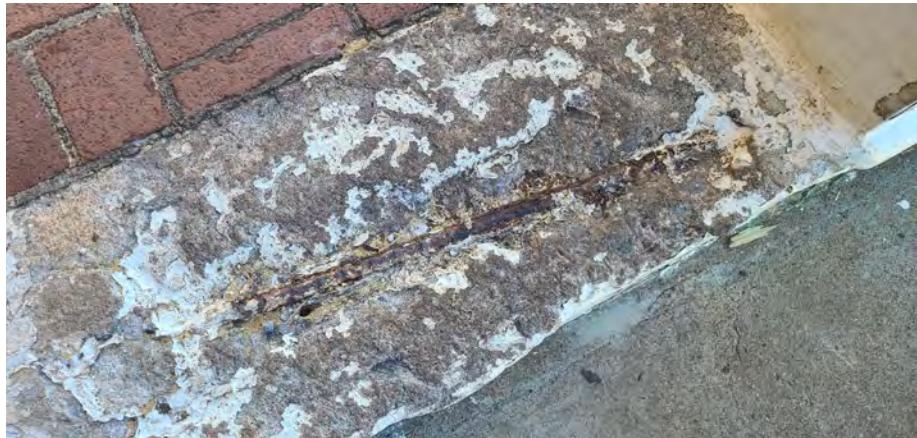
FRONT PORTICO -
DETERIORATION TO PRECAST
EXPOSING REINFORCING

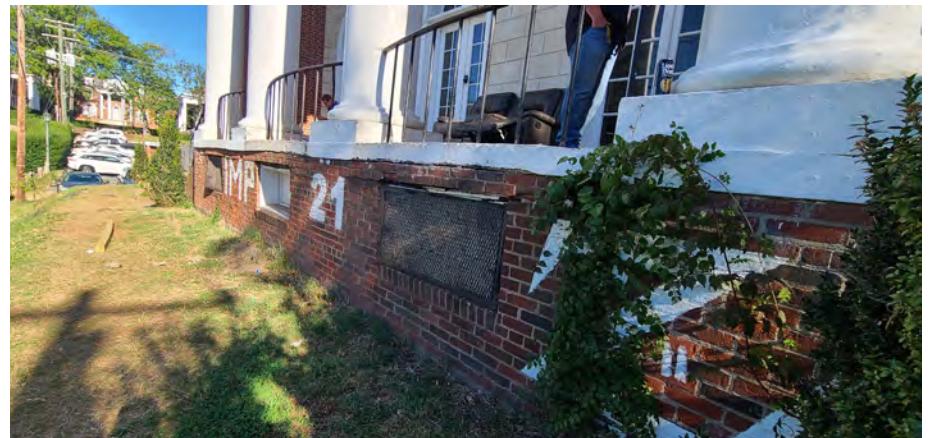
FRONT PORTICO -
BRICK DETERIORATION
PLYWOOD INFILLS TO WINDOWS

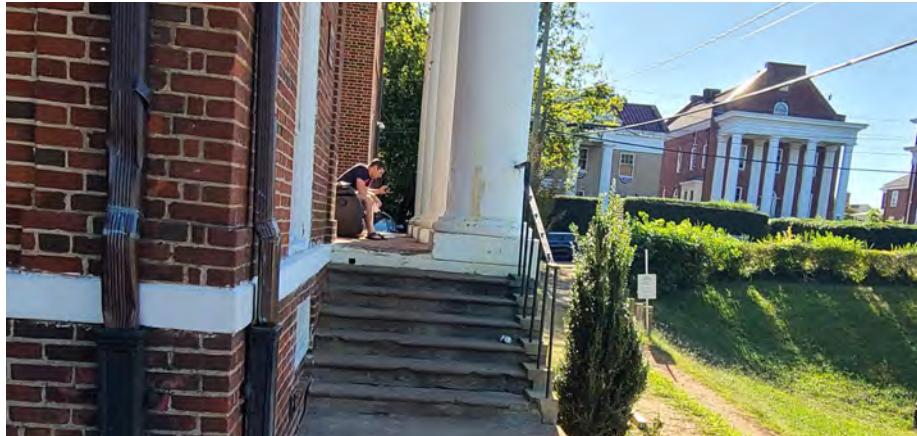
LEFT SIDE EXTERIOR STAIRS -
DETERIORATION TO CONCRETE AND
BRICK & PREVIOUS ATTEMPTS AT REPAIR

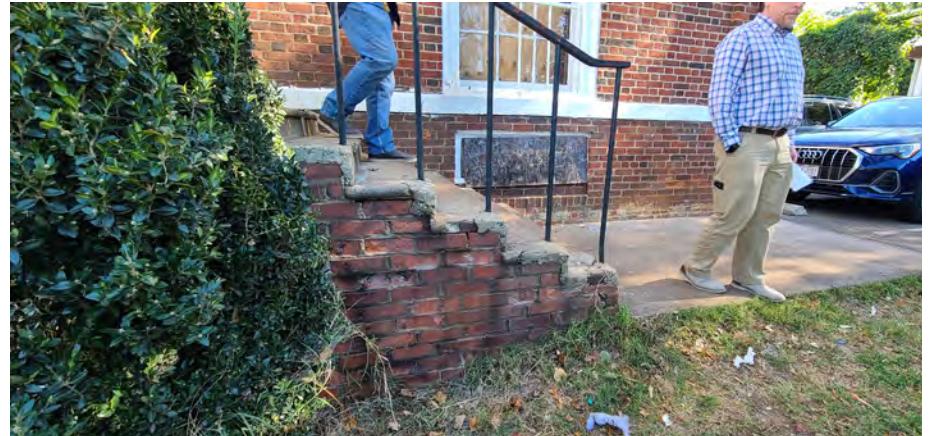
RIGHT SIDE EXTERIOR STAIRS -
DETERIORATION TO CONCRETE AND
BRICK & PREVIOUS ATTEMPTS AT REPAIR
