From: Werner, Jeffrey B
Sent: Wednesday, April 17, 2024 4:34 PM
To: Chinh Q. Le
Subject: 712 Ridge Street - BAR action March 2024

Certificate of Appropriateness
BAR 24-03-01
712 Ridge Street, TMP 250067000
Ridge Street ADC District
Owner/Applicant: Chinh Le
Project: Replace doors/windows, remove chimney, construct driveway

Certificate of Appropriateness Application

BAR 24-03-01

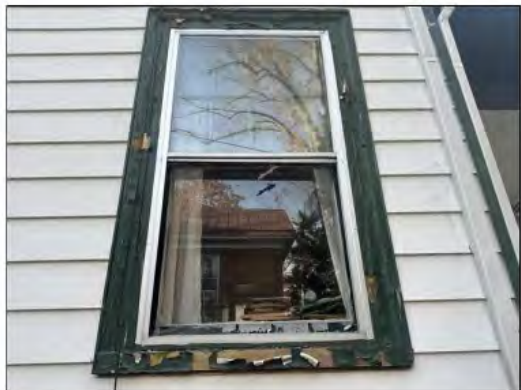
2.2 Item 1(Picture)

Scrape, caulk, paint the five (5) windows and trim around windows to help ensure the windows don't deteriorate faster and to help prevent water entering into the interior of the home thus causing more issues. This is routine maintenance that happens on every home and should be done every 3-5 years depending on the wear of the paint/caulk used.

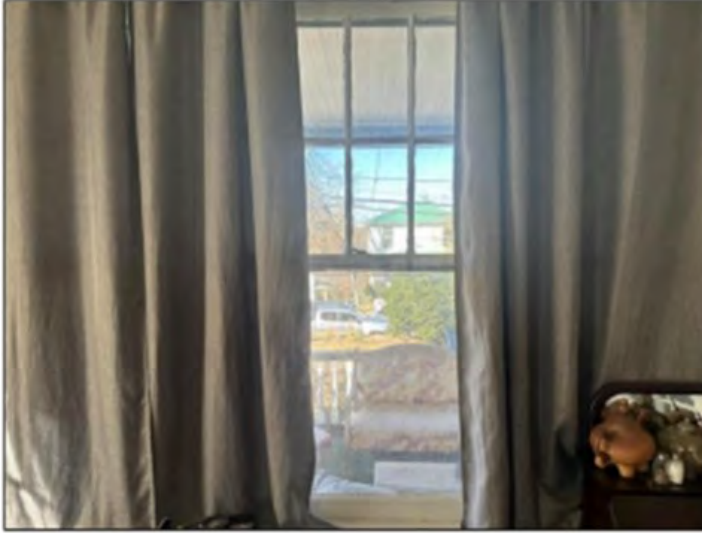
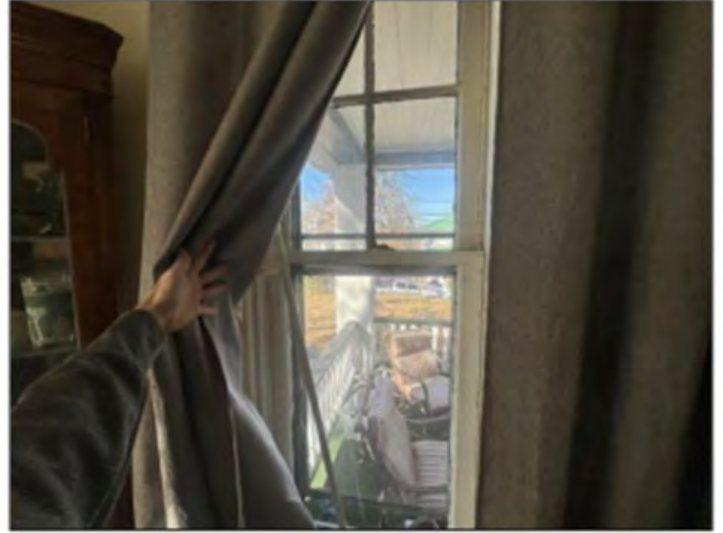
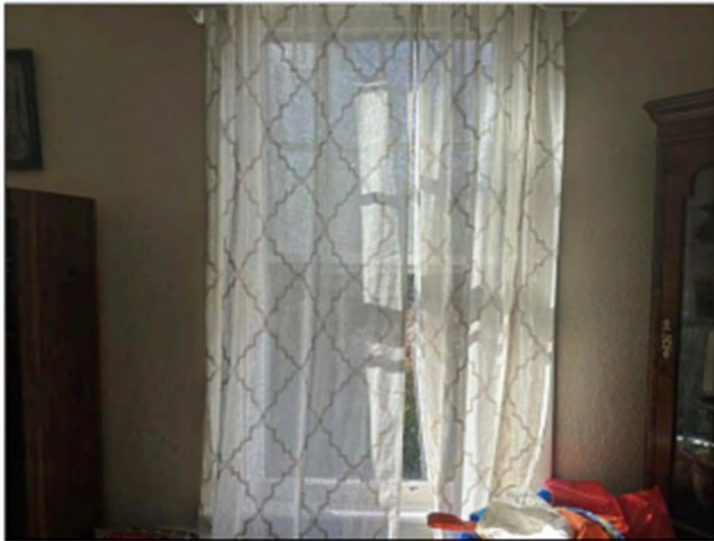
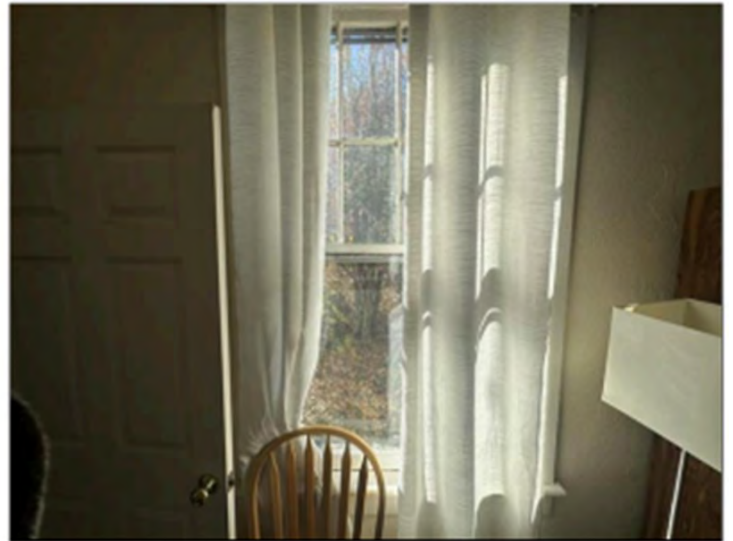
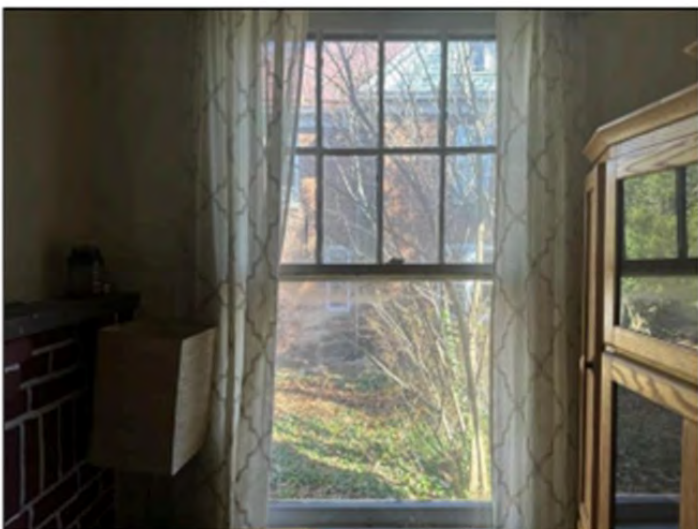
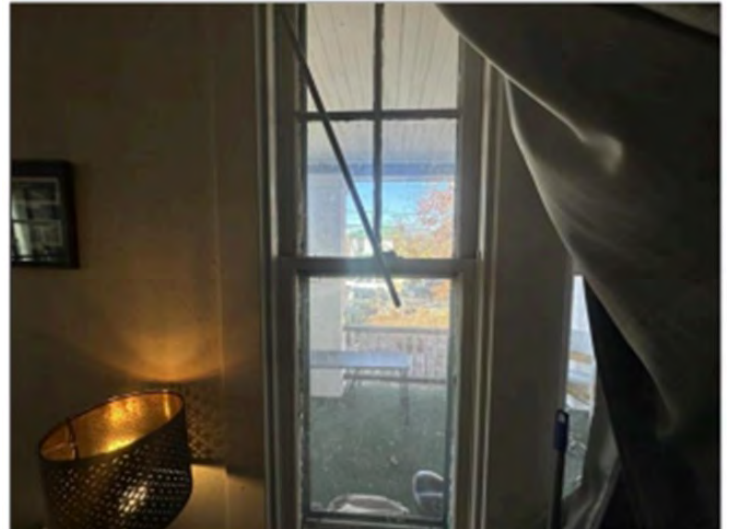
There were ten (10) windows on the main level that would not open at the time of the inspection. There were four (4) windows on the upper level of the home that did not open during the inspection. They have either been painted shut or have been fastened shut. I recommend having a qualified window contractor repair/replace as needed such that the windows operate as designed. Also, windows in bedrooms should be operational for fire egress. This should be considered when addressing the issue.

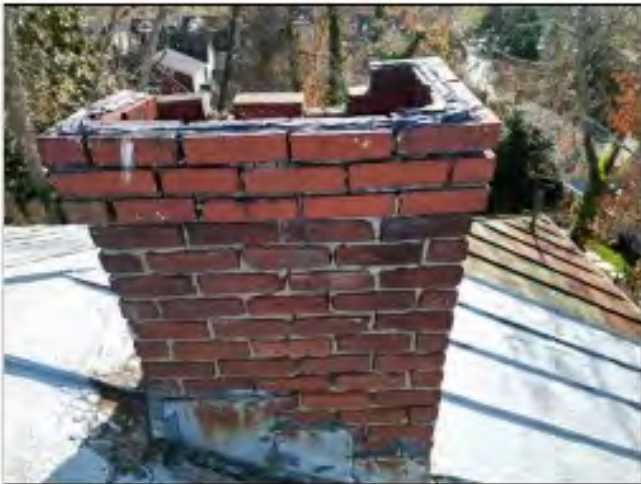
3.5 Item 1(Picture)

The home currently has two chimneys, one on the left side of the house, which is connected to a working fireplace, and one on the right side of the house, which is no longer in use. The housing inspection report we obtained prior to purchasing the house, which is attached, indicates that the chimney on the right side of the house is structurally unsound, unsafe, and needs to be removed or rebuilt. ([see below] See pages 10-11, 12-13; photos included.) The top of the chimney is visibly uneven to the naked eye, and the base of the chimney is also bulging and vulnerable to collapse.

Because the chimney on the right side of the house is dangerous and no longer working, and because there is a prominent (and still functioning) chimney on the other side of the house, we propose hiring a masonry professional to remove the entire chimney from the ground up. Removing the chimney so would save us from having to completely reconstruct a chimney structure that would remain unused and that would take up space in the middle of the right side of the home and that would prevent efficient use of the space inside the home.

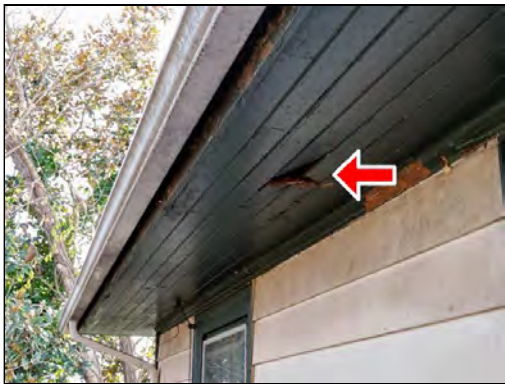
2.5 Item 1(Picture)

There is a hole in the soffit on the left side of the home. This can allow animals to gain access to the attic. I recommend a qualified contractor replace the broken section of the wood soffit. Item 1(Picture)

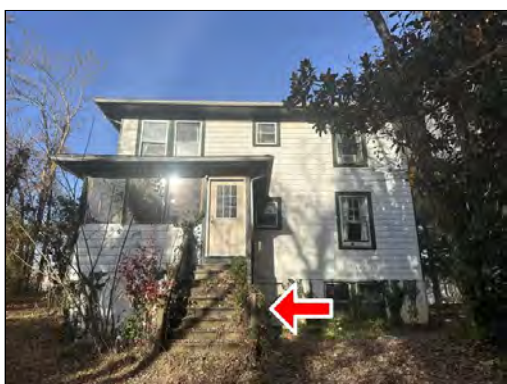
3.0 Item 4(Picture)

(2) The majority of the above-grade block foundation at the rear of the home is made of dry stacked block without mortar joints. This area needs to be pointed up. This process will help the foundation wall retain its strength as well as preventing animal/pest intrusion from occurring into the crawl spaces of the home. This task can be completed by a licensed masonry contractor.

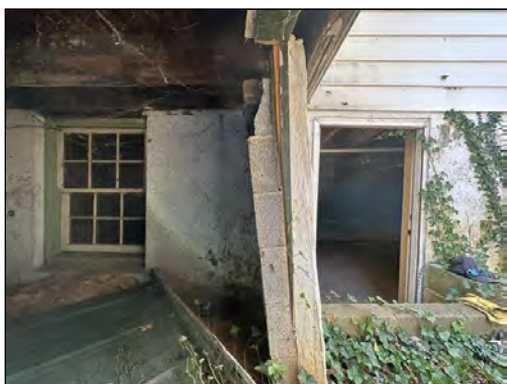
3.0 Item 8(Picture)

(3) The rear CMU foundation wall has settled and is no longer supporting the structure above. I recommend a licensed masonry contractor investigate further and repair the structure.

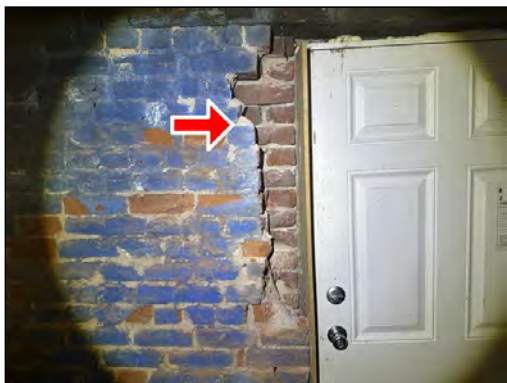
3.1 Item 1(Picture)

The structural brick is missing on the left side of the basement exterior door frame. The brick needs to be replaced to give the door frame proper structural support. I recommend a qualified mason to complete this task.

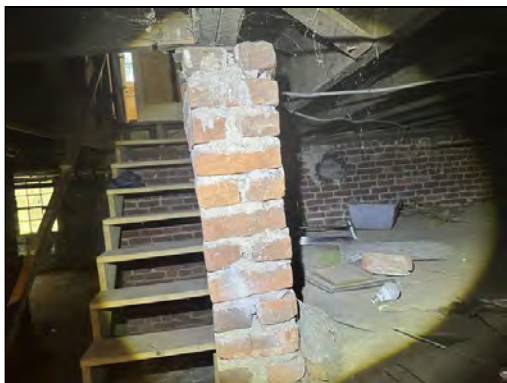
3.2 Item 1(Picture)

The brick support column in the basement is leaning, weakening it's structural integrity. I recommend a qualified mason rebuild the column.

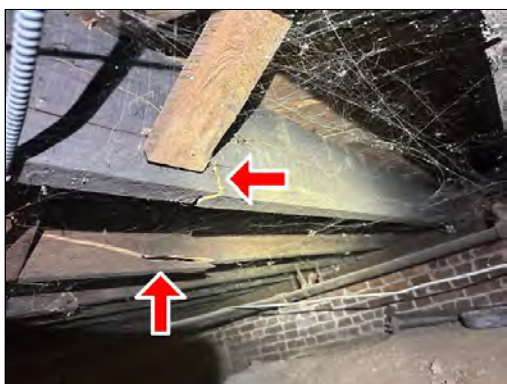
3.3 Item 1(Picture)

There were three (3) cracked floor joist in the basement. The effectiveness of these joist being able to support the floor above has been compromised due to the broken joists. I recommend having a licensed contractor repair as needed to properly support the floor.

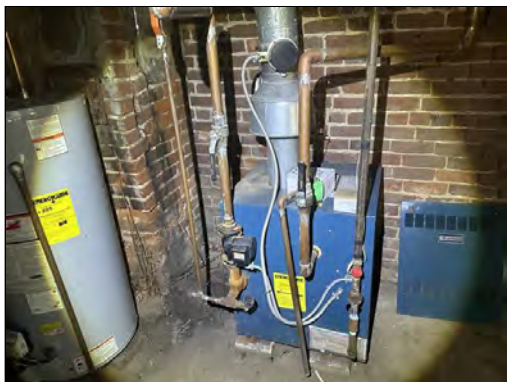
4.0 Item 1(Picture)

The circulating boiler was working at the time of the inspection. However the unit was not fully combusting the natural gas this is causing the unit to run less efficiently. I recommend a qualified boiler technician inspect further and repair. This unit is past the national life expectancy rate of 15-20 years. I recommend having the unit serviced and starting a budget for it's eventual replacement.

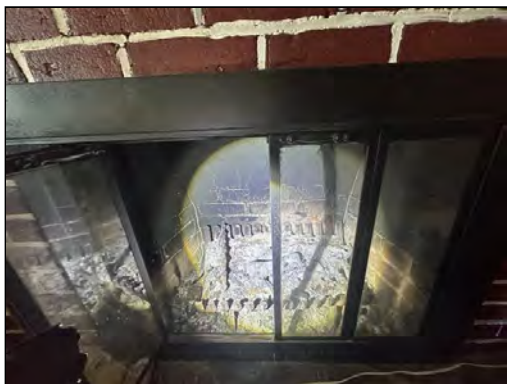
4.5 Item 1(Picture)

(1) I recommend having the chimney inspected by a qualified chimney sweep before use as the inspection conducted today is a visual inspection and does not take into consideration the current status of the inner workings of the chimney flue.

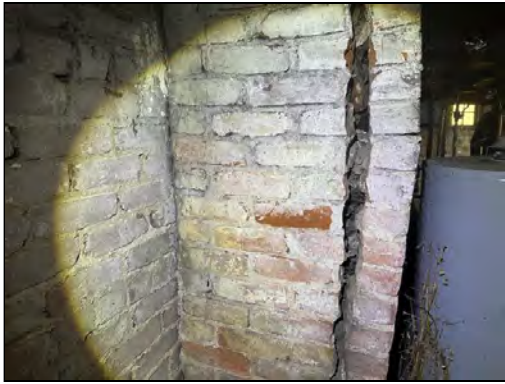
4.5 Item 3(Picture)

(2) The right side chimney's structural brick is failing and in need of rebuilding. This can impact the effectiveness of any gas-powered appliances' ability to properly ventilate carbon monoxide gas to the exterior. I recommend a licensed mason complete this task.

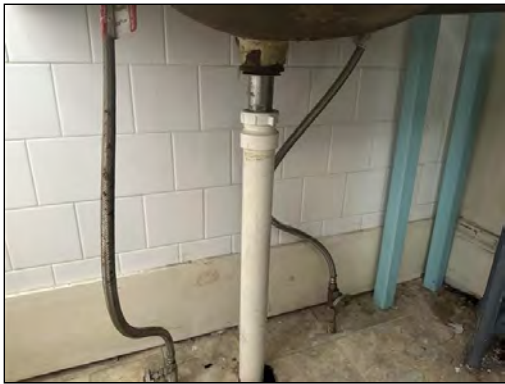
5.1 Item 1(Picture)

(1) There is no P-Trap installed at the upstairs bathroom sink. A P-Trap is designed to get sewer gases from back flowing into the home. I recommend a licensed plumber investigate and the necessary repairs to each sink.

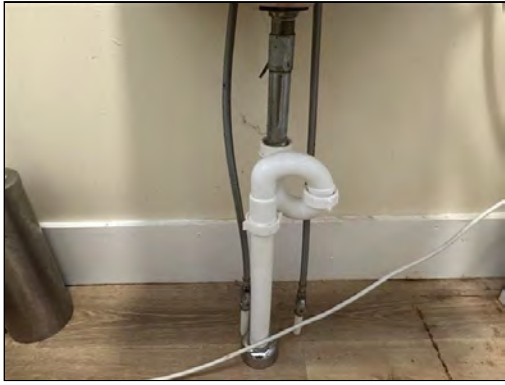
5.1 Item 3(Picture)

of the trap. I recommend having a licensed plumber repair the piping as needed such that only a p-trap can be installed and remove the risk of siphoning of the trap system.

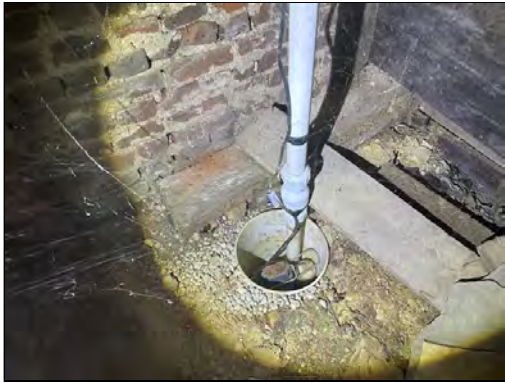
5.6 Item 1(Picture)

The sump pump did not have a proper cover that was secured to the floor to prevent unwanted gases from emitting in the home. I recommend having a licensed plumber install one.

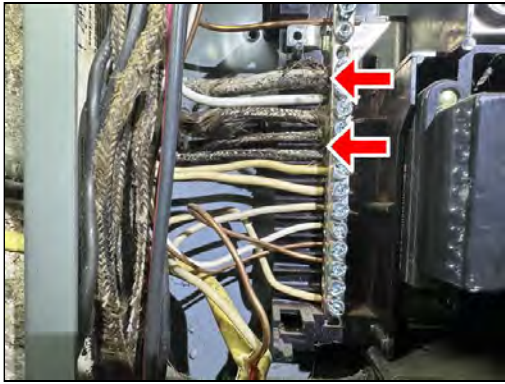
6.2 Item 1(Picture)

(1) There was cloth wiring present in the panel. This has been known to cause fires in the past and is no longer used in construction today. I recommend having a licensed electrician investigate further and correct as needed for safe operation.

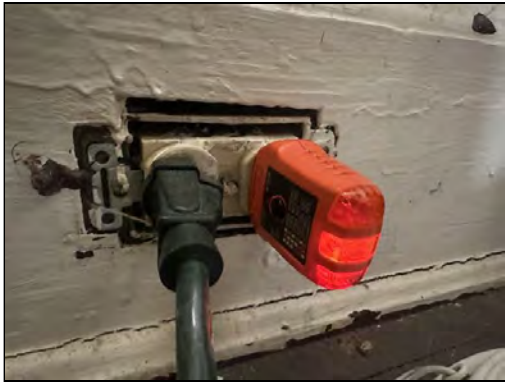
6.3 Item 1(Picture)

There was one (1) outlet on the first floor of the home that was not properly grounded during the inspection. I recommend having a licensed electrician investigate further and correct as needed. A properly grounded outlet is important because it protects the appliances connected and people from the potential risk of electrical shock due to a power surge. There were six (6) outlets found during the inspection that are old style two-pronged. Today's devices require a three-pronged out with ground. I recommend a licensed electrician replace these with three-pronged outlets. Item 3(Picture) Item 4(Picture) Item 5(Picture) Item 6(Picture) Item 7(Picture) Item 8(Picture) Item 2(Picture)

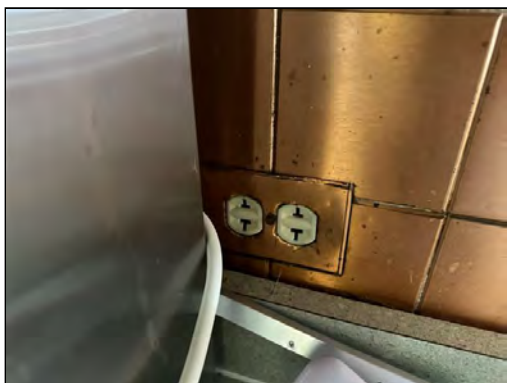
6.4 Item 1(Picture)

The outlet in the kitchen is not properly GFCI-protected. Any exterior, garage, or outlet within 6' of a plumbing fixture must be GFCI-protected to protect both the appliances and people from the potential of electrical surges that can harm the appliance or people. I recommend having a licensed electrician investigate further and correct as needed.

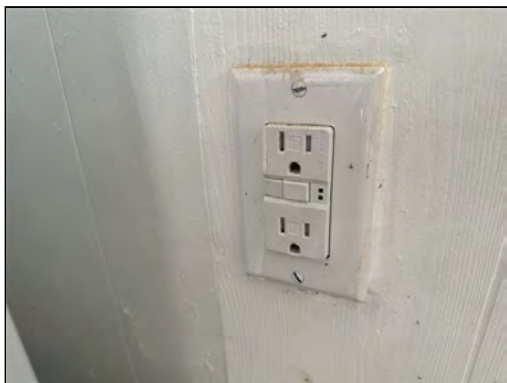
6.5 Item 1(Picture)

The laundry room GFCI outlet was not functioning properly at the time of the inspection. I recommend a licensed electrician replace it with a new GFCI outlet.

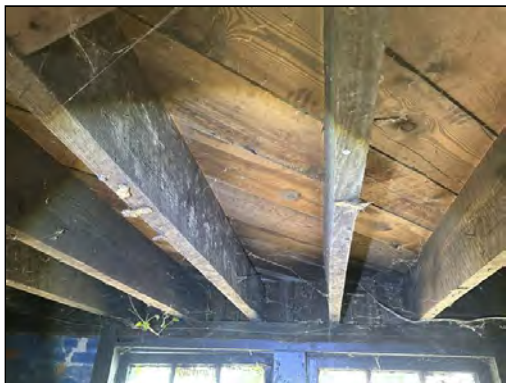
7.1 Item 1(Picture)

There was no insulation present under the floor system during the inspection. I recommend having a qualified insulation contractor install enough insulation to achieve a minimum R-19 value which is needed for this area of the country.

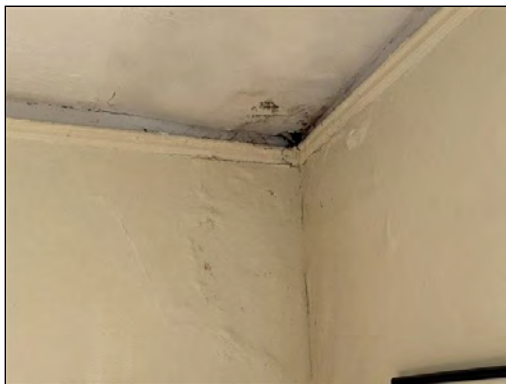
8.1 Item 1(Picture)

There was water damage present on the ceiling of the main level back bedroom. The area was tested with a moisture meter and was found to be dry at the time of the inspection. I recommend monitoring the area and having a qualified contractor repair the finishes.

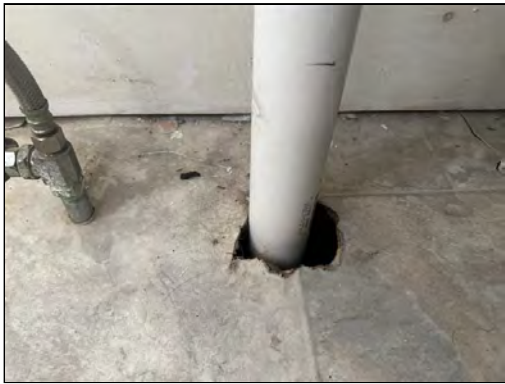
8.2 Item 2(Picture)

(2) There are two (2) areas in the upstairs bathroom where we need to seal around the plumbing penetrations in the floor. I recommend a qualified contractor repair the floor around these penetrations.

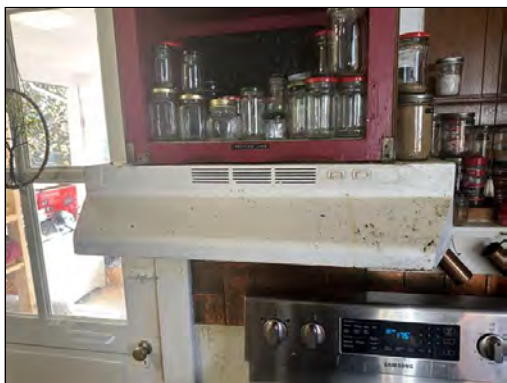
9.2 Item 1(Picture)

The exhaust fan did not function at the time of the inspection. I recommend replacing it with a unit that vents to outside the home. A qualified contractor can complete this task.

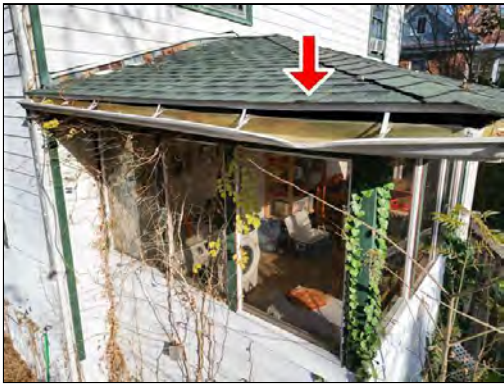
1.3 Item 2(Picture)

(2) The gutter on the rear right side of the home is damaged. This needs to be repaired to ensure the gutter functions properly. A qualified gutter specialist can complete this task.

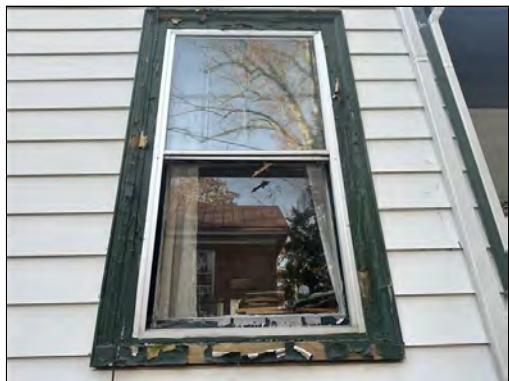
2.2 Item 1(Picture)

Scrape, caulk, paint the five (5) windows and trim around windows to help ensure the windows don't deteriorate faster and to help prevent water entering into the interior of the home thus causing more issues. This is routine maintenance that happens on every home and should be done every 3-5 years depending on the wear of the paint/caulk used.

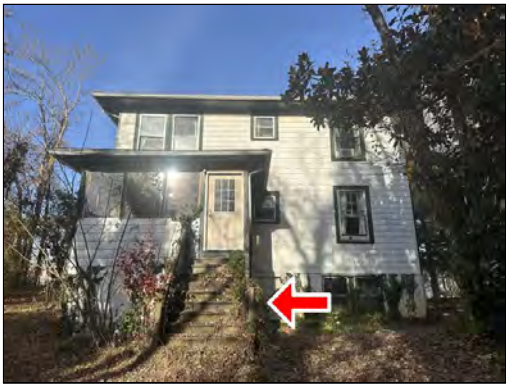
3.0 Item 4(Picture)

(2) The majority of the above-grade block foundation at the rear of the home is made of dry stacked block without mortar joints. This area needs to be pointed up. This process will help the foundation wall retain its strength as well as preventing animal/pest intrusion from occurring into the crawl spaces of the home. This task can be completed by a licensed masonry contractor.

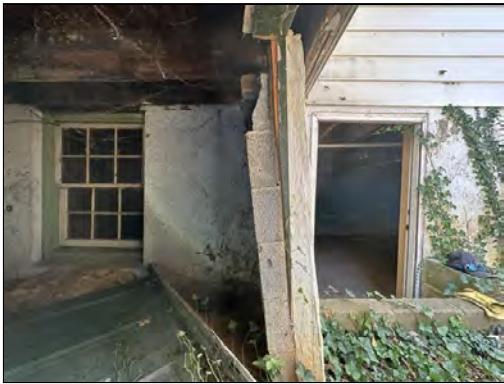
3.0 Item 8(Picture)

(3) The rear CMU foundation wall has settled and is no longer supporting the structure above. I recommend a licensed masonry contractor investigate further and repair the structure.

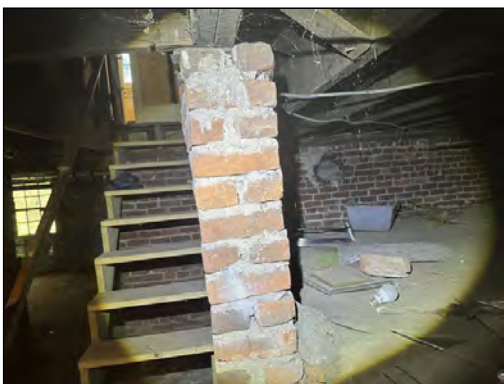
3.2 Item 1(Picture)

The brick support column in the basement is leaning, weakening it's structural integrity. I recommend a qualified mason rebuild the column.

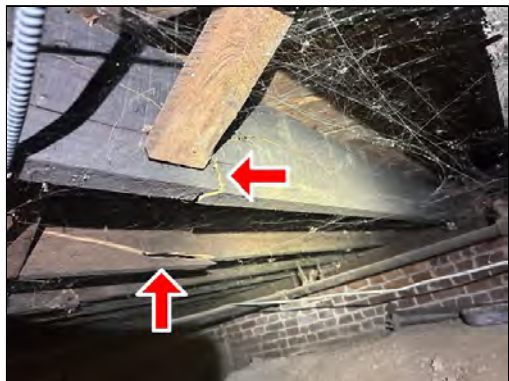
3.3 Item 1(Picture)

There were three (3) cracked floor joist in the basement. The effectiveness of these joist being able to support the floor above has been compromised due to the broken joists. I recommend having a licensed contractor repair as needed to properly support the floor.

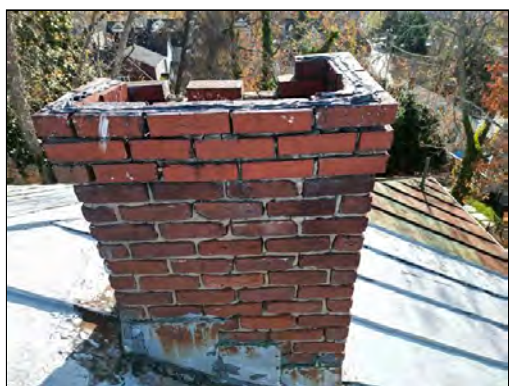
3.5 Item 1(Picture)

(1) The chimney on the right side of the home needs to be rebuilt as it is unsafe and unstable. I recommend a qualified mason investigate and recommend a solution.

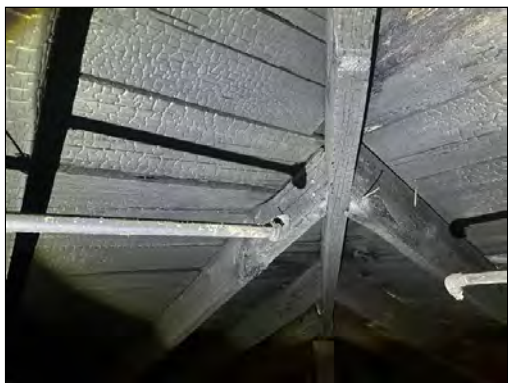
3.5 Item 4(Picture)

(2) Rafters and sheathing inside the attic indicate evidence of a previous fire. I probed charred wood members with a "stab tool" or awl. I recommend monitoring as my probing revealed that the majority of the charring was superficial as the roof structure was in, stable condition during the inspection.

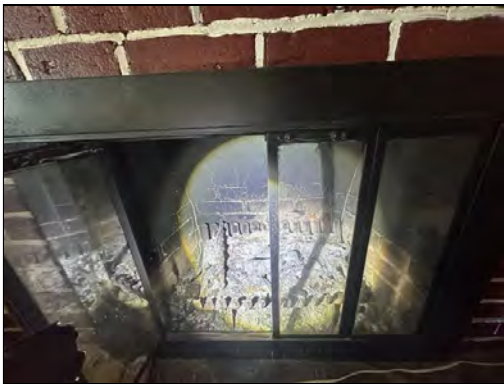
4.5 Item 1(Picture)

(1) I recommend having the chimney inspected by a qualified chimney sweep before use as the inspection conducted today is a visual inspection and does not take into consideration the current status of the inner workings of the chimney flue.

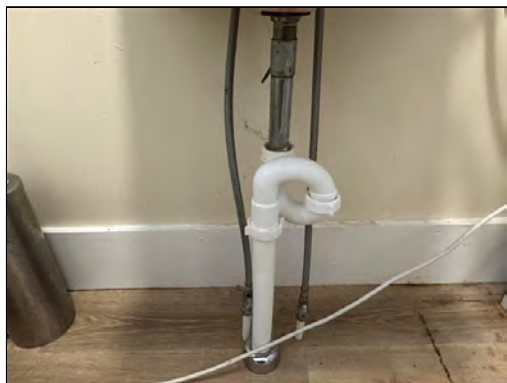
5.1 Item 3(Picture)

(3) The main level half bath sink has an S-trap installed for the drain. S-traps are considered illegal in today's construction due to the fact that the configuration of the trap has the potential of siphoning all water from the trap when used causing sewer gases to build up in the home, which defeats the purpose of the trap. I recommend having a licensed plumber repair the piping as needed such that only a p-trap can be installed and remove the risk of siphoning of the trap system.

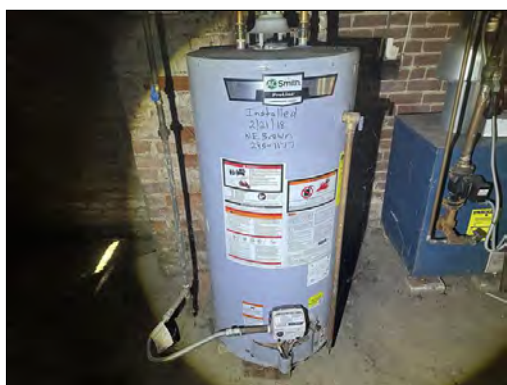
5.2 Item 1(Picture)

Overall, the water heater was in good working condition during the inspection. Hot water was present at all fixtures in an appropriate time with acceptable functional flow. With proper maintenance (yearly flushing of the unit), this unit could last well beyond the national average of 10 years.

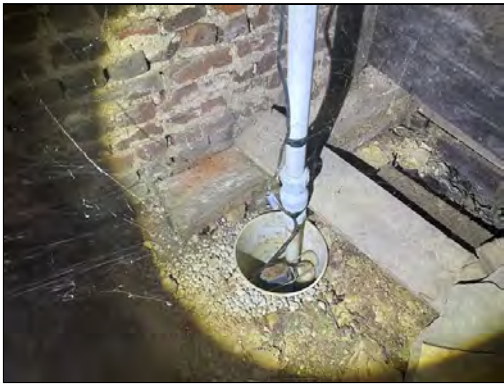
5.6 Item 1(Picture)

The sump pump did not have a proper cover that was secured to the floor to prevent unwanted gases from emitting in the home. I recommend having a licensed plumber install one.

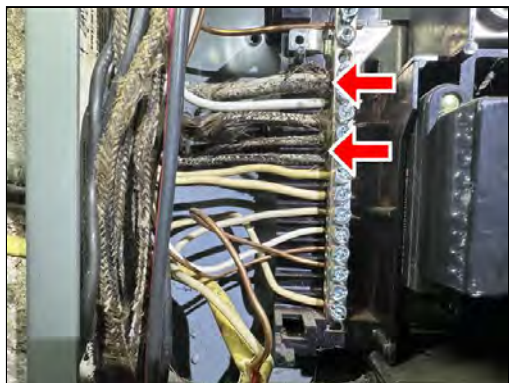
6.2 Item 1(Picture)

(1) There was cloth wiring present in the panel. This has been known to cause fires in the past and is no longer used in construction today. I recommend having a licensed electrician investigate further and correct as needed for safe operation.

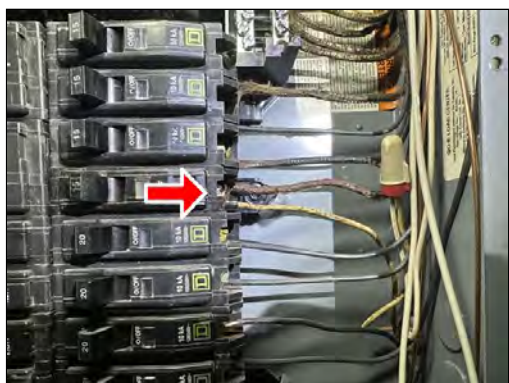
6.2 Item 4(Picture)

(2) I observed two (2) double taps that were present in the main electrical panel during the inspection. Double taps can lead to overheating of the breaker or could lead to a spark or arc between the wiring. I recommend having a licensed electrician investigate further and correct as needed.
