From: Scala, Mary Joy
Sent: Friday, July 19, 2013 9:31 AM
To: Eric Amtmann (EAmtmann@dgparchitects.com)
Cc: 'jjg@dzshq.com'
Subject: BAR Action - 144 Chancellor Street

Delta Zeta National Housing Corporation
202 E Church Street
Oxford, OH45056

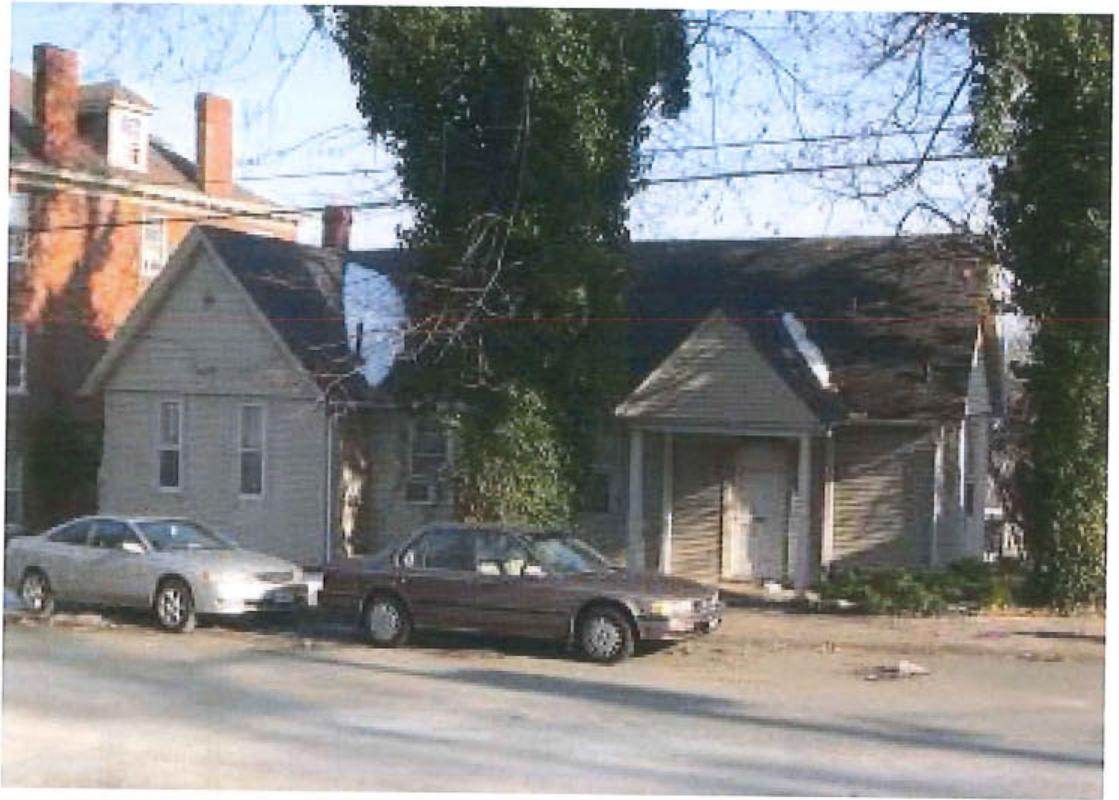
West (Chancellor Street) Elevation

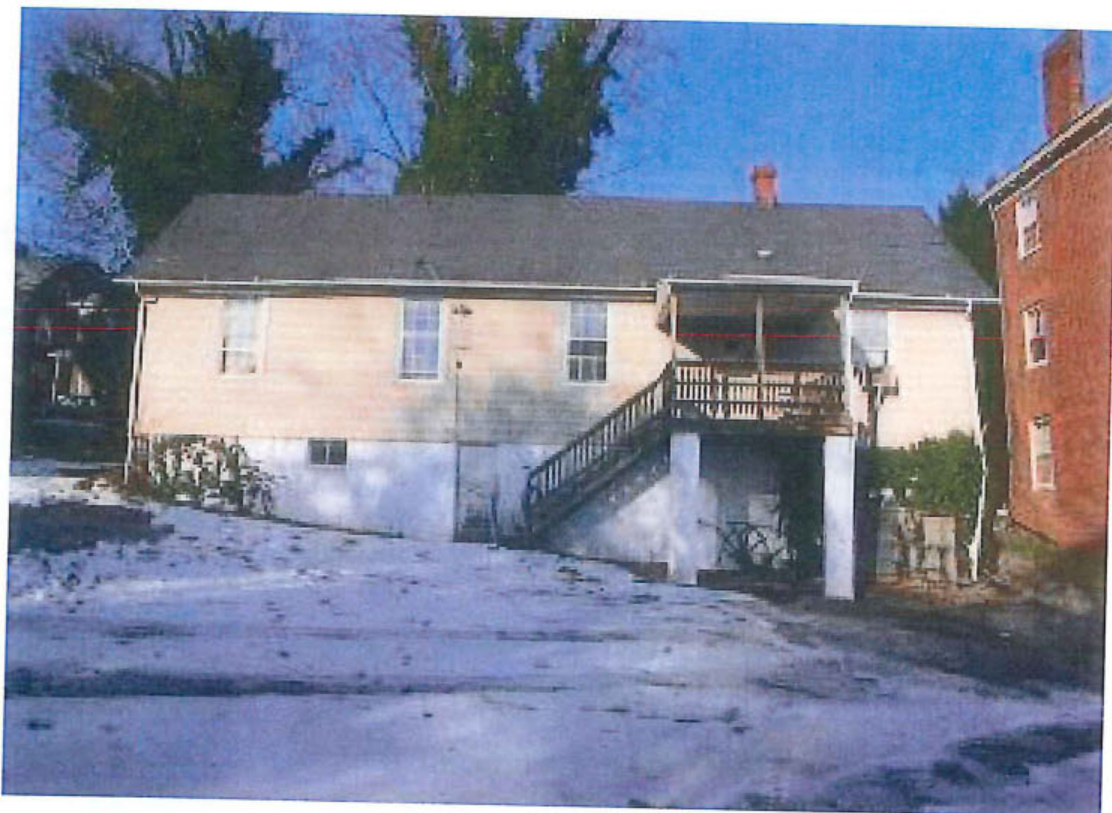
East (Rear) Elevation

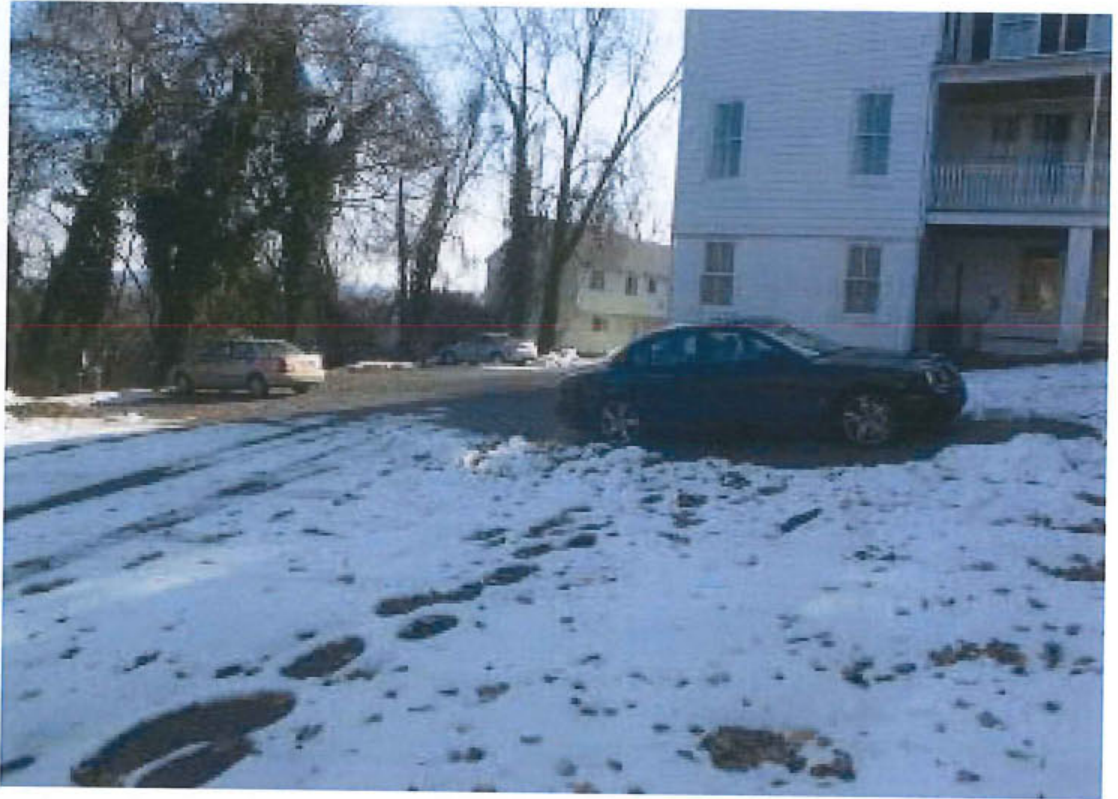
Parking Area (Southeast View)

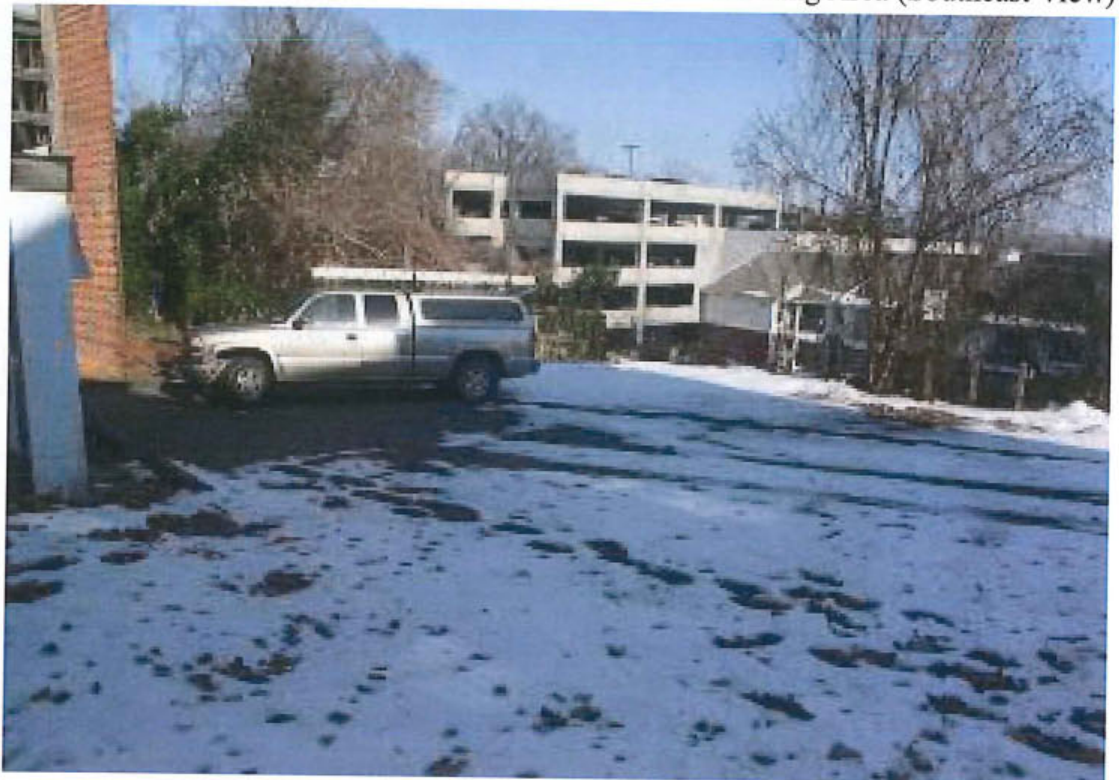
Parking Area (Northeast View)

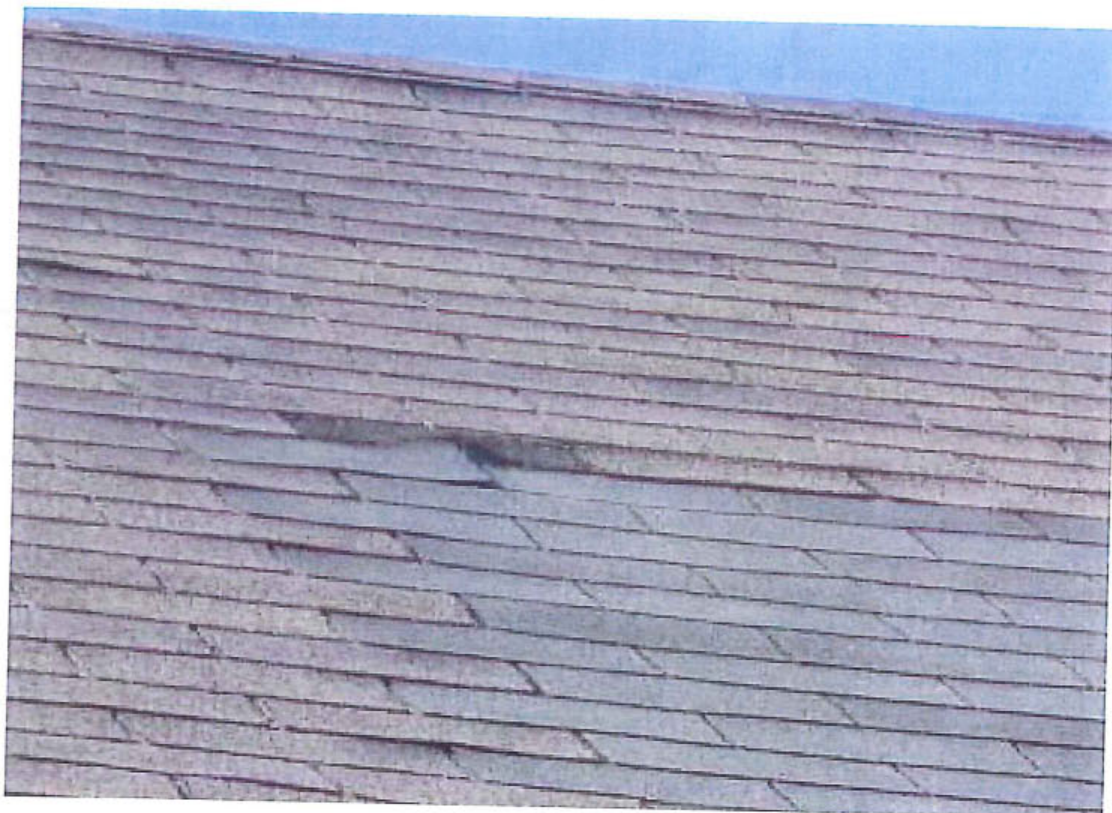
Roof Shingles / Patch

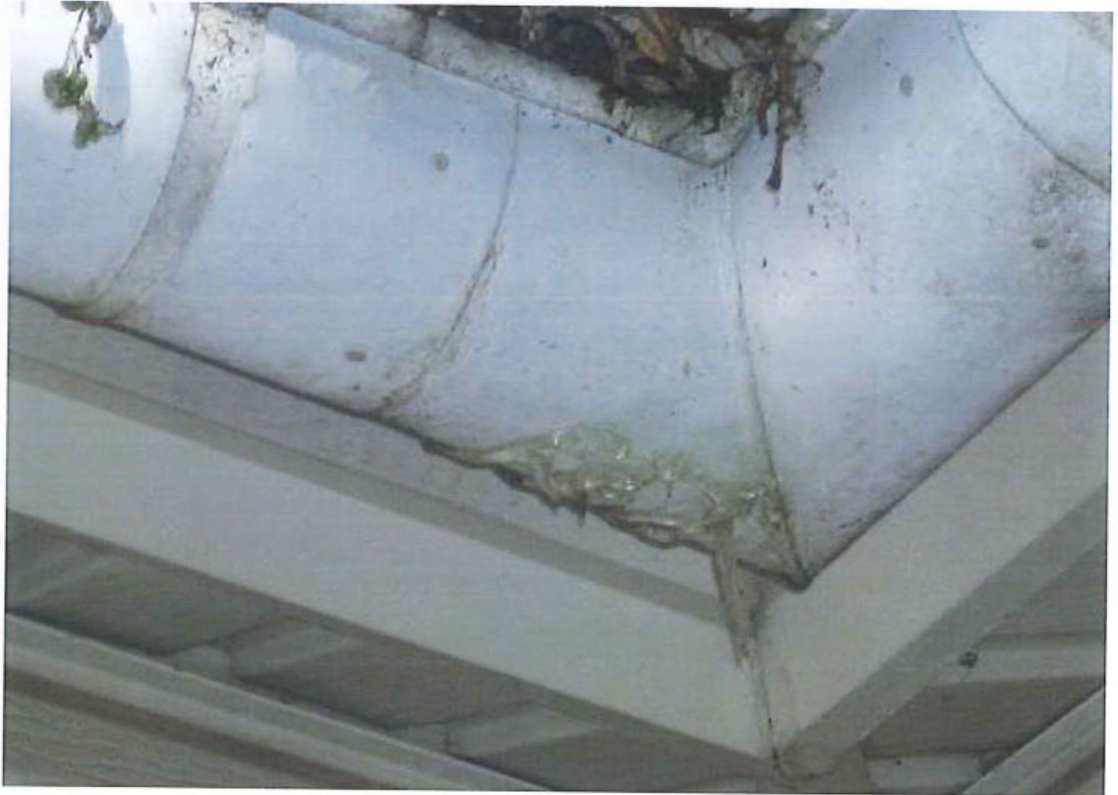
Existing Condition Photography

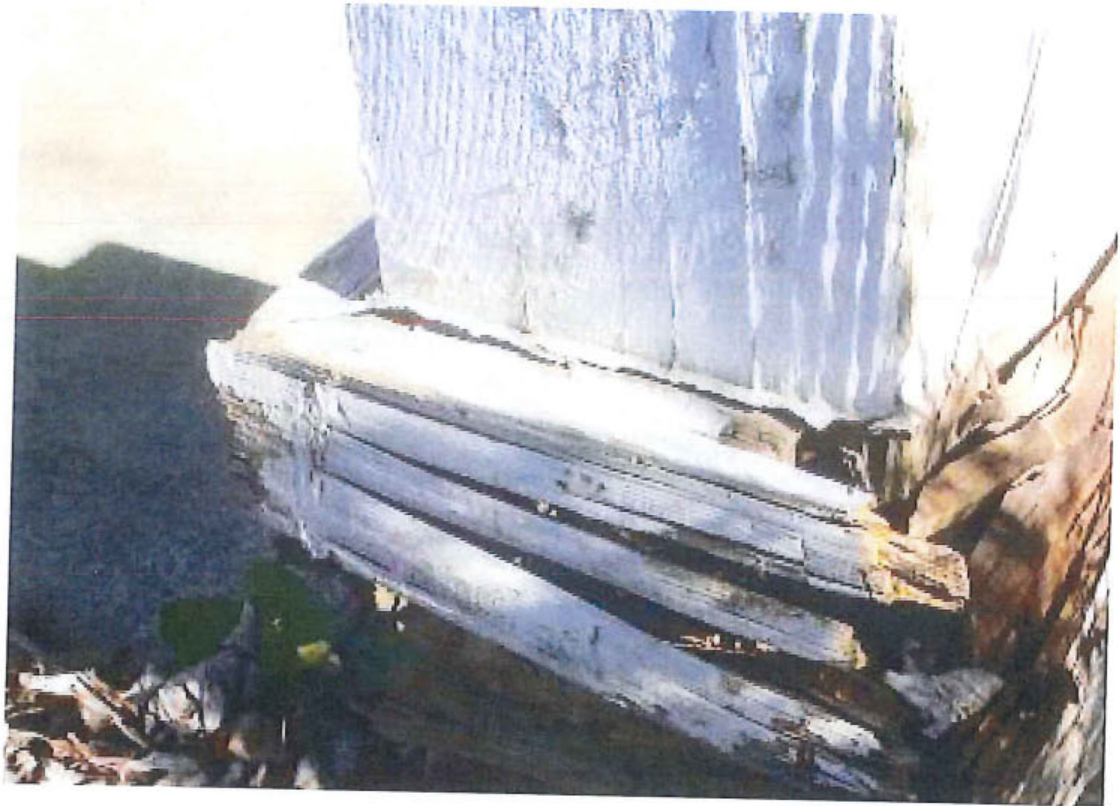
Deteriorated Post Base

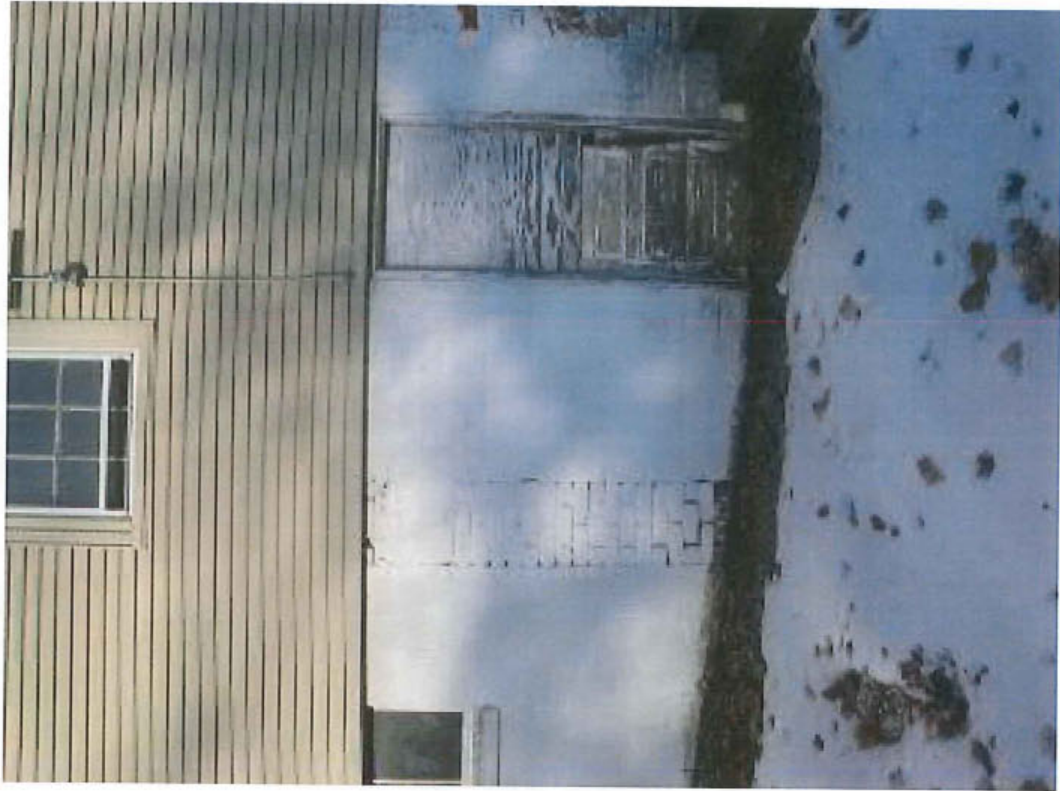
Original Brick Piers and CMU Infill

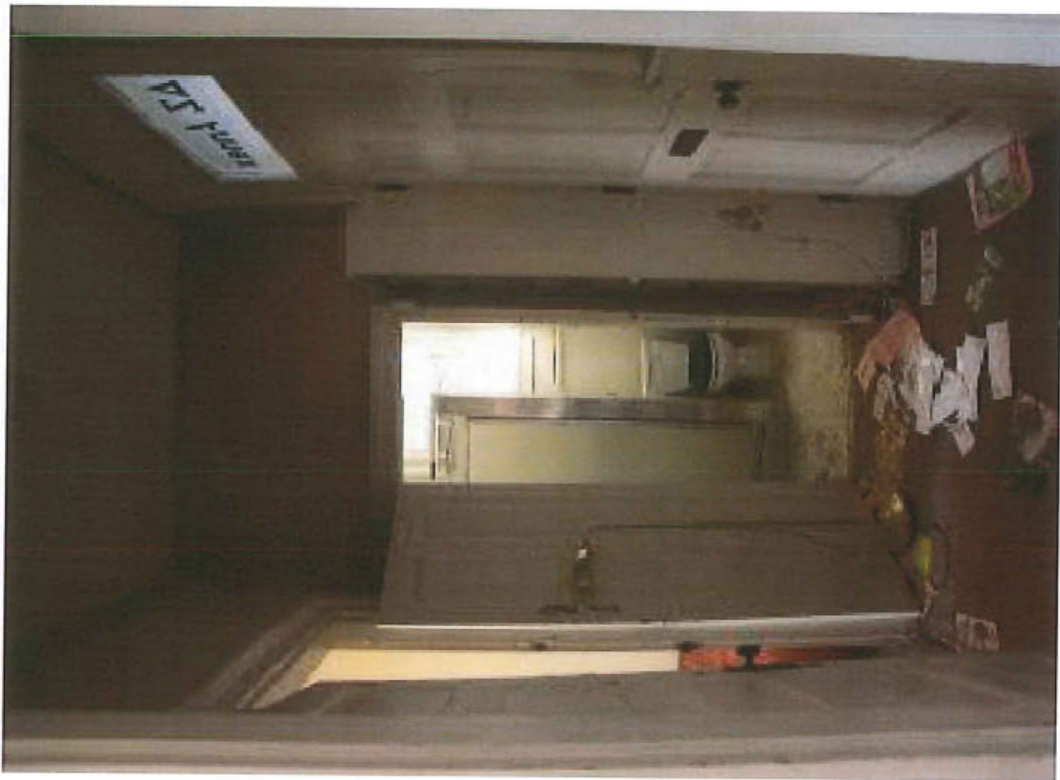
Entry Hall and South Bathroom

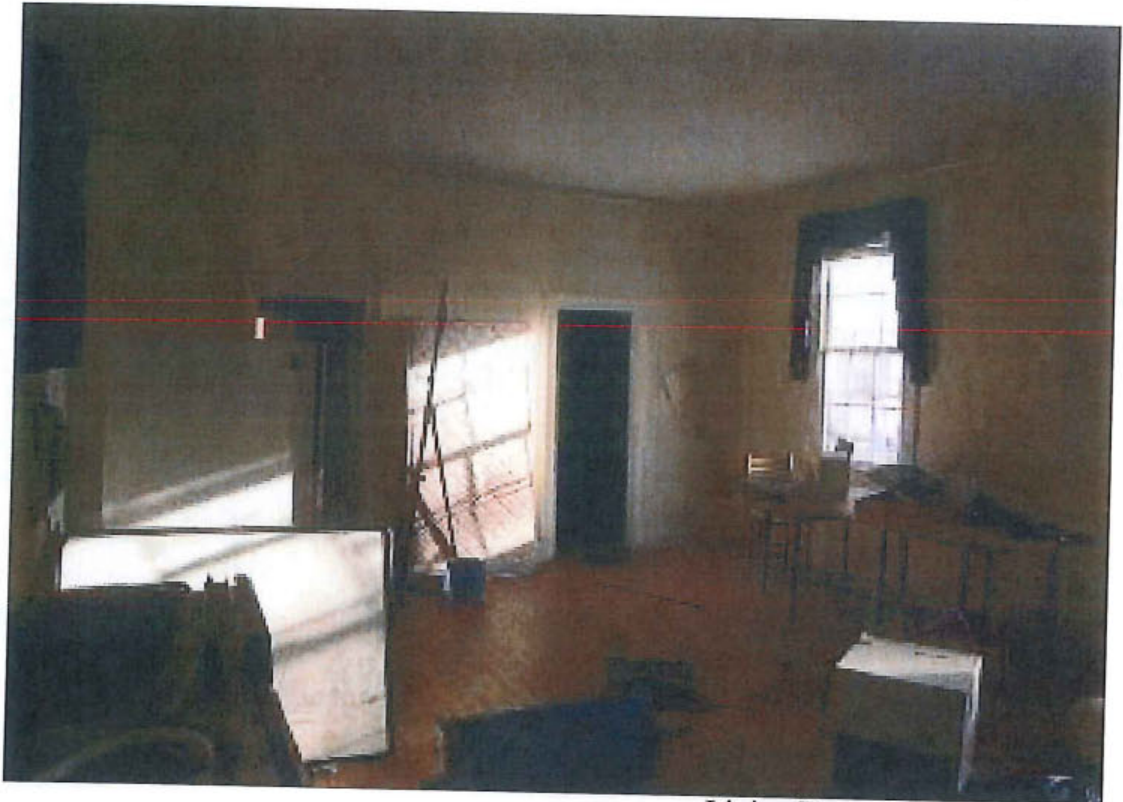
Living Room (Northeast View)

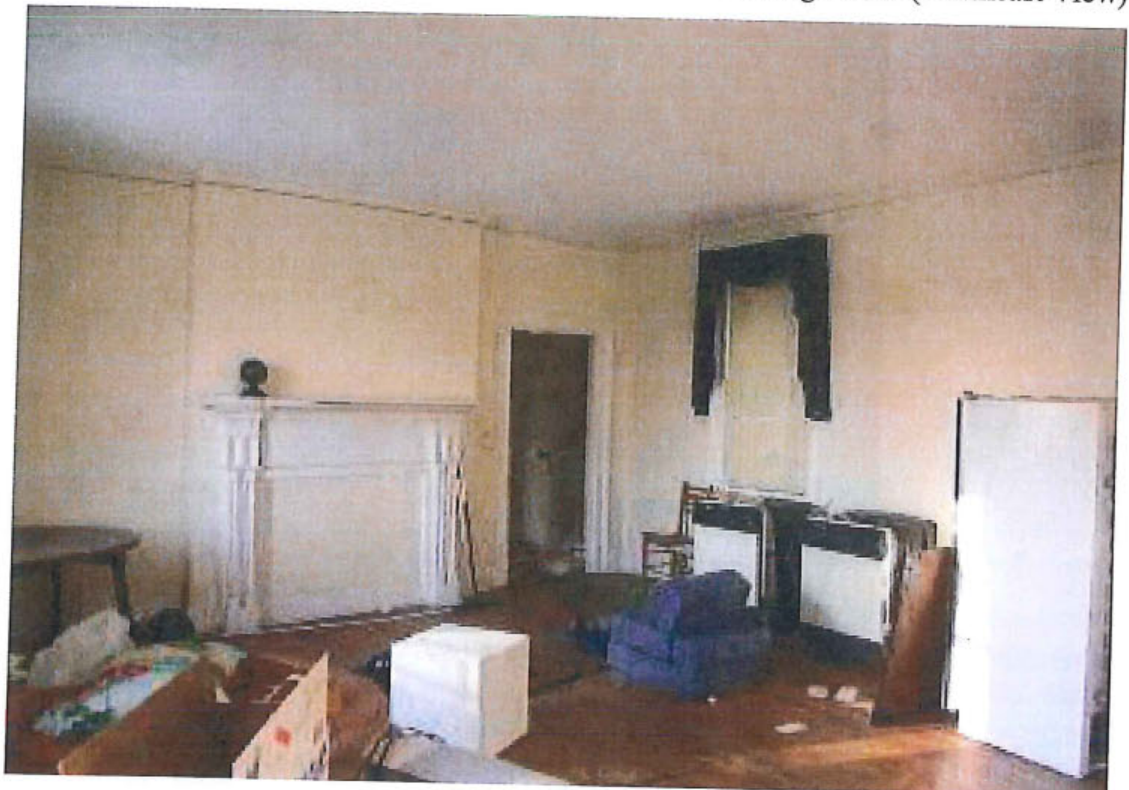
Living Room (Southwest View)

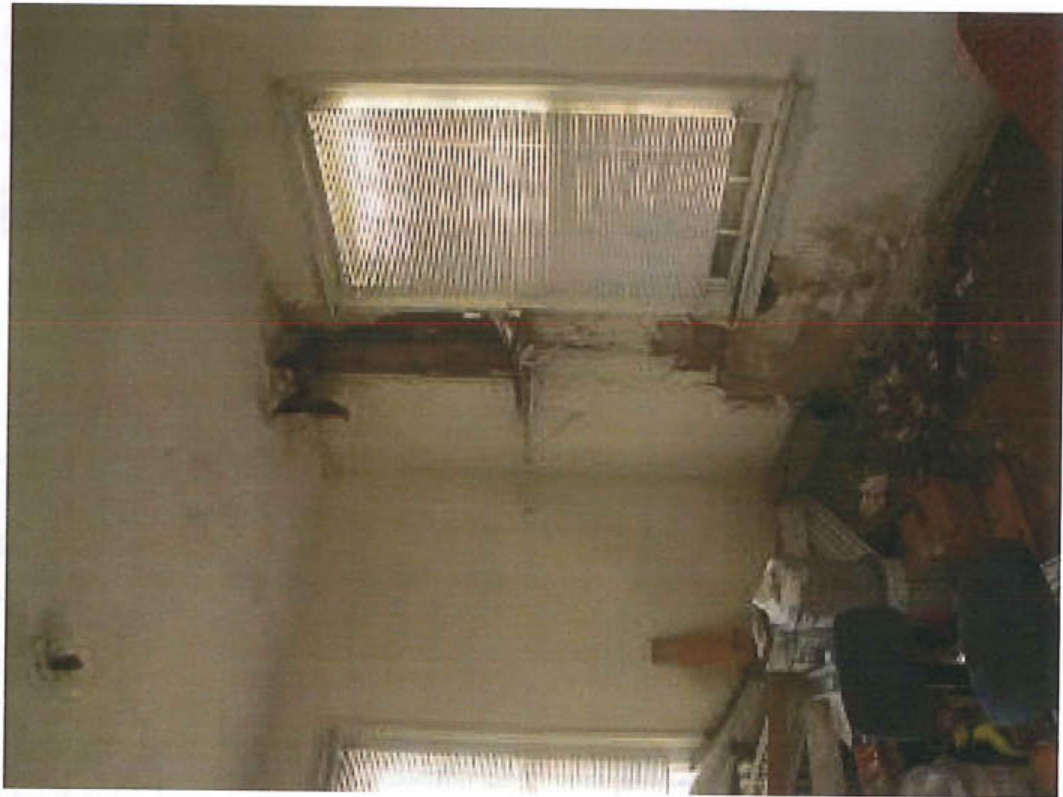
“South” Bedroom and damage

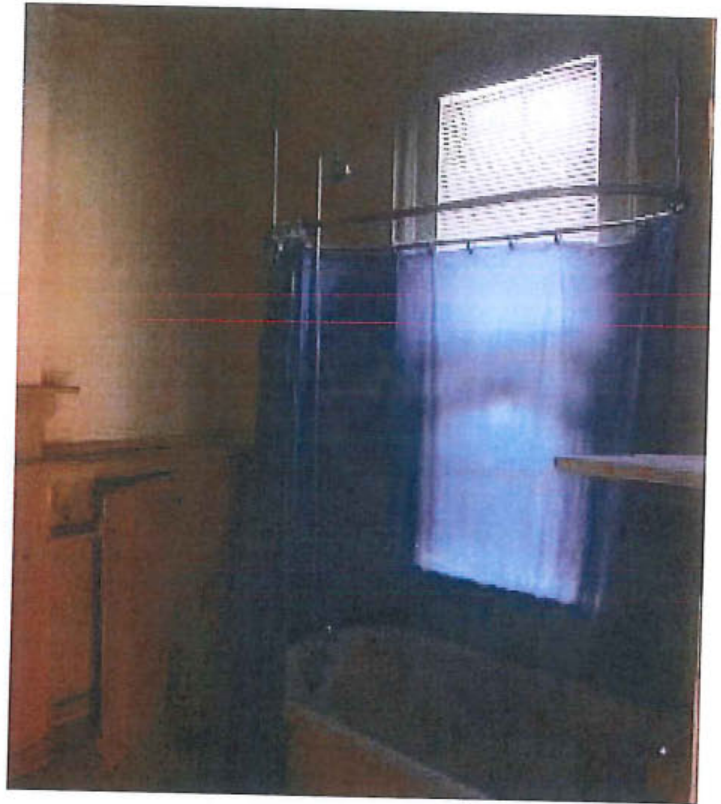
Existing Condition Photography

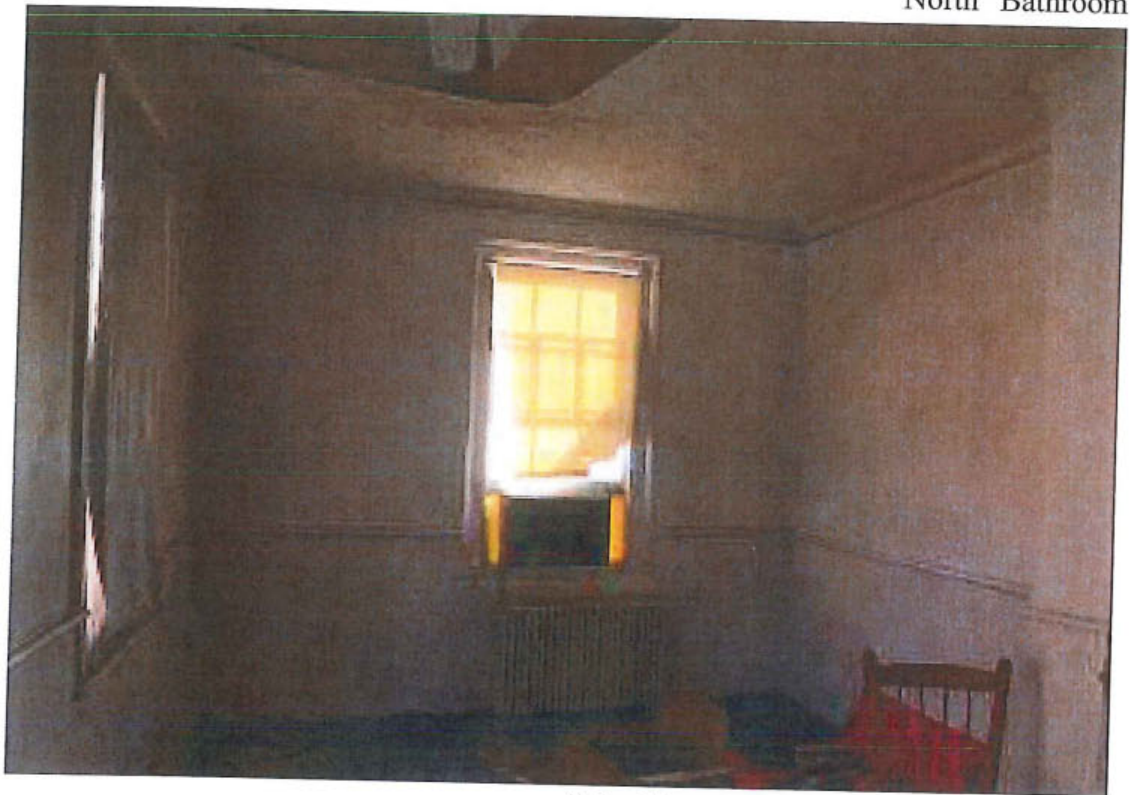
"North" Bedroom (Note: Ceiling Failure)

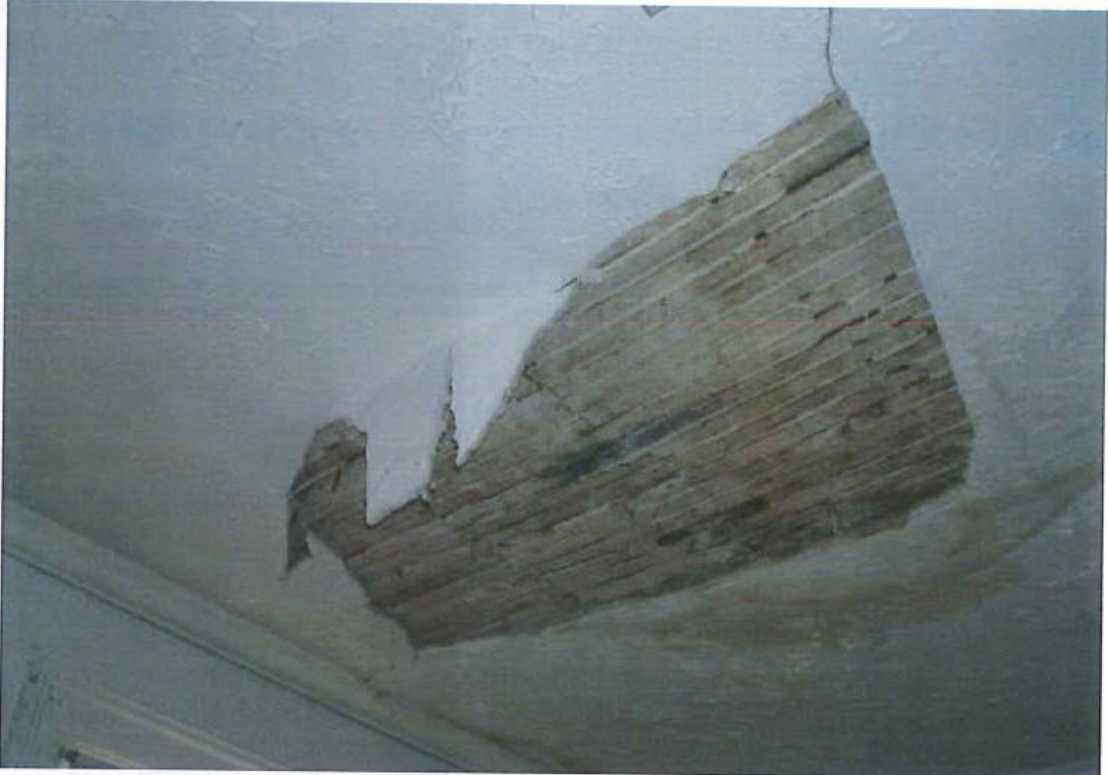
Roof Leak / Ceiling Failure

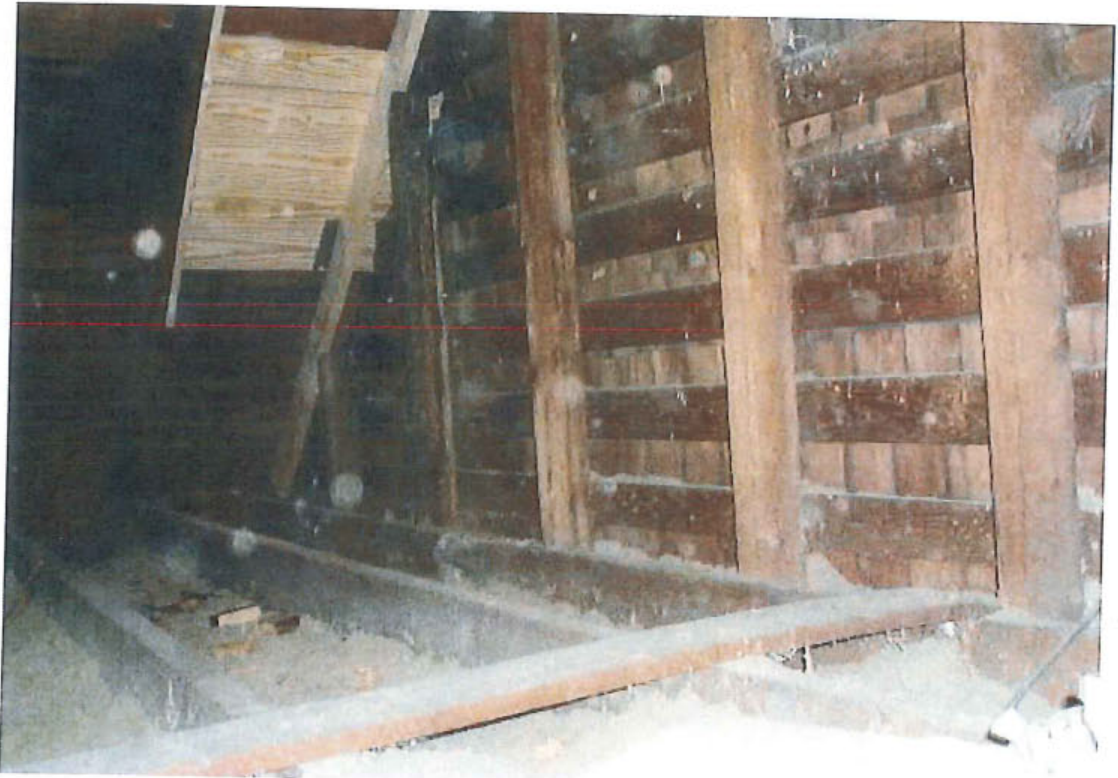
Existing Condition Photography

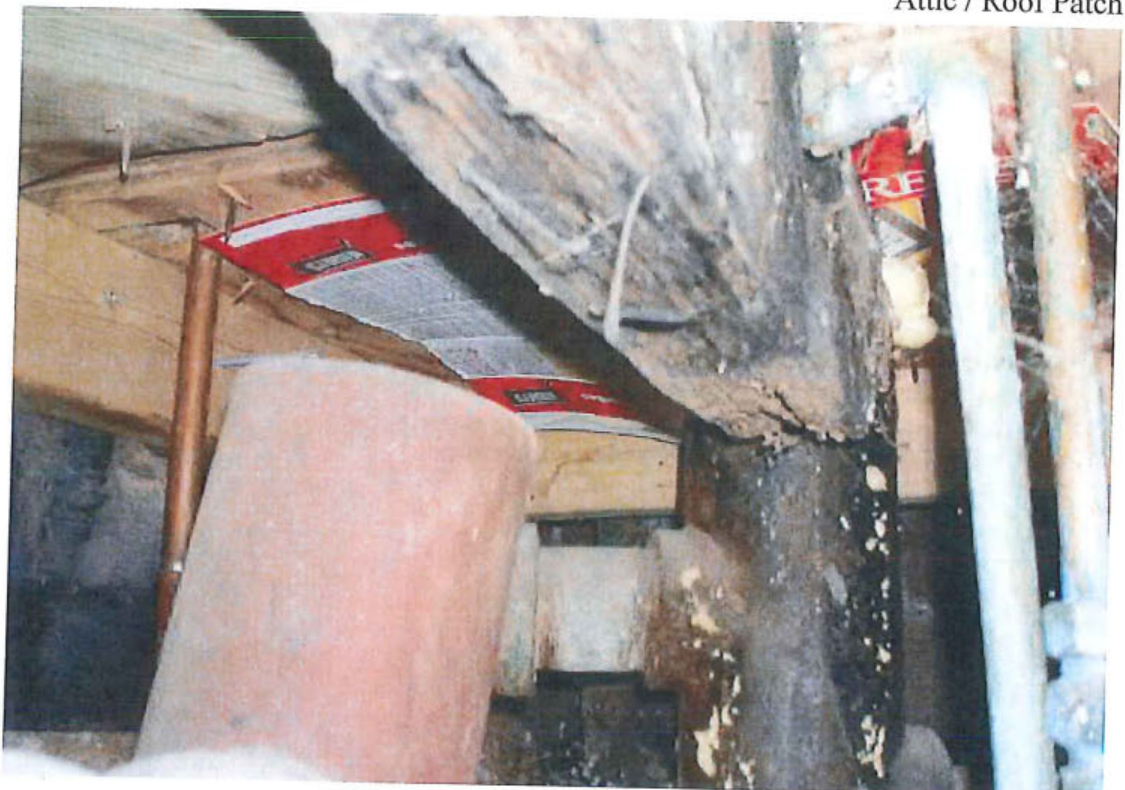
Primitive Floor Patch / Rotten Beam

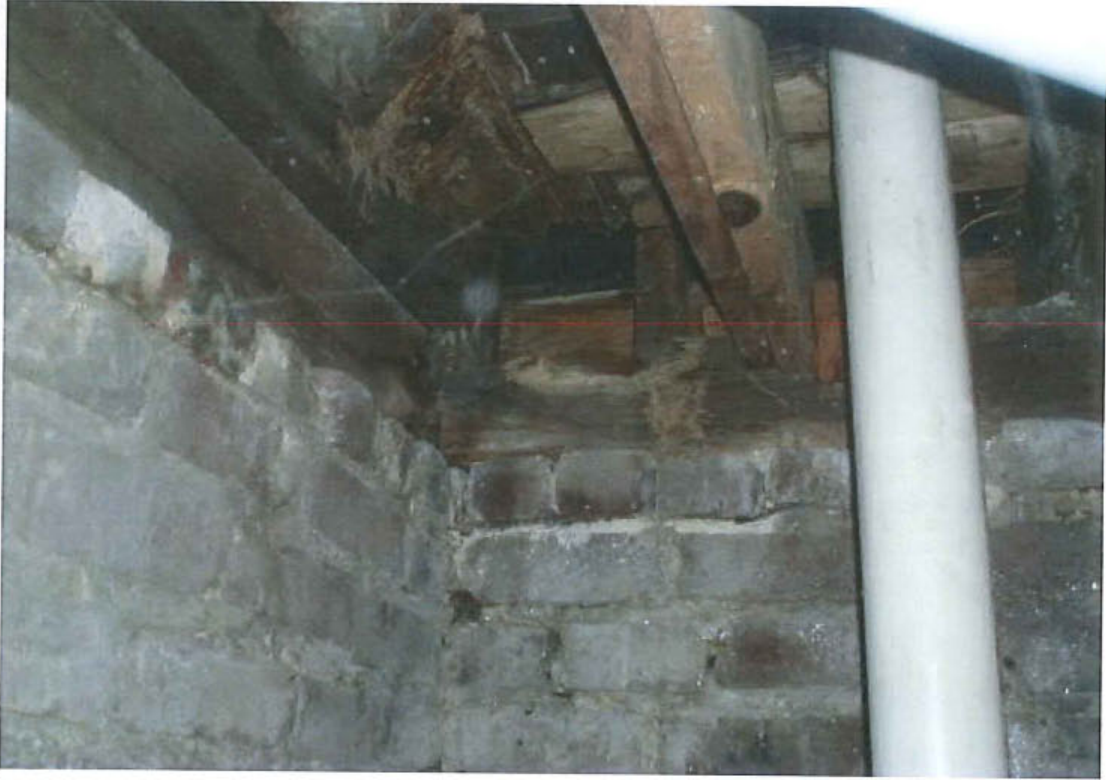
Existing Condition Photography

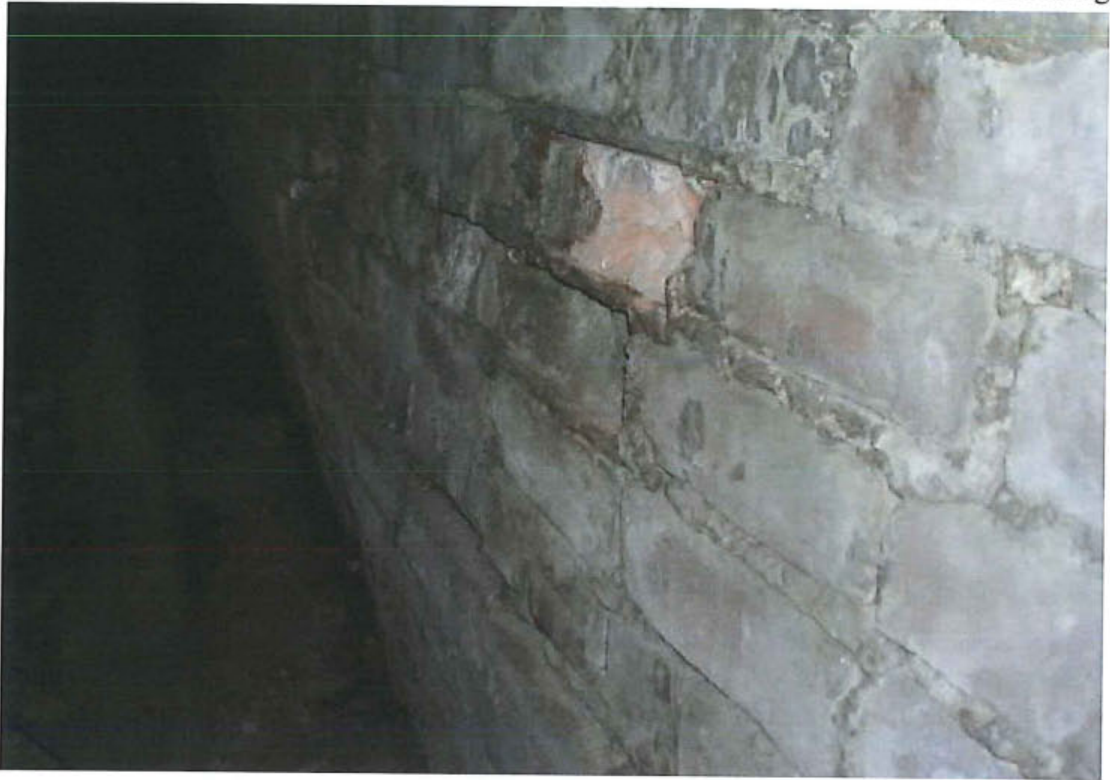
Bulging Foundation Wall at Street Side

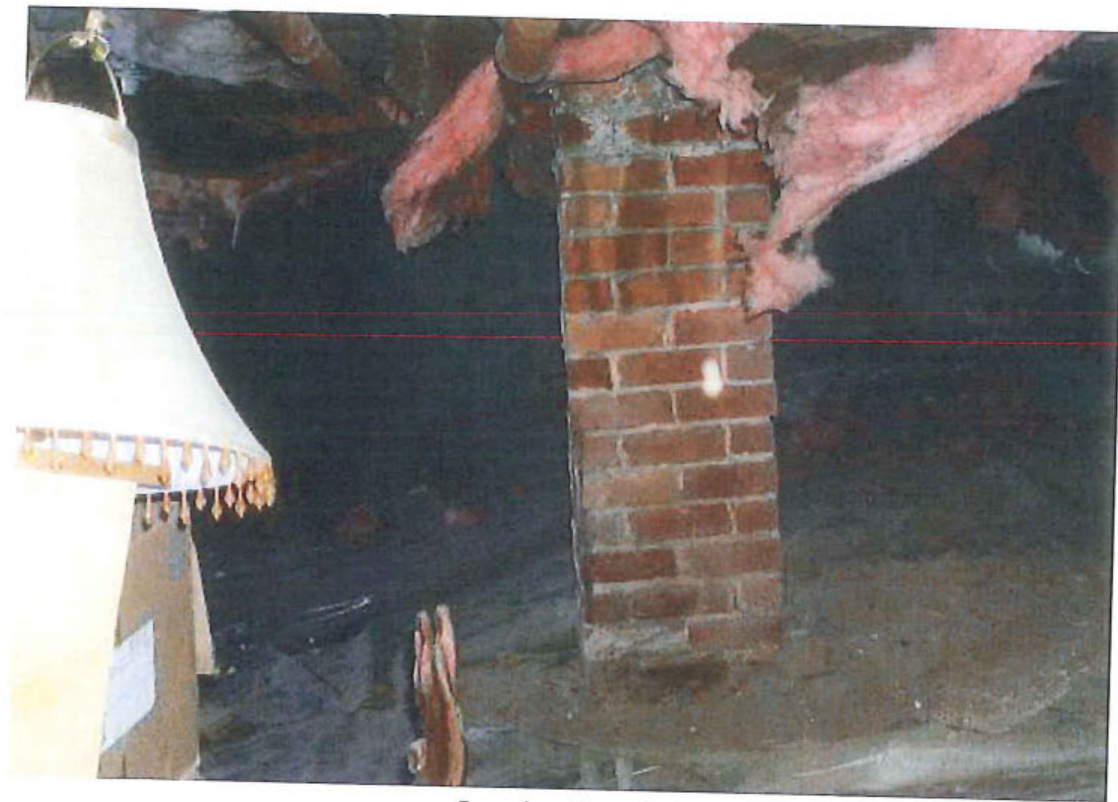
Leaning Foundation Pier / mice-infested insulation

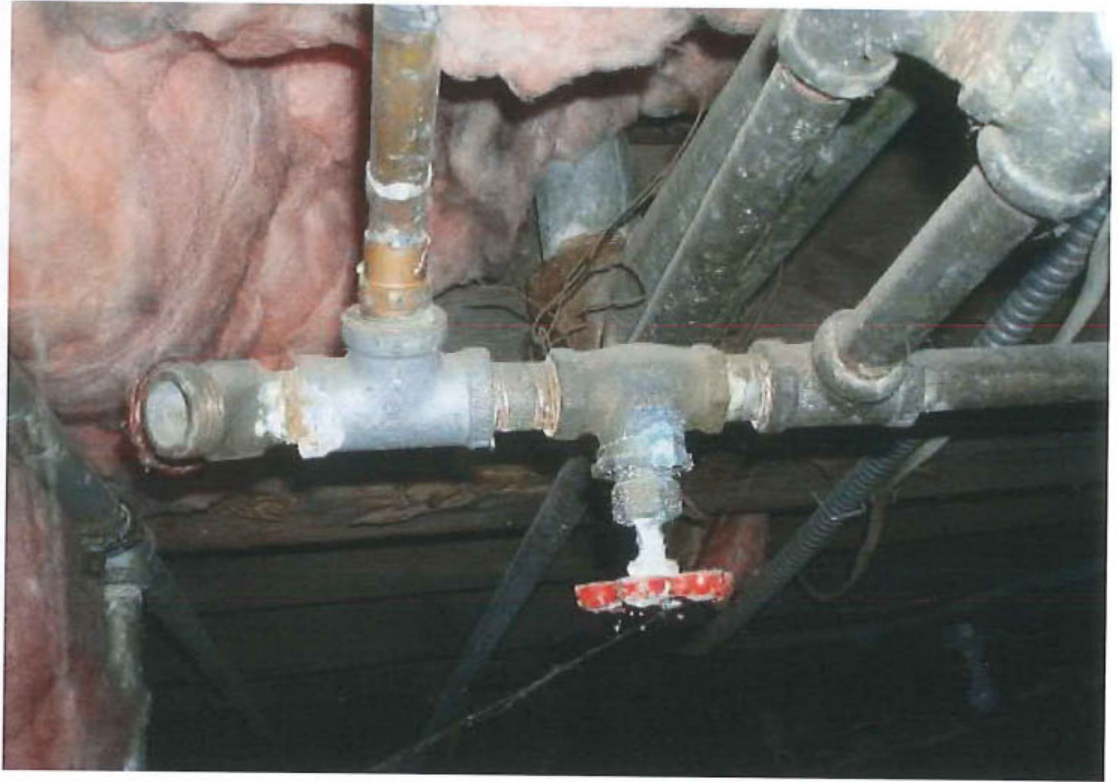
Corroded and mismatched piping

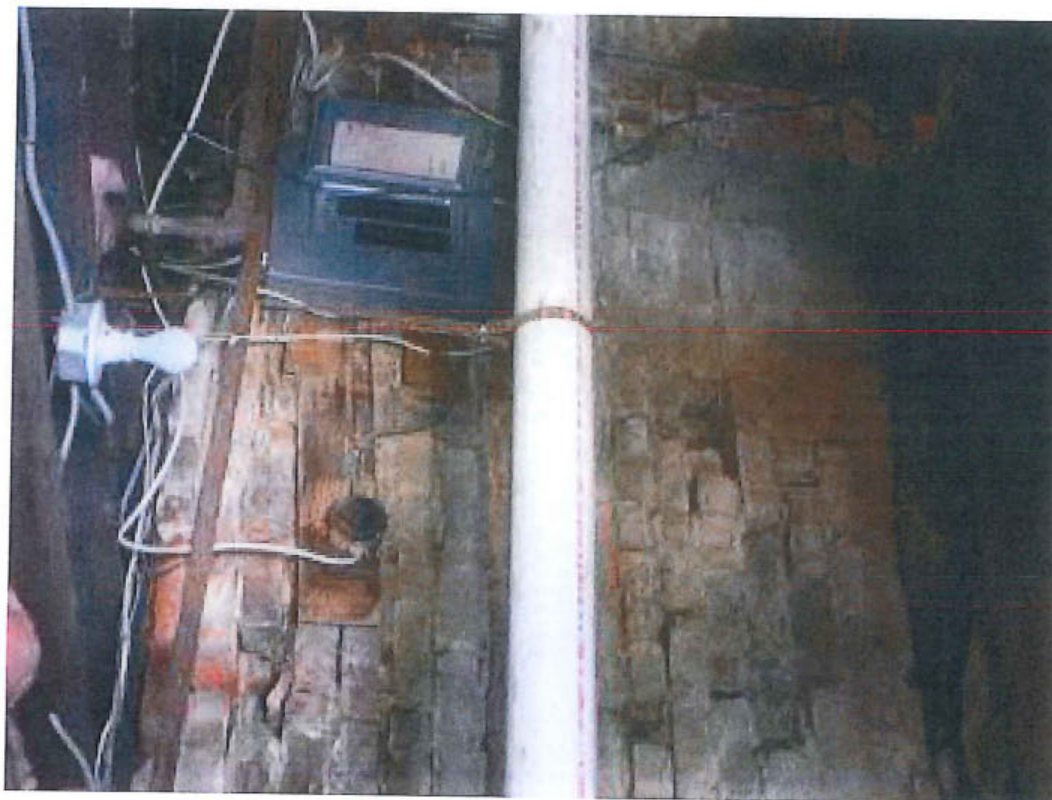
Electric Panel and West Foundation Wall

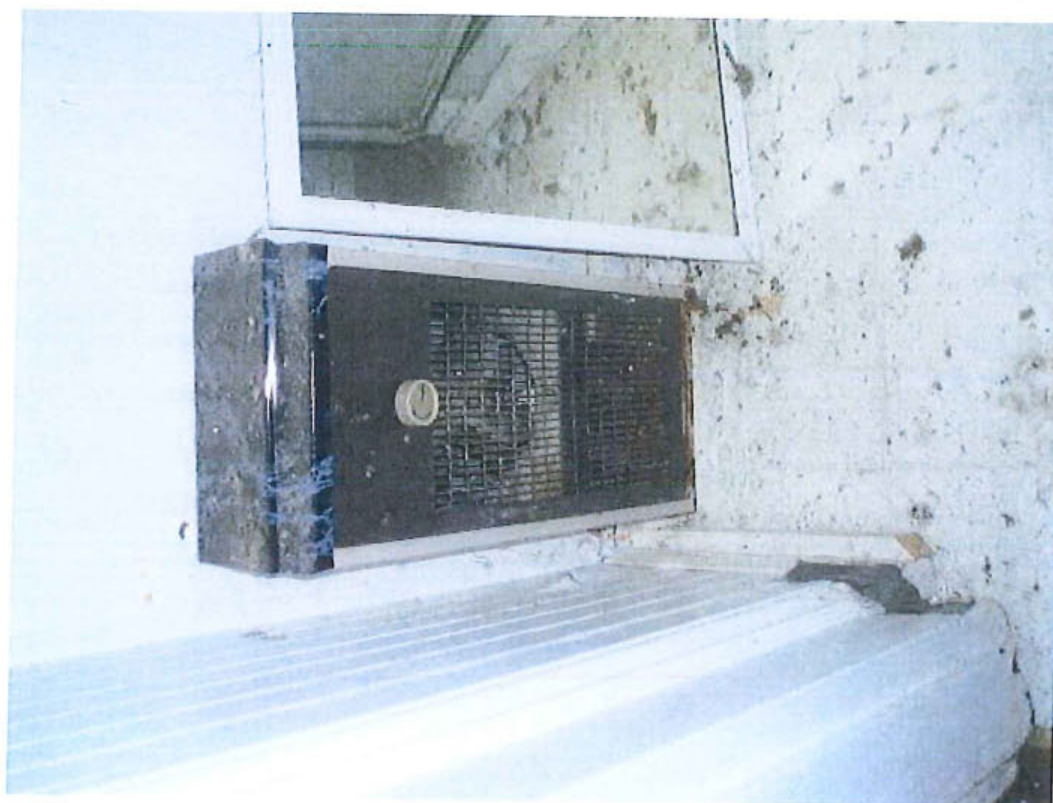
Electric Heater in Bathroom

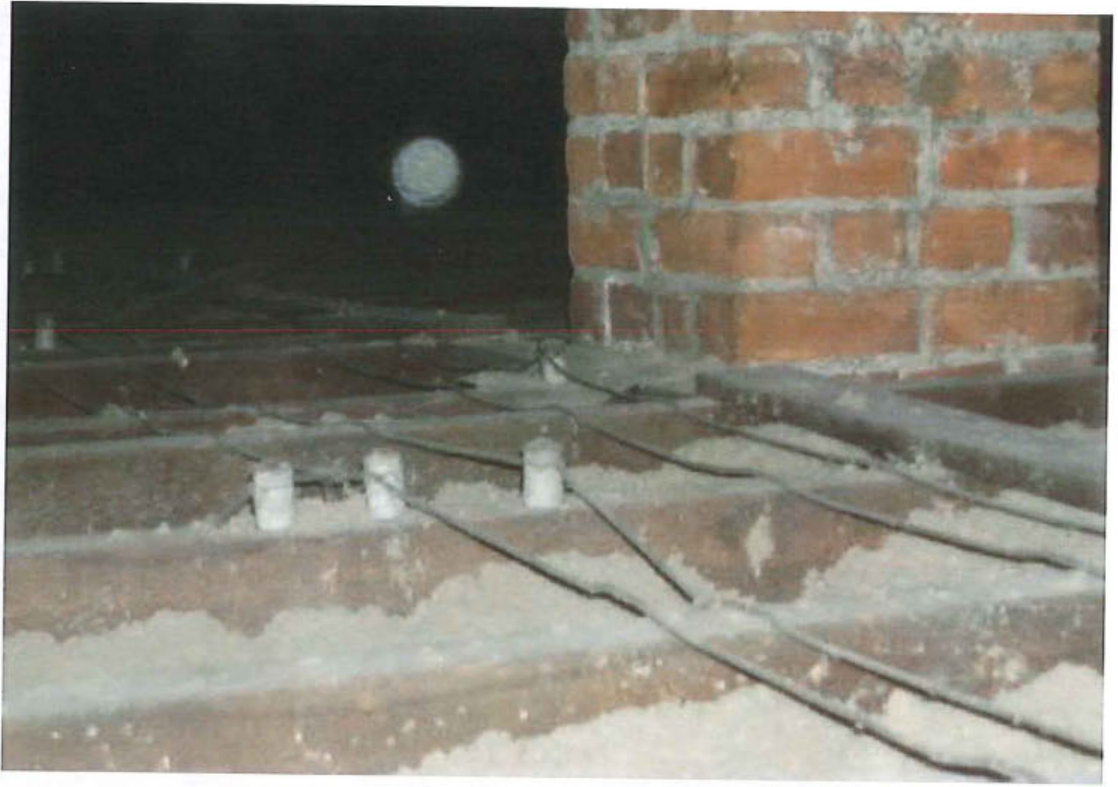
“Knob and Tube” Wiring in Attic

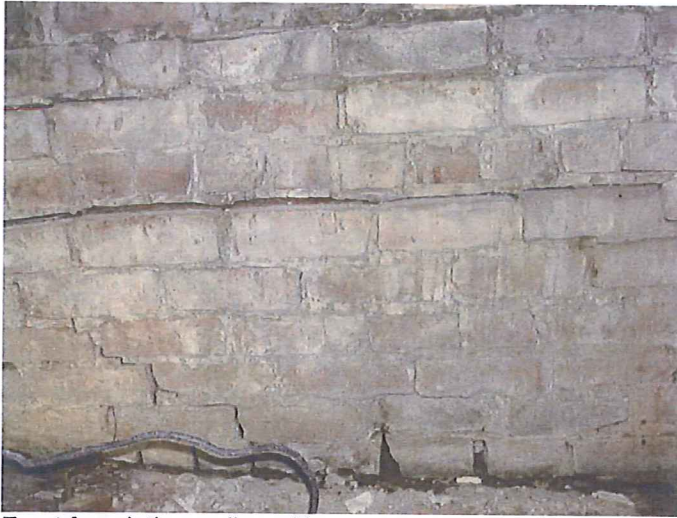
Front foundation wall cracking

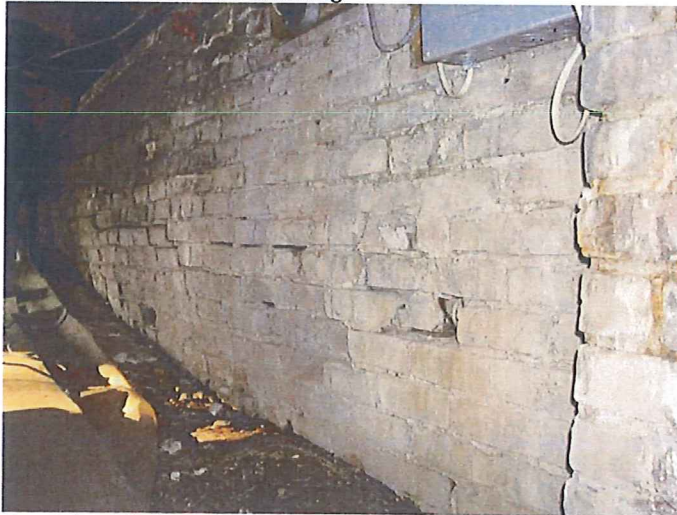
Front foundation wall inward displacement and cracking

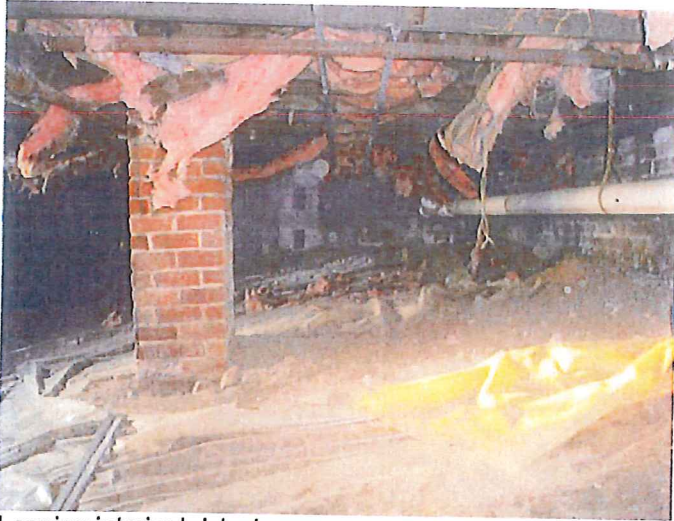
Leaning interior brick pier

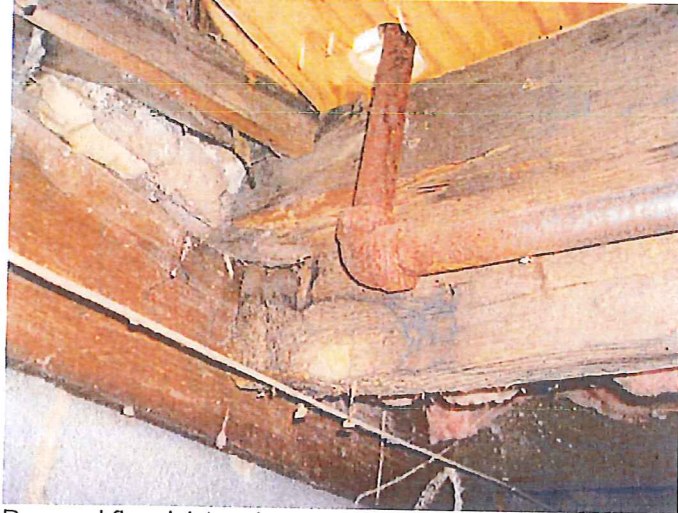
Decayed floor joist end

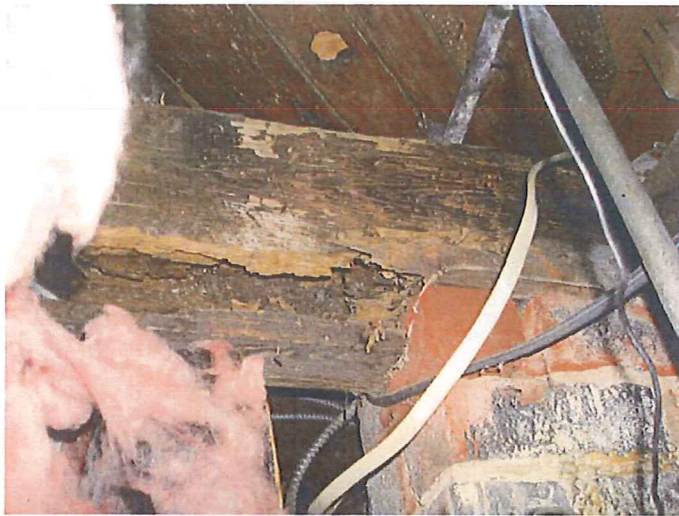
Severely decayed and damaged joist end (below partition wall)

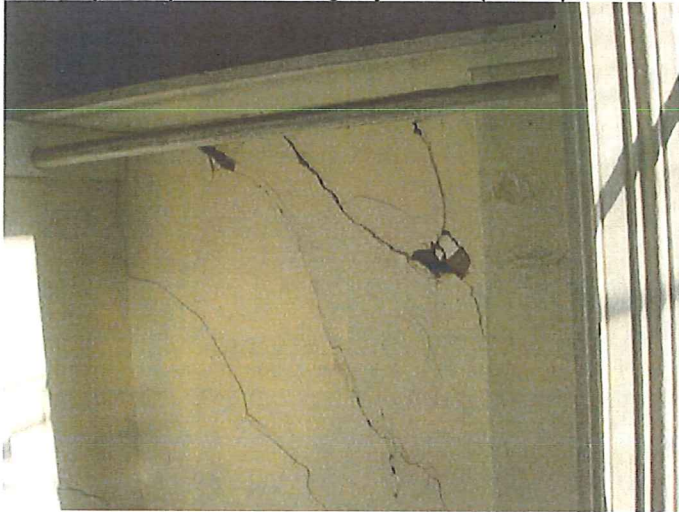
Cracked plaster at interior partition wall
