From: Scala, Mary Joy
Sent: Friday, July 19, 2013 9:31 AM
To: Eric Amtmann (EAmtmann@dgparchitects.com)
Cc: 'jjg@dzshq.com'
Subject: BAR Action - 144 Chancellor Street

Delta Zeta National Housing Corporation
202 E Church Street
Oxford, OH45056

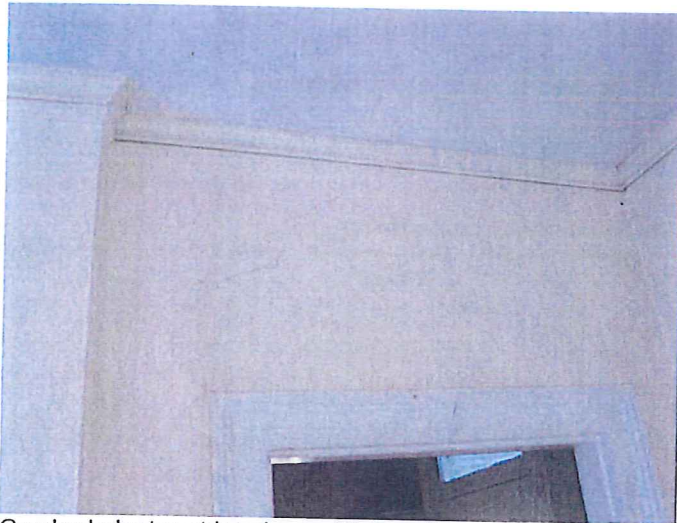
Cracked plaster at interior partition wall

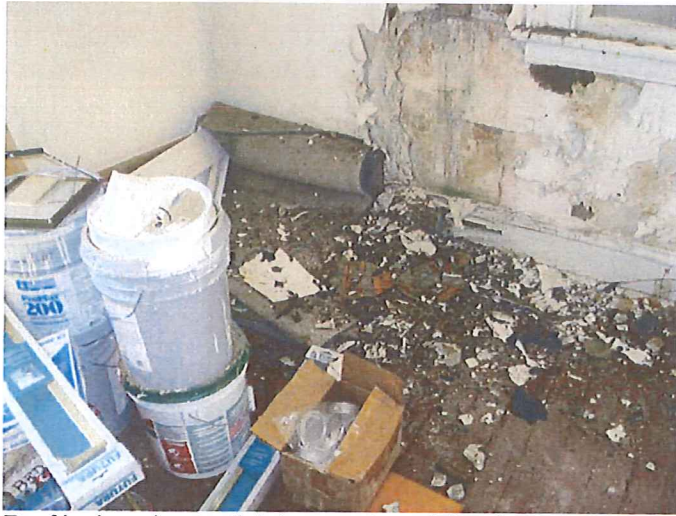
Roof leak and potential damage to wall framing.

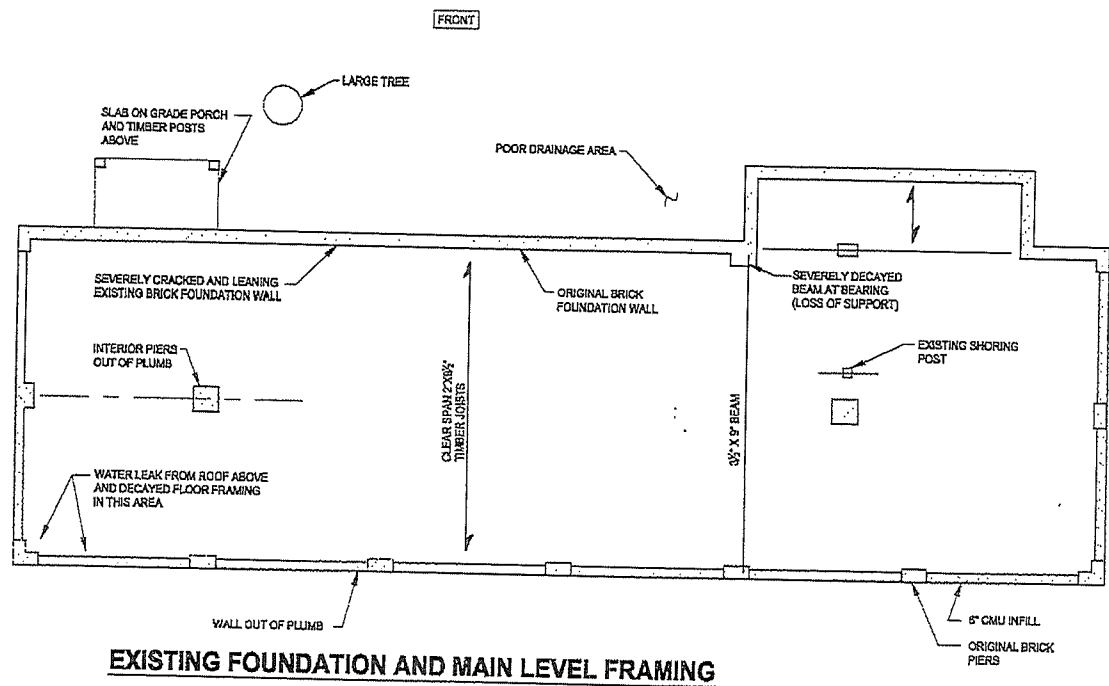
CITY OF CHARLOTTESVILLE
