MEMO TO: Maurice Jones
FROM: Mary Joy Scala
DATE: June 20, 2013
RE: 1600 Grady Avenue Tree Removal Request

Tree Conservation Plan

Preston Court Apartments

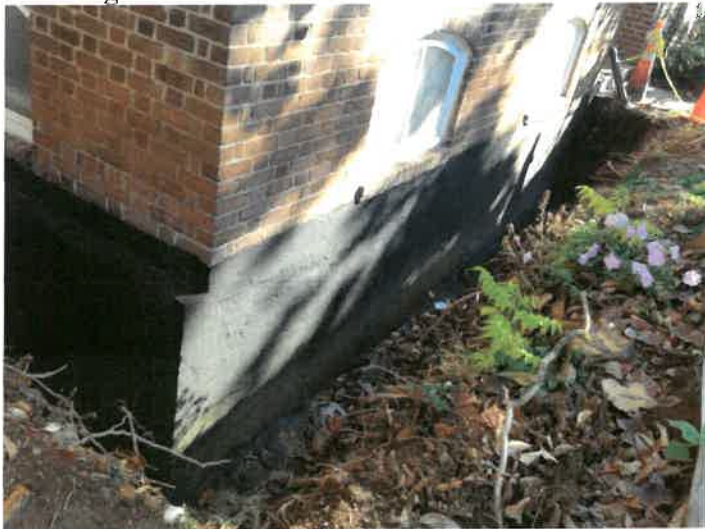
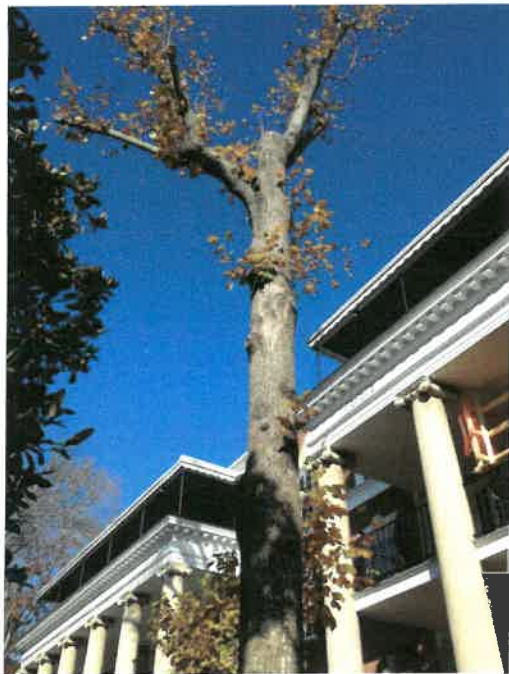
Site Images:

The Poplar Tree in question has been determined to be in poor health by several professional arborists. The tree has been rotting for many years and recent severe storms have brought down major branches from all of the Poplars on the front of the site. It has also been determined that the planting area is too small for this type of large canopy tree and that these Poplars will never thrive in this location. As you are aware, the removal of this one tree will have no significant impact on the canopy coverage for the site. The significant Beech, Pecan and Ash trees have been determined to be the primary contribution towards site canopy and character.

As presented in the BAR meeting, the building foundation has never been waterproofed previously, nor does the building have any working drainage system in place. The City of Charlottesville Public Works crew has also confirmed that there is no existing City Storm Drain for this site either; something which they consider very rare. Given that the site is bedrock, the ground around the building is also acting as a sponge and holding water directly against the building. As a result of these factors, much of the basement level has been exposed to significant water damage. Thus, the owner has begun the proper measures to ensure the protection of the historic building. Photos of this area and the Poplar Tree are included.

We are excited to come before you in the near future and present a comprehensive and thoughtful vision for the Preston Court Apartments site. In the meantime, we hope that you will consider allowing staff to grant an administrative approval of the removal of one tree that is in very poor condition to allow for the proper preservation and maintenance of this historic structure. Please let us know if there is any additional information we can provide to assist in your consideration.
