### **Certificate of Appropriateness Application**

BAR 18-06-01

404 East Main Street

**Window Replacement**

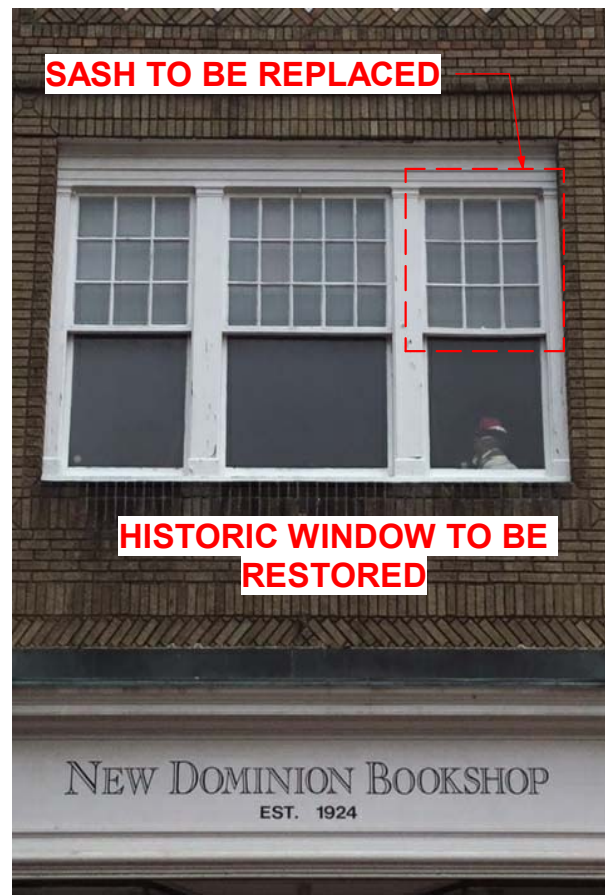
SASH TO BE REPLACED

HISTORIC WINDOW TO BE RESTORED

SECOND FLOOR WINDOWS ON MALL SIDE: EXISTING TRIPLE UNIT IS TO REMAIN AND BE RESTORED, EXCEPT THAT THE UPPER SASH ON ONE UNTIL IS TO BE REPLACED IN KIND. THE NEW SASH WILL REPLICATE THE EXISTING PROFILES AND DIMENSIONS. NEW INTERIOR HARDWARE WILL REPLACE THE EXISTING HARDWARE, WHICH IS NOT ORIGINAL OR HISTORIC. THE EXISTING CHAINS AND WEIGHTS WILL BE REPLACED AS REQUIRED TO MAKE THE WINDOWS FUNCTIONAL. THE EXISTING SASH TRACKS ARE TO BE LINED WITH COPPER TO ALLOW FREE MOVEMENT OF THE SASH.

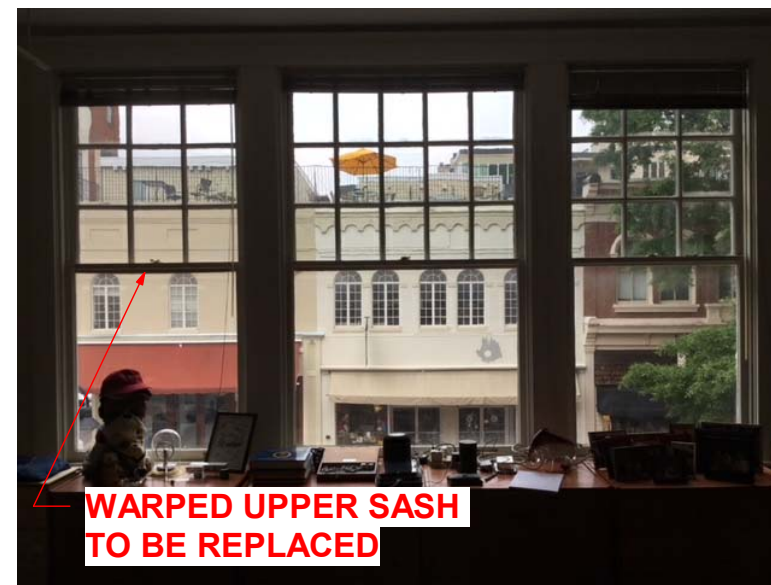
WARPED UPPER SASH TO BE REPLACED

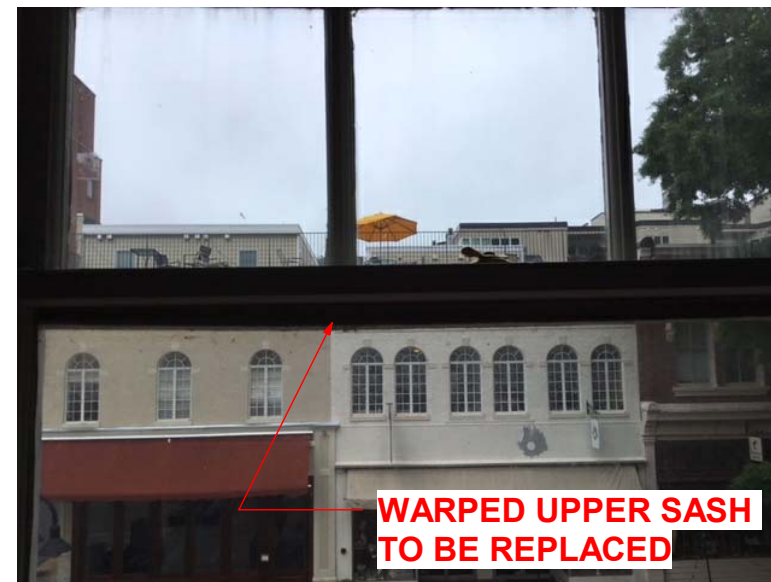
WARPED UPPER SASH TO BE REPLACED

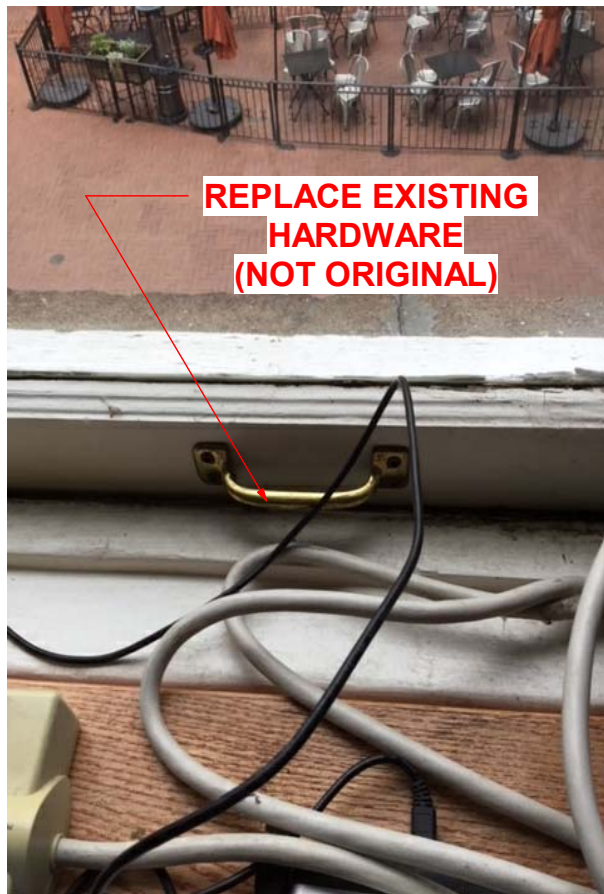
REPLACE EXISTING HARDWARE (NOT ORIGINAL)

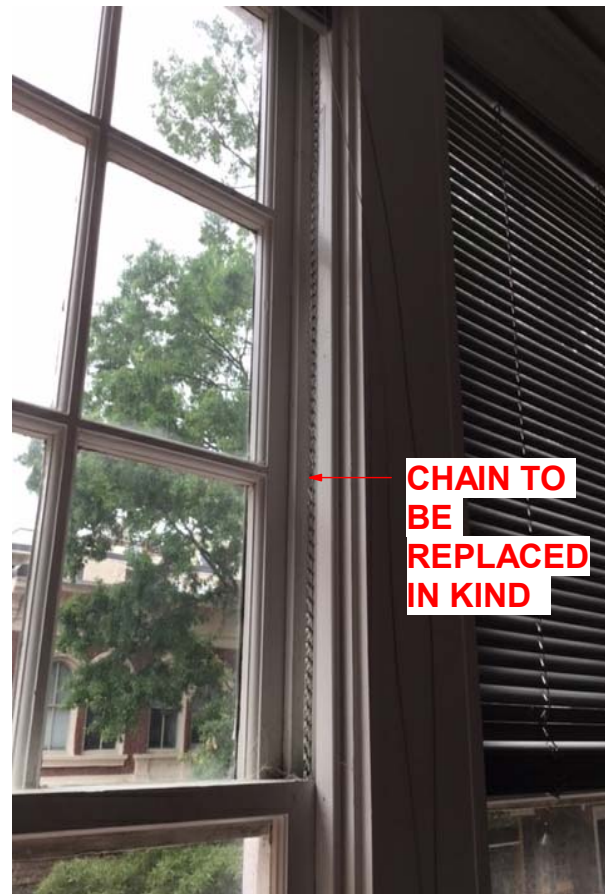
CHAIN TO BE REPLACED IN KIND

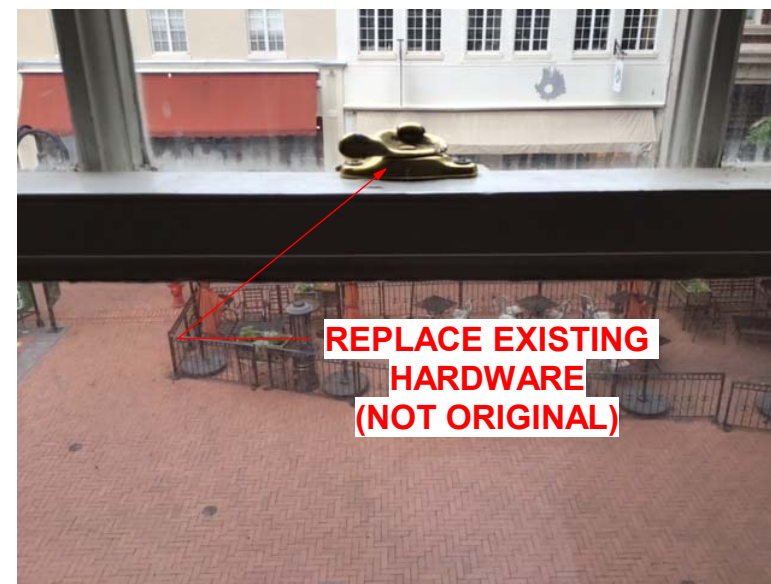
REPLACE EXISTING HARDWARE (NOT ORIGINAL)

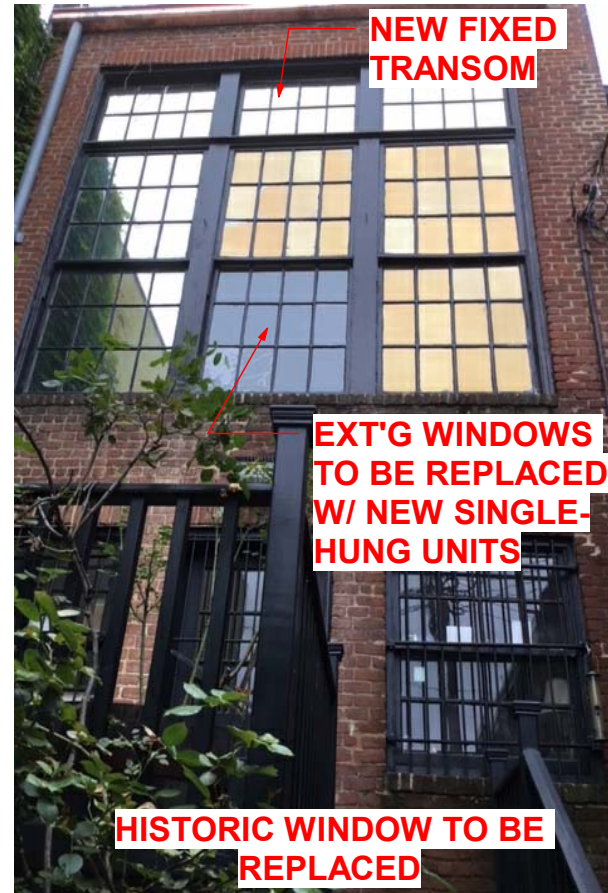
NEW FIXED TRANSOM

EXT'G WINDOWS TO BE REPLACED W/ NEW SINGLE-HUNG UNITS

HISTORIC WINDOW TO BE REPLACED

SECOND FLOOR WINDOWS ON ALLEY SIDE: EXISTING TRIPLE UNIT IS IN VERY POOR CONDITION. ALL UNITS HAVE BEEN EXTENSIVELY REPAIRED WITH PUTTY AND FILLER, AND HAVE PERVASIVE WOOD ROT AND EVIDENCE OF WATER INFILTRATION. ALL OF THE SASHES ARE DEFORMED DUE TO WATER DAMAGE. WE ARE PROPOSING TO REPLACE ALL OF THESE WINDOW UNITS WITH NEW MARVIN ALUMINUM-CLAD DOUBLE-PANE SINGLE-HUNG AND FIXED TRANSOM UNITS. NEW UNITS ARE TO HAVE LOW-E GLAZING AND TRUE DIVIDED LITE CONSTRUCTION WITH 1 1/8" WIDE MUNTINS AND BRONZE CLAD FINISH.

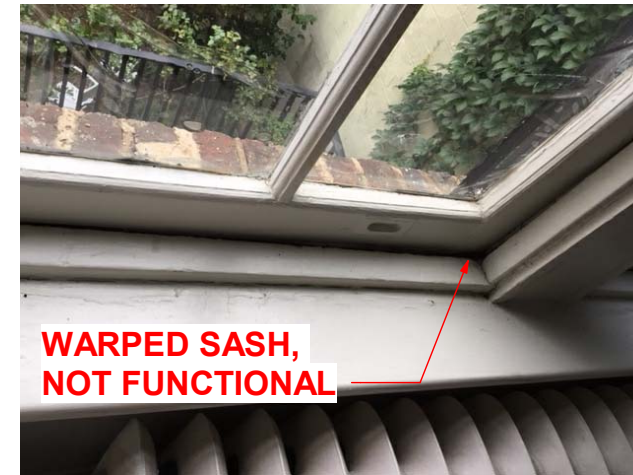
WARPED SASH, NOT FUNCTIONAL

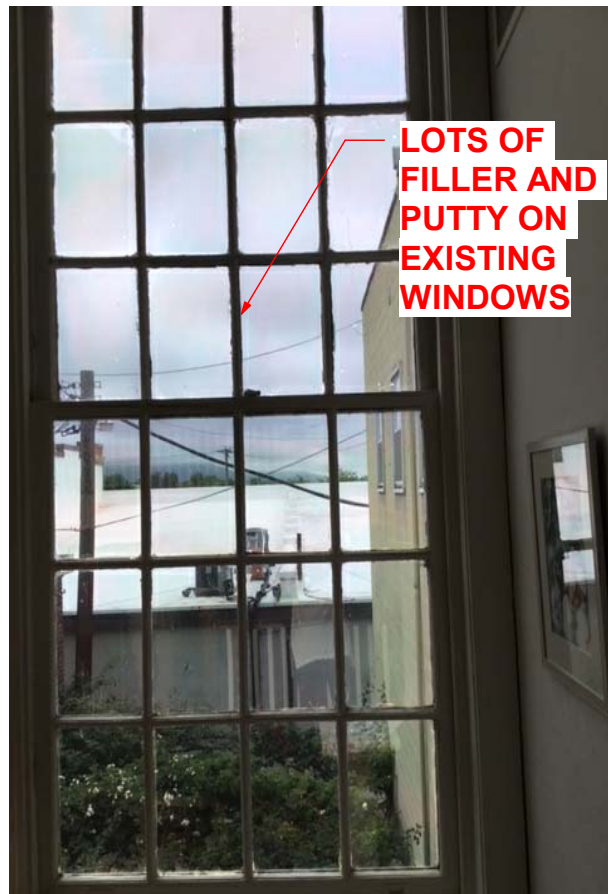
LOTS OF FILLER AND PUTTY ON EXISTING WINDOWS

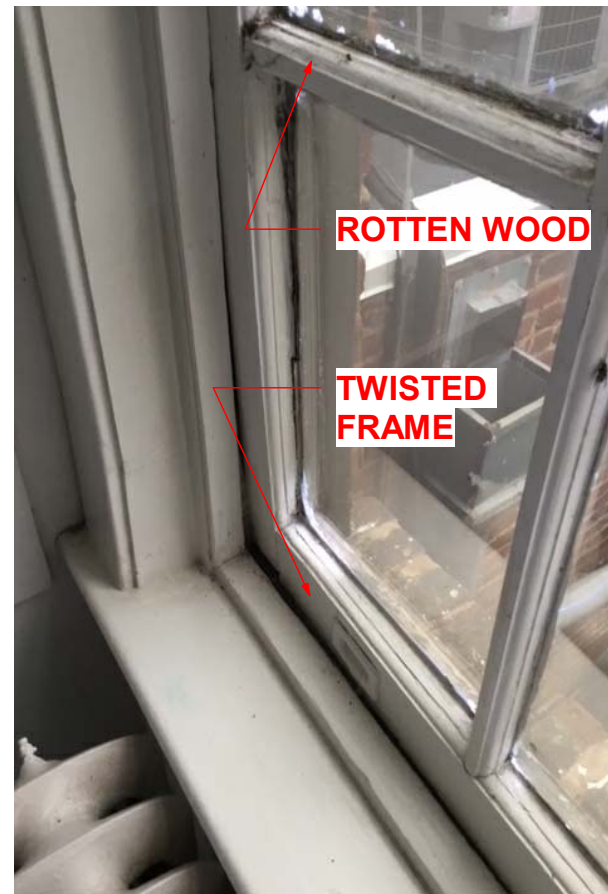
ROTTEN WOOD

TWISTED FRAME

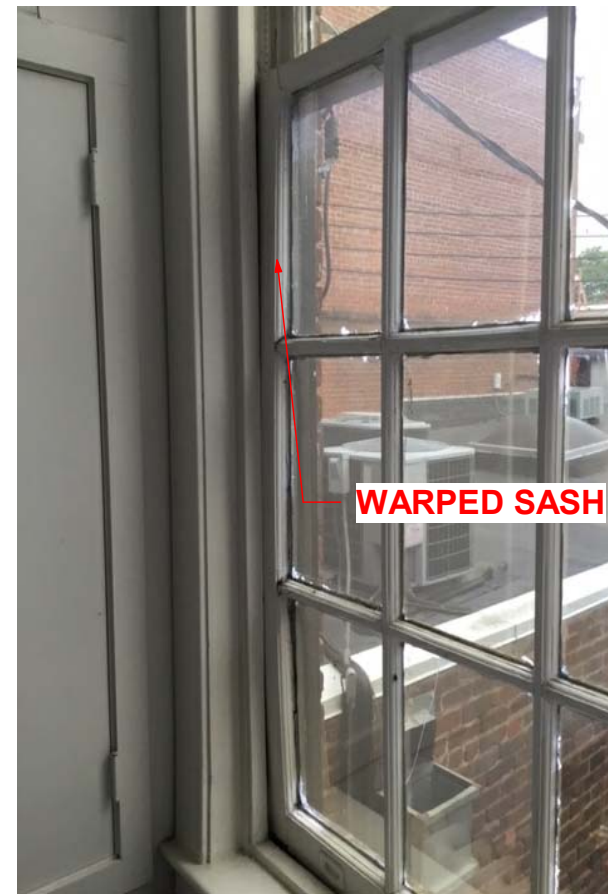
WARPED SASH

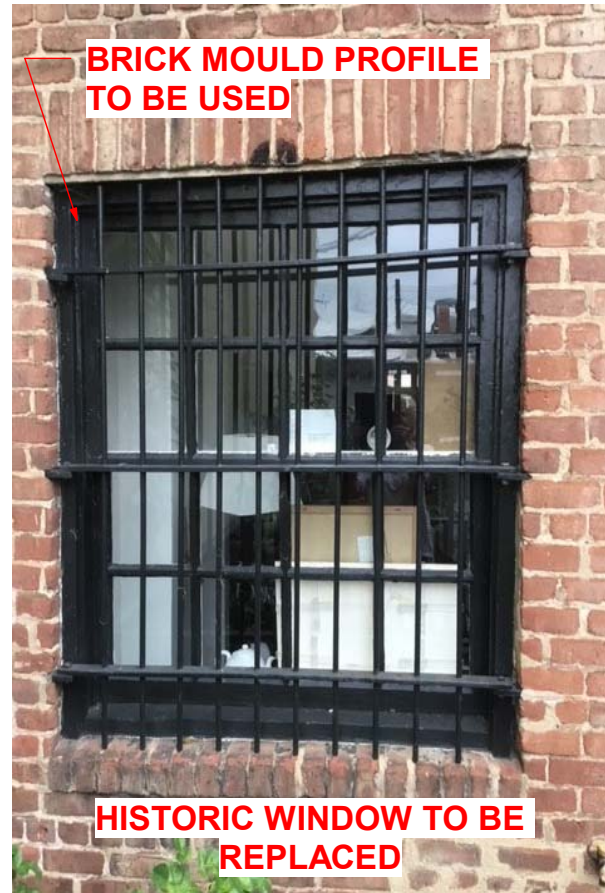
**BRICK MOULD PROFILE TO BE USED**

**HISTORIC WINDOW TO BE REPLACED**

FIRST FLOOR WINDOWS ON ALLEY SIDE: TWO EXISTING DOUBLE-HUNG UNITS ARE IN VERY POOR CONDITION. ALL UNITS HAVE PERVASIVE WOOD ROT AND EVIDENCE OF WATER INFILTRATION, AND THE SASHES ARE DEFORMED DUE TO WATER DAMAGE. WE ARE PROPOSING TO REPLACE BOTH OF THESE WINDOWS WITH NEW MARVIN ALUMINUM-CLAD DOUBLE-PANE DOUBLE-HUNG UNITS. NEW UNITS ARE TO HAVE LOW-E GLAZING AND TRUE DIVIDED LITE CONSTRUCTION WITH 1 1/8" WIDE MUNTINS AND BRONZE CLAD FINISH.

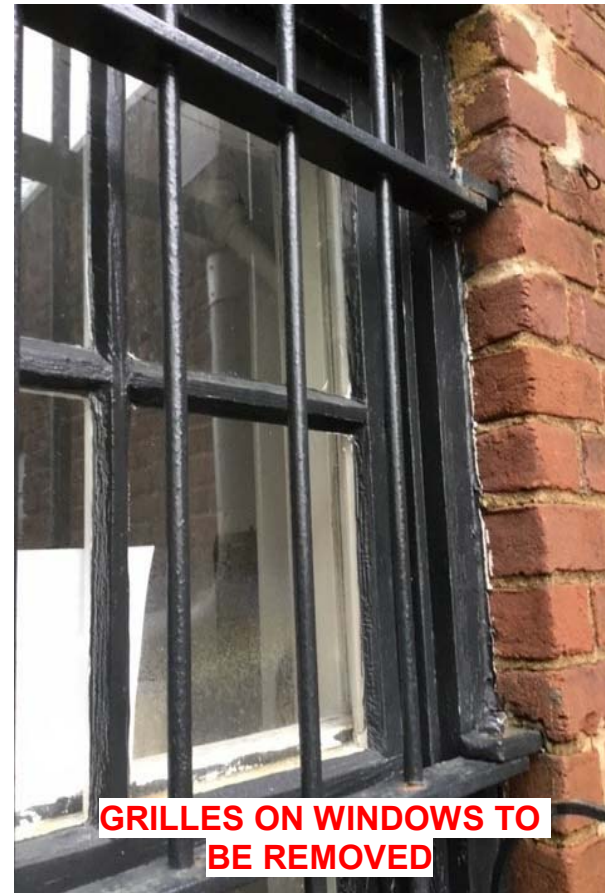
**GRILLES ON WINDOWS TO BE REMOVED**

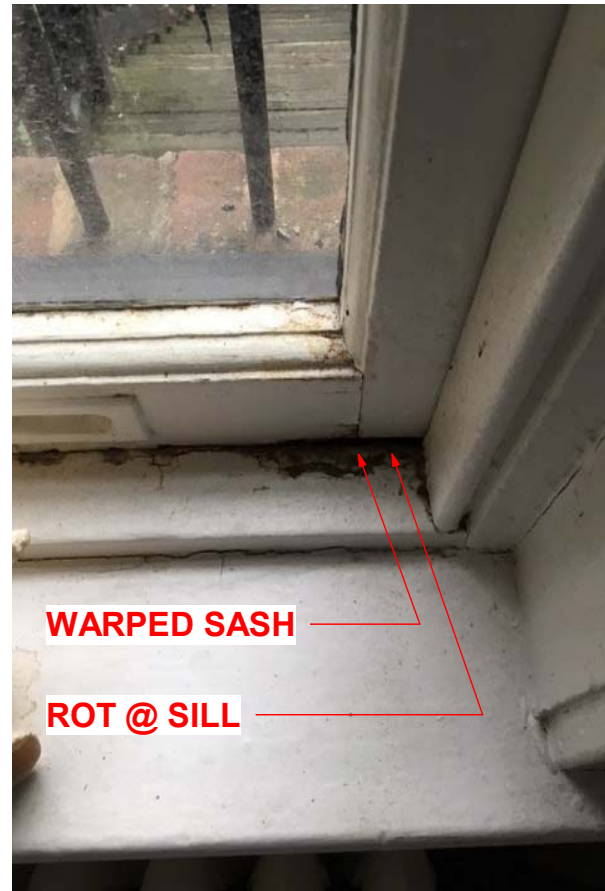
**WARPED SASH**

**ROT @ SILL**

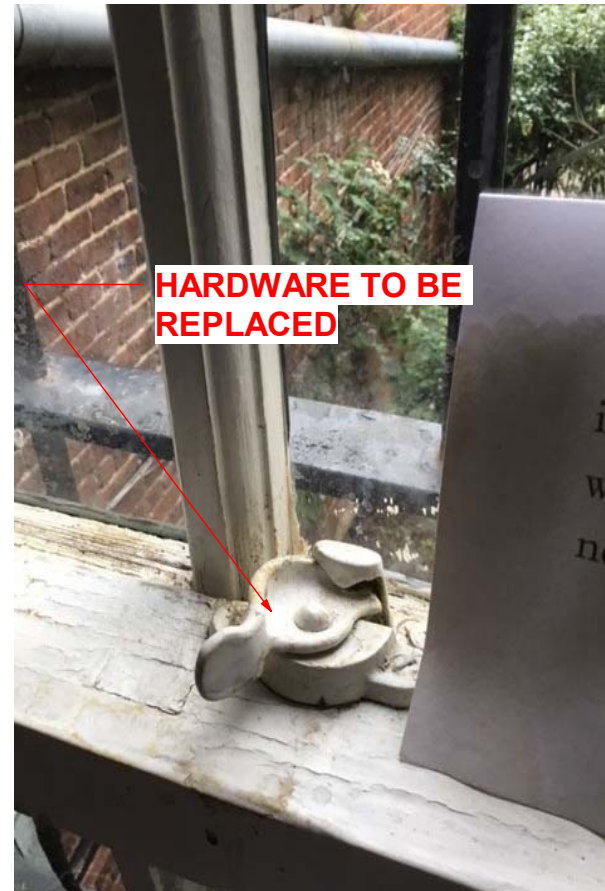
**HARDWARE TO BE REPLACED**

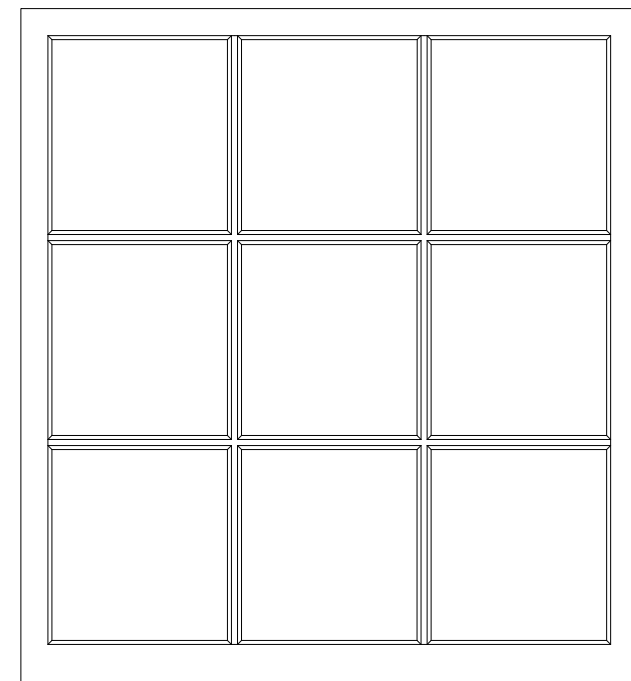
EXISTING HISTORICAL FRONT SASH TO BE REPLICATED
