Lasley, Timothy G

From: Lasley, Timothy G
Sent: Thursday, August 22, 2019 11:57 AM
To: kschafer@designdevelopllc.com
Cc: Werner, Jeffrey B
Subject: BAR Action - August 20, 2019 - 1532 & 1534 Virginia Avenue

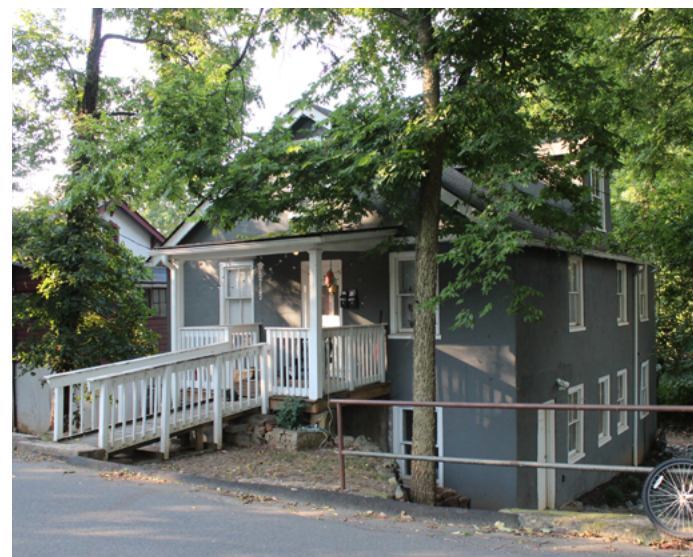
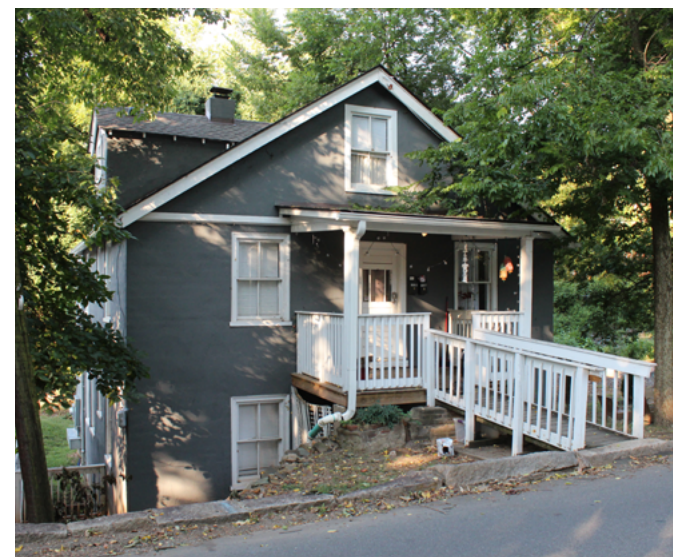
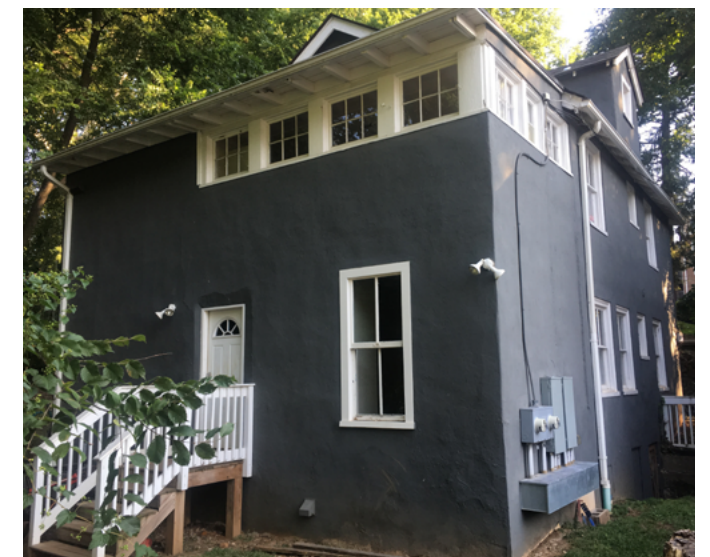
Structural Condition Assessment

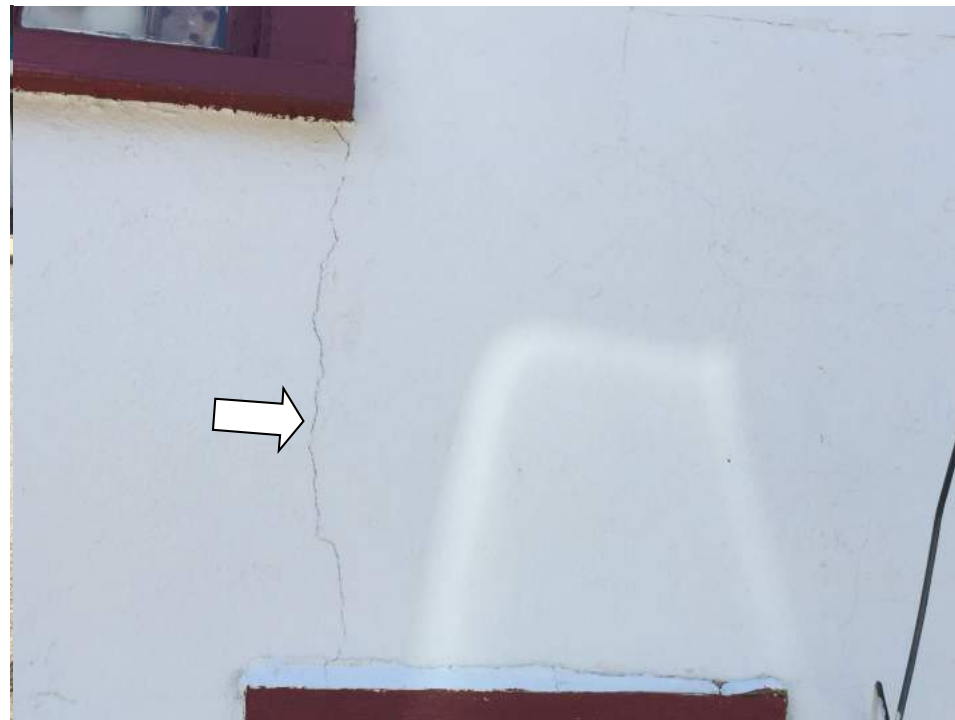
Cracking in exterior foundation walls

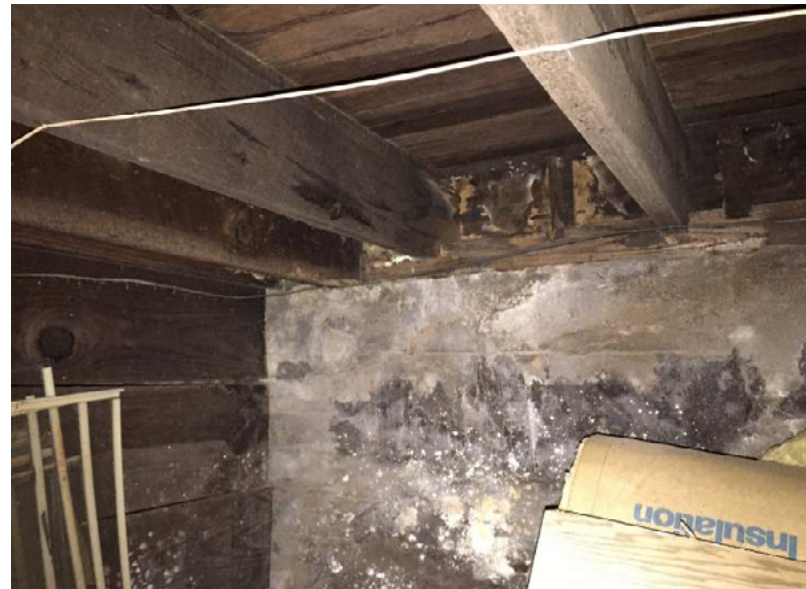
Water infiltration through foundation wall and damaged floor framing.

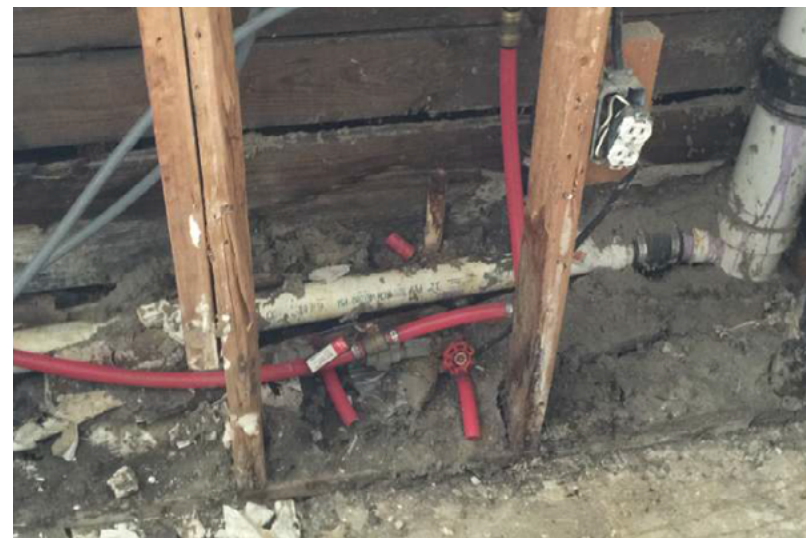
Below grade wood foundation with decay and water infiltration.

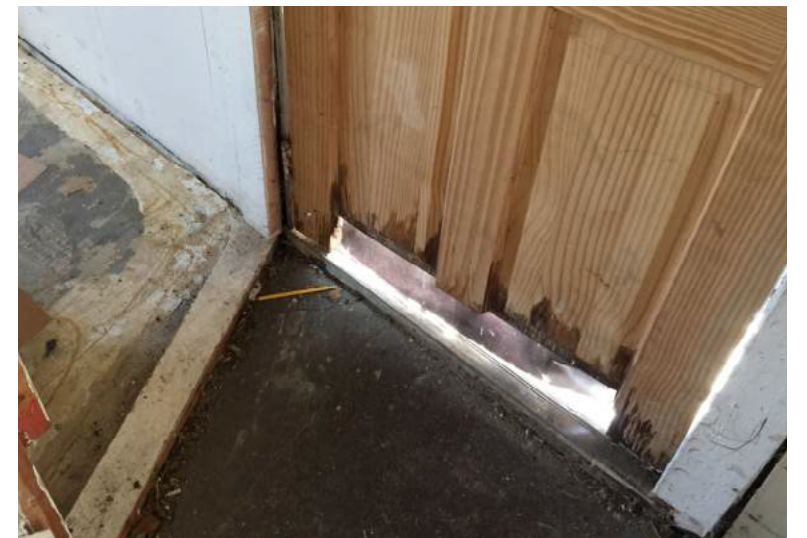
Water infiltrating lower level floor.

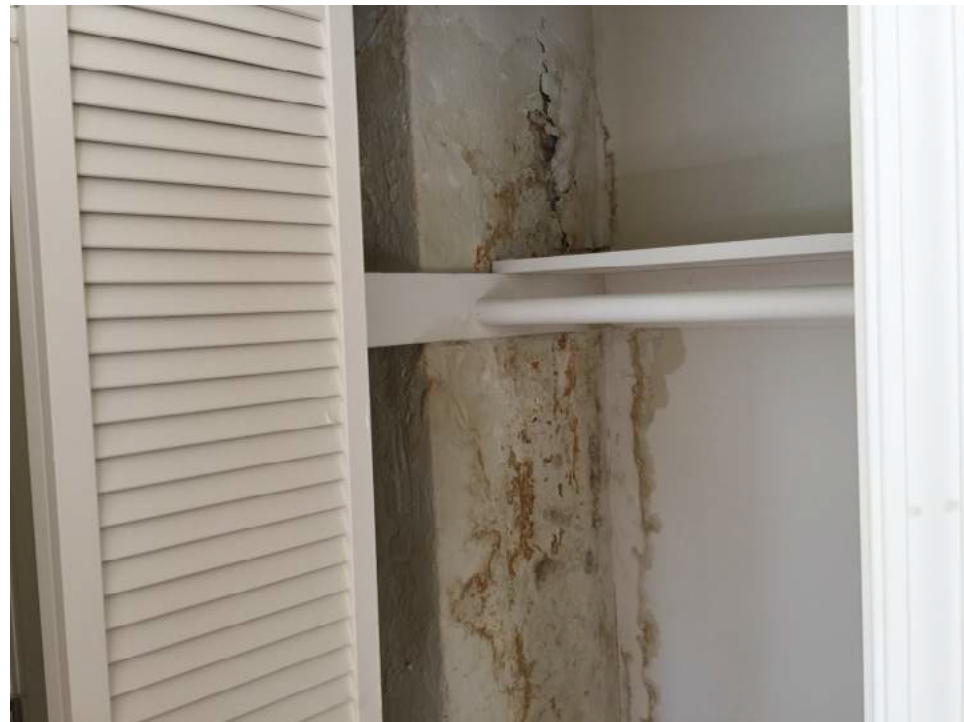
Water infiltration through old chimney.

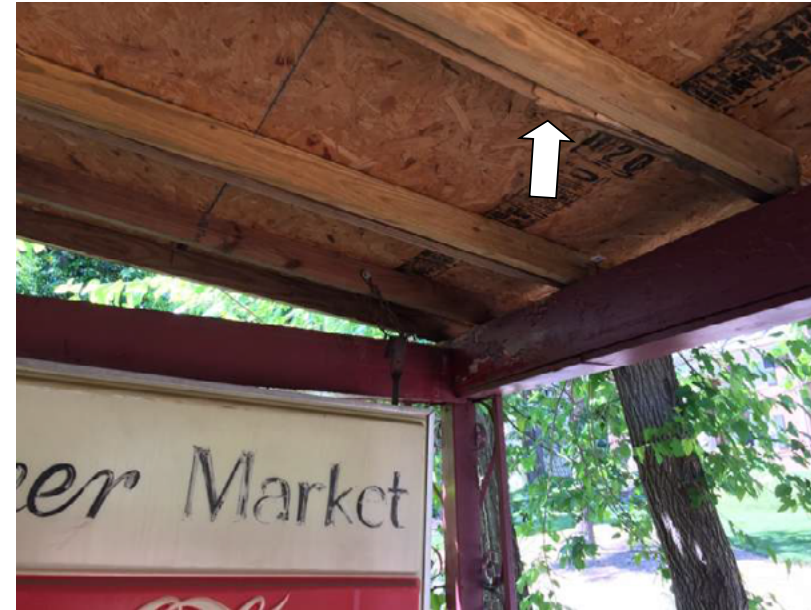
Undersized porch roof beams and rafters. Failed rafter at porch.

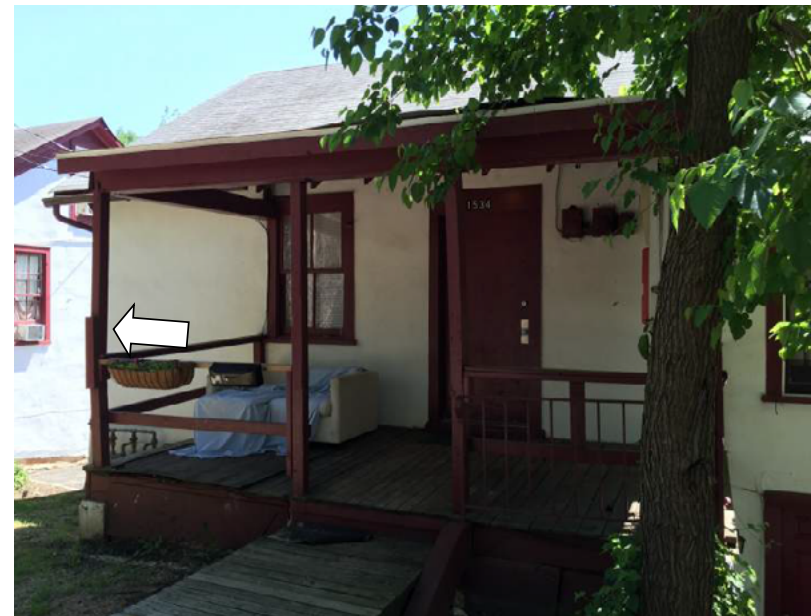
Corner post at porch is spliced and buckling.

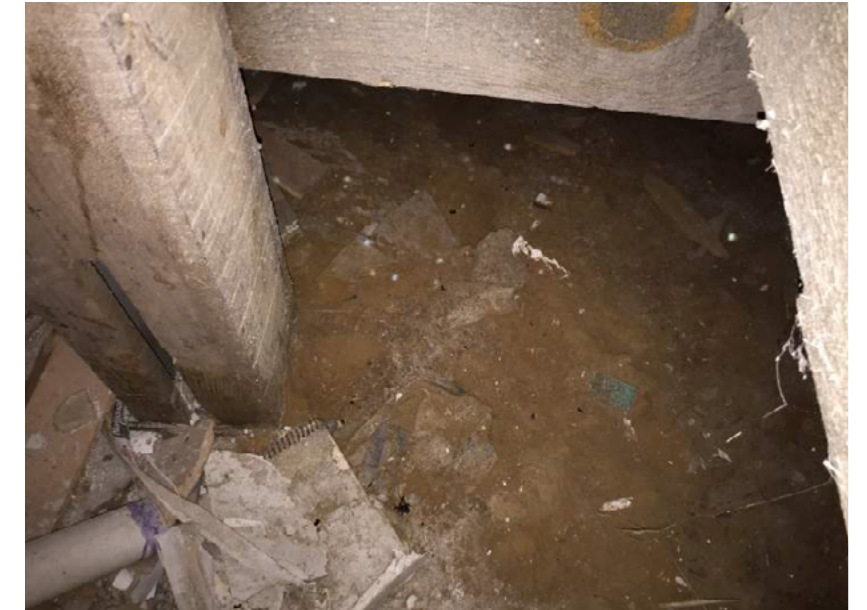
Low, damp crawl space with questionable foundation support for load

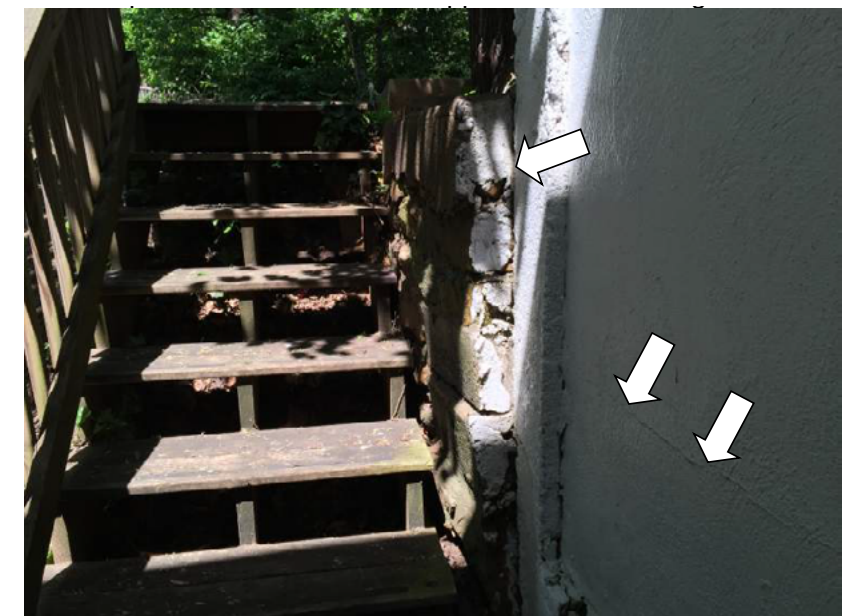
Cracked foundation wall and leaning stacked masonry retaining wall.

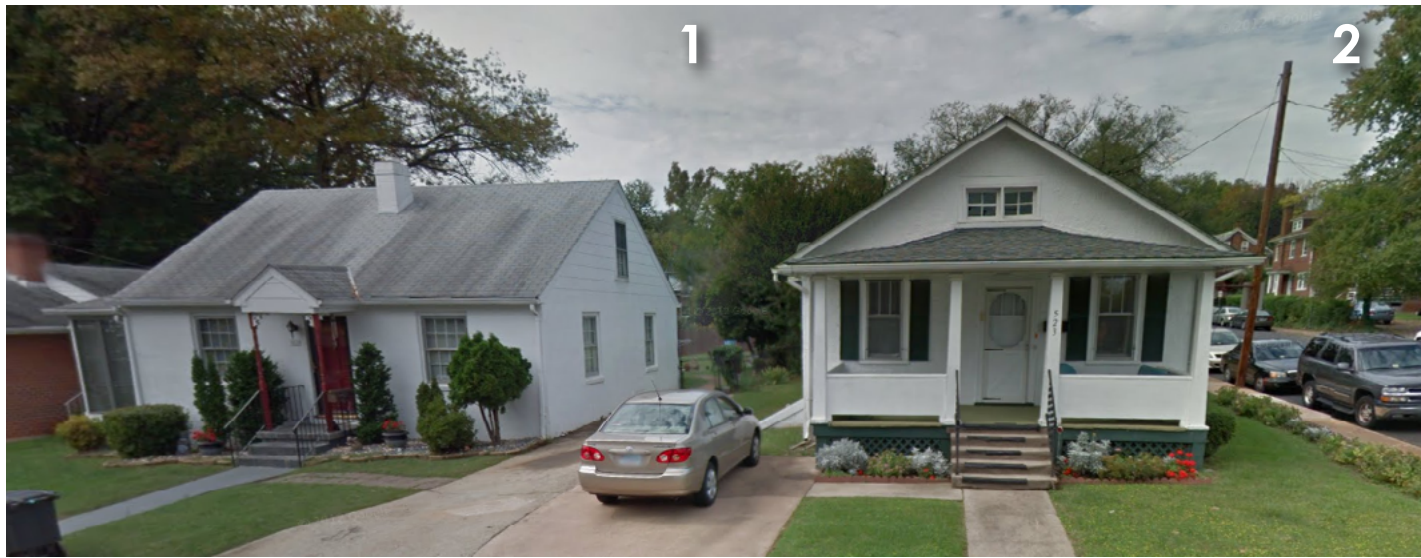
511 (c. 1948) & 523 (c. 1927) 13TH STREET
