## 2020-07 BAR Decision for 418 East Jefferson Street

### **Certificate of Appropriateness Application**

418 East Jefferson Street

Repair/replace windows

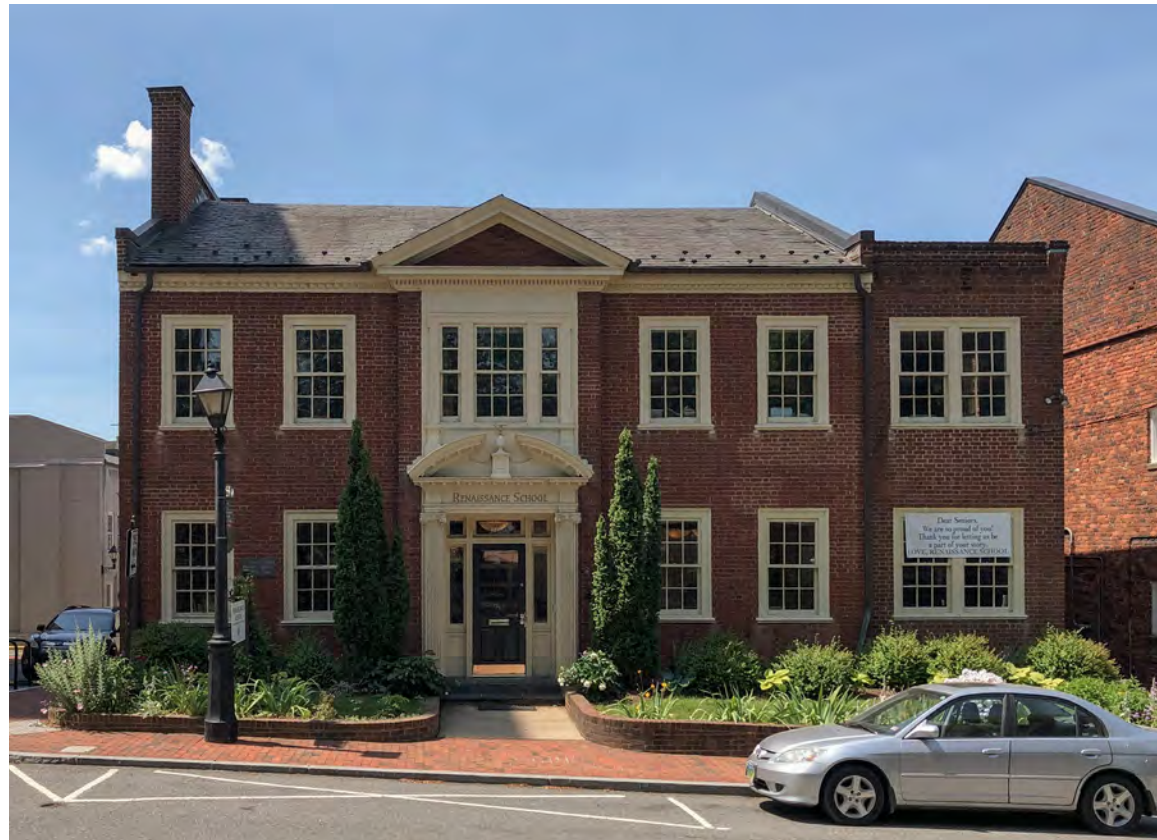
NORTH (E JEFFERSON ST) - SHEET 05

- 01. SASH WARPED AND LOOSE IN FRAME
- 02. ROTTING SASH (WOOD ROT)
- 03. PLEXIGLASS OVER EXISTING WINDOW DUE TO WATER AND AIR INFILTRATION ISSUES
- 04. INTERIOR STORM WINDOW
- 05. DOES NOT APPEAR TO BE ORIGINAL SASH - MISSING MUNTINS
- 06. DAMAGE FROM PREVIOUS APPLICATION OF SEALANTS
- 07. DAMAGED EXTERIOR TRIM OR SILL
- 08. CRACKED GLASS

WINDOW "A" - EITHER (SEE NARRATIVE)  
 A-R EXISTING TO BE REHABILITATED OR REPLACED - SEE DETAIL 01, SHEET 07.  
 A-M NEW MARVIN ULTIMATE DOUBLE HUNG INSERT G-2 - SEE DETAIL 02, SHEET 07.  
 REPAIR & REPAINT EXISTING TRIM

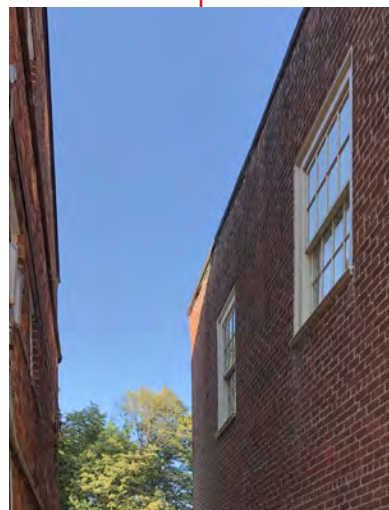
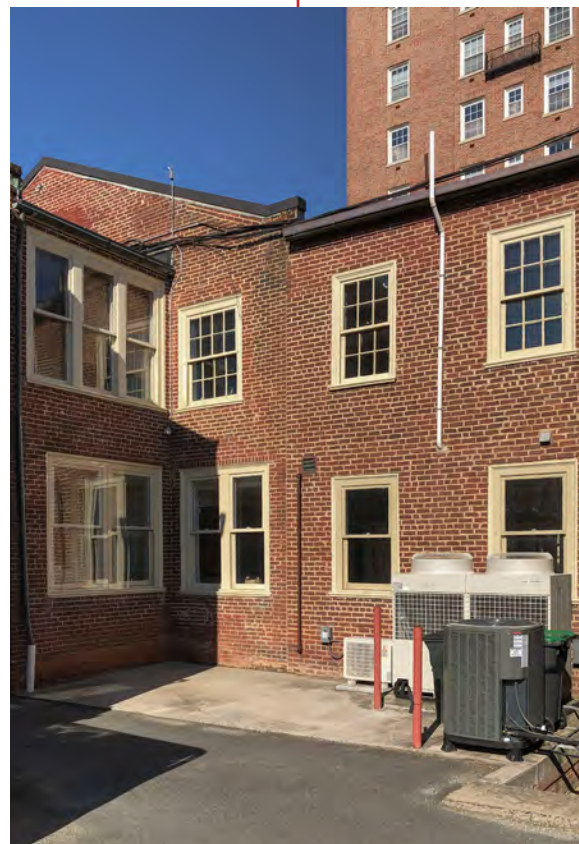
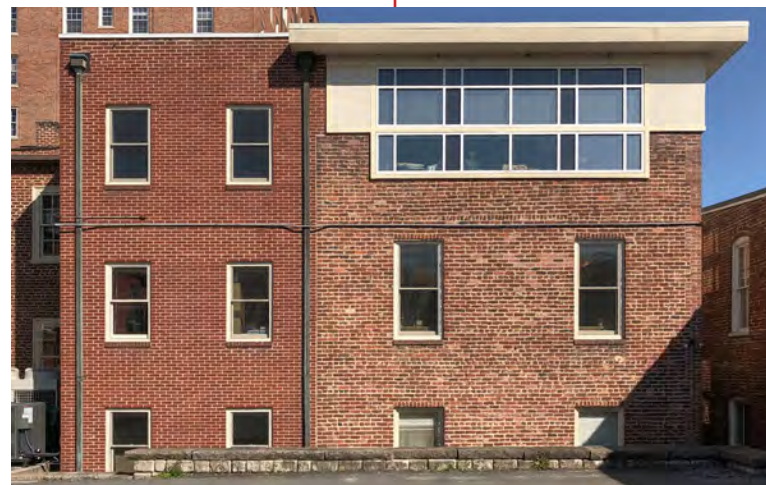
WEST (ALLEY) - SHEET 13

- 01. SASH WARPED AND LOOSE IN FRAME
- 02. ROTTING SASH (WOOD ROT)
- 03. PLEXIGLASS OVER EXISTING WINDOW DUE TO WATER AND AIR INFILTRATION ISSUES
- 04. INTERIOR STORM WINDOW
- 05. DOES NOT APPEAR TO BE ORIGINAL SASH - MISSING MUNTINS
- 06. DAMAGE FROM PREVIOUS APPLICATION OF SEALANTS
- 07. DAMAGED EXTERIOR TRIM OR SILL
- 08. CRACKED GLASS

- WINDOW "B" - EITHER (SEE NARRATIVE)
- B-R EXISTING TO BE REHABILITATED OR REPLACED - SEE DETAIL 01, SHEET 10.
  - B-M NEW MARVIN ULTIMATE DOUBLE HUNG INSERT G-2 - SEE DETAIL 02, SHEET 10.
- REPAIR & REPAINT EXISTING TRIM  
NEW WINDOW "B" AT EXISTING DOOR

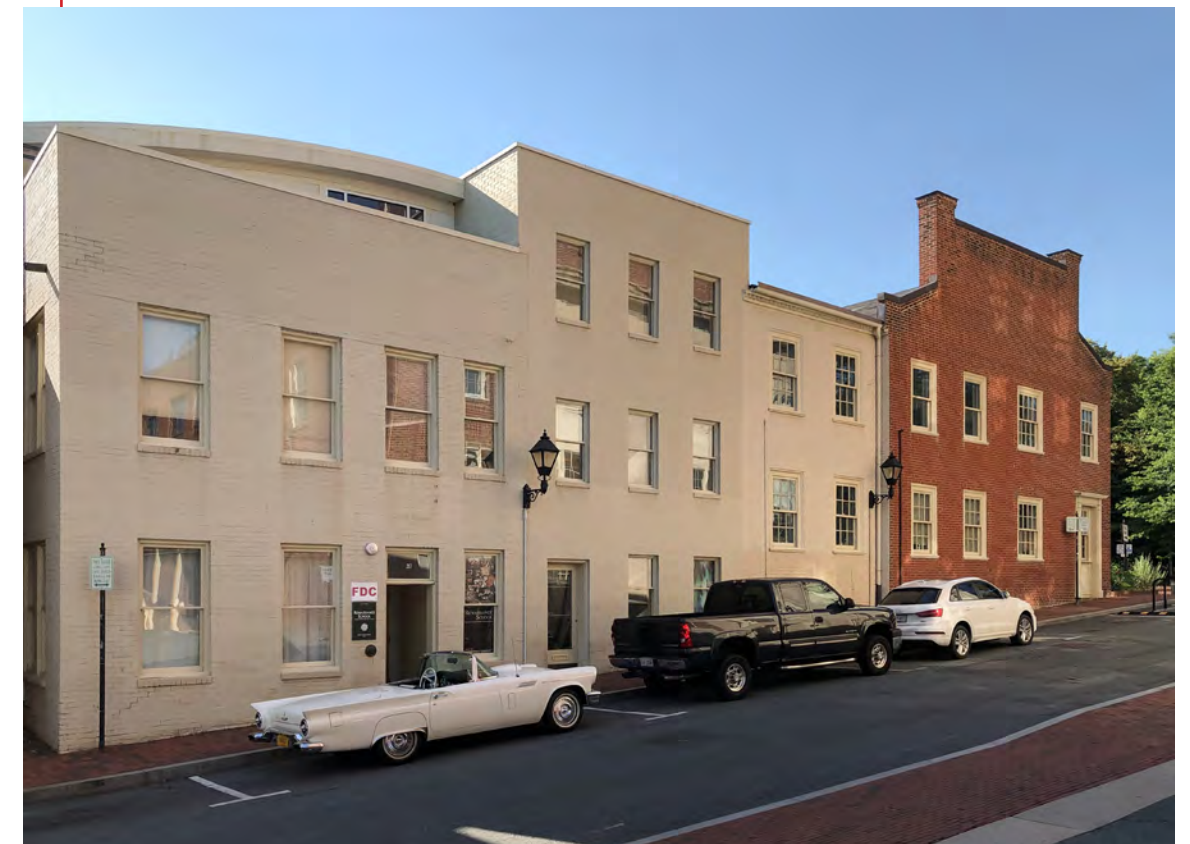
EAST (5TH ST NE) - SHEET 08

- 01. SASH WARPED AND LOOSE IN FRAME
- 02. ROTTING SASH (WOOD ROT)
- 03. PLEXIGLASS OVER EXISTING WINDOW DUE TO WATER AND AIR INFILTRATION ISSUES
- 04. INTERIOR STORM WINDOW
- 05. DOES NOT APPEAR TO BE ORIGINAL SASH - MISSING MUNTINS
- 06. DAMAGE FROM PREVIOUS APPLICATION OF SEALANTS
- 07. DAMAGED EXTERIOR TRIM OR SILL
- 08. CRACKED GLASS

WINDOW "B" - EITHER (SEE NARRATIVE)  
 B-R EXISTING TO BE REHABILITATED OR REPLACED - SEE DETAIL 01, SHEET 10.  
 B-M NEW MARVIN ULTIMATE DOUBLE HUNG INSERT G-2 - SEE DETAIL 02, SHEET 10.  
 REPAIR & REPAINT EXISTING TRIM  
 NEW WINDOW "B" AT EXISTING DOOR
