March 2021 BAR Decision

**City of Charlottesville
Board of Architectural Review
Staff Report
March 16, 2021**

BAR 21-03-08

Project: Replace four, apartment windows

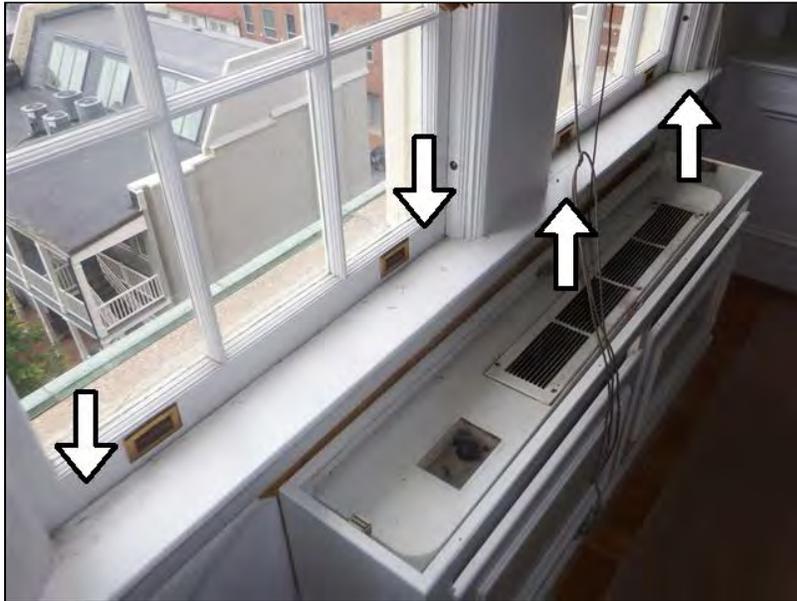
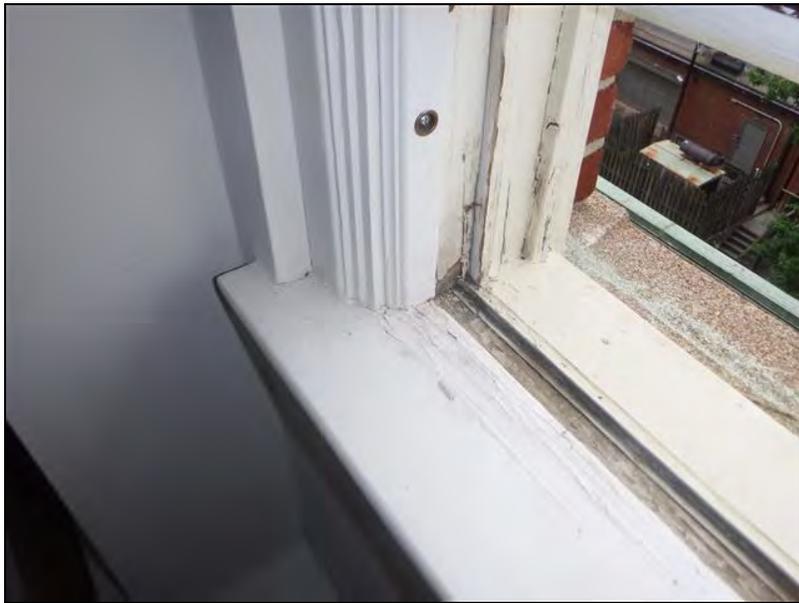
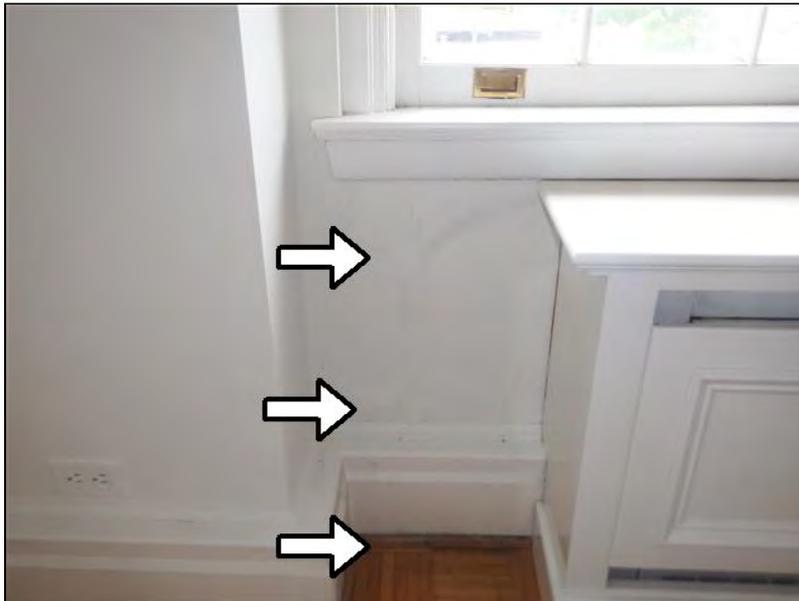
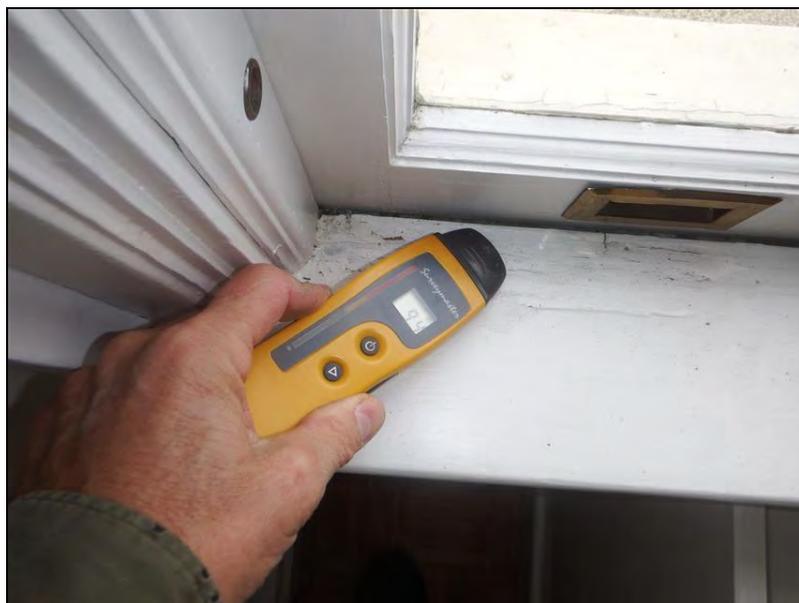
- D** (1) There was evidence of repeated water intrusion at the living room window sill, most notably at the left most jamb. The evidence extended down the wall and onto the floor. The area was checked with a moisture meter and found to be dry during the inspection.

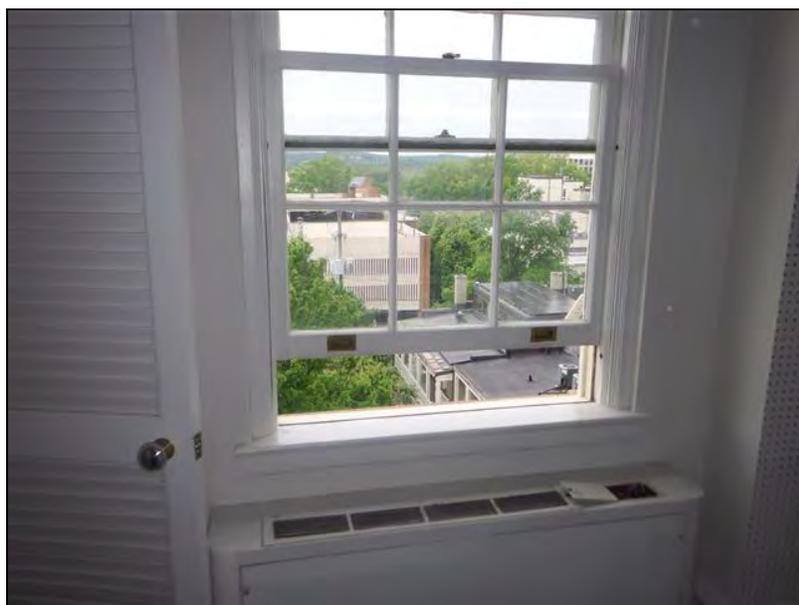
kitchen

D (2) Using reasonable force the two sashes where located in the pictures below could not be fully opened.

NOTE: The window treatment on the left window was deteriorated and not functioning properly as can be seen in the picture.
