**From:** Scala, Mary Joy  
**Sent:** Thursday, January 21, 2016 11:02 AM  
**To:** Hunt, Richard  
**Subject:** BAR Action Jan 19, 2016 -610 Ridge Street

BAR 16-01-02  
610 Ridge Street  
Tax Parcel 290263000  
L Juanita and Ruth L Jones, Owners/ City of Charlottesville, Applicant  
Necessary remediation for blighted property

**CITY OF CHARLOTTESVILLE  
BOARD OF ARCHITECTURAL REVIEW  
STAFF REPORT  
January 19, 2016**

Construction Documents	
610 Ridge Street Stabilization Charlottesville, Virginia  Construction Documents 21 December 2015 Train Architects P.O. Box 911 - City Hall Charlottesville, Virginia 22902 www.trainarchitects.com	  Rev 01: Not Used Rev 02: Not Used Rev 03: Not Used Rev 04: Not Used Rev 05: Not Used
Project Information	T1.01

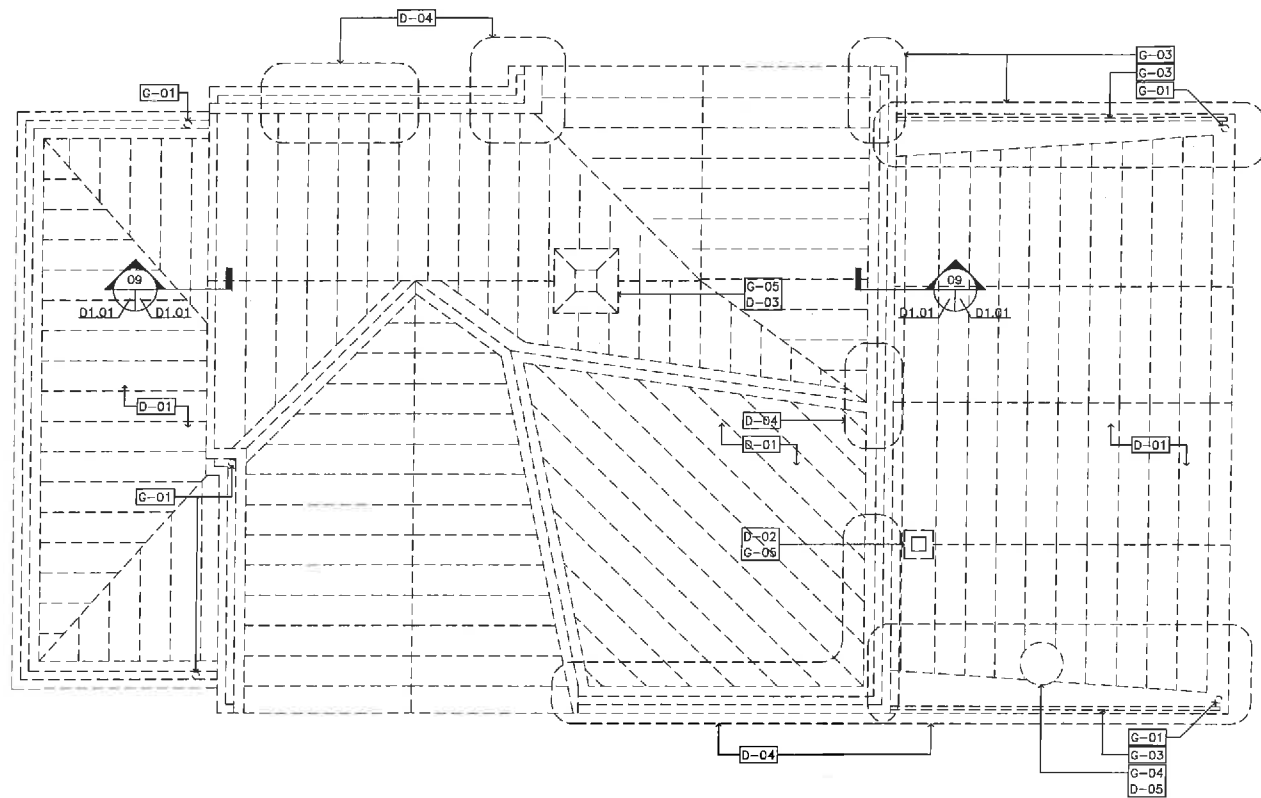
**06 Roof Demolition Plan**  
Scale:  $\frac{1}{4}" = 1'-0"$

- **Roof and gutter system replacement - \$62,500**  
The metal roof is old and has been patched in several locations. The perimeter has deteriorated in several spots and it is not cost efficient to repair. There are some obvious

structural repairs to make and anything that gets removed to make those repairs will likely not be salvageable. Tying in new metal to existing is not practical. The Philadelphia style gutters have completely failed and should be rebuilt with new flashing, lining, and downspouts. Downspouts will have to be tied in to the existing storm water drains. Those drains may or may not be currently functioning. Soffit and fascia trim will need to be replaced and painted to match existing.

Roof and gutter system: The entire roof and Philadelphia gutters will be removed and replaced. The proposed new roof is 26 gauge Galvalume standing seam metal with 17.25" pan width and 1" seam height.
