**From:** Lasley, Timothy G  
**Sent:** Thursday, July 19, 2018 10:01 AM  
**To:** 'carlae@purplecherry.com'  
**Cc:** Werner, Jeffrey B; Mess, Camie  
**Subject:** BAR Actions - July 17, 2018 - 404 East Main Street

### **Certificate of Appropriateness Application**

BAR 18-06-01

404 East Main Street; Tax Parcel 280046000

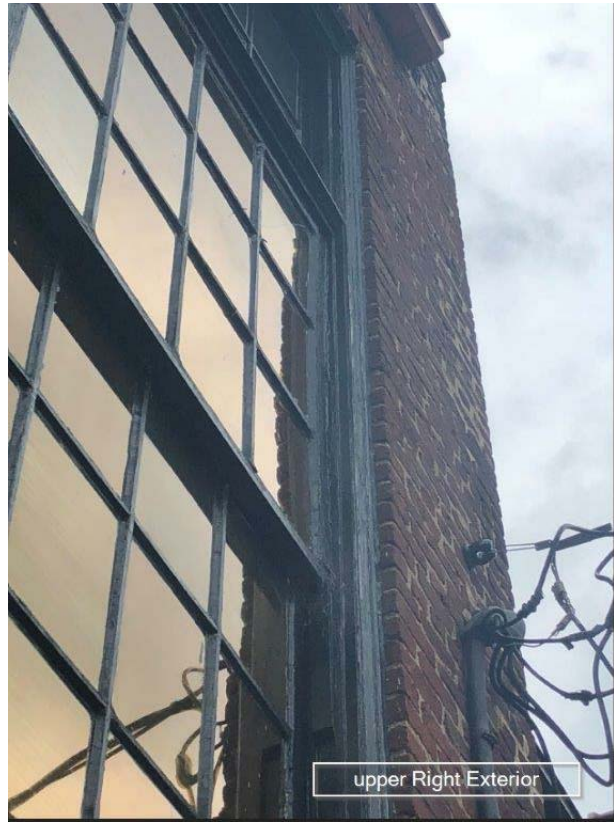
1

In the matter of the windows on the Old Dominion Bookstore, Gaston & Wyatt has come to the conclusion that the windows cannot be restored and it would be the best course to replace them. There is easy to see and apparent rotting of the wood. There is likely more rot than the eye can see that is hidden by layers of paint. When you have wavy or bubbled paint it is true sign that water has been able to compromise the paint and likely has deteriorated the wood behind it. So, even if the apparent locations seem like they could be restored, there are hidden locations that would make the restoration task even greater.

It appears that the millwork has had some restoration attempts over the years that have now become apparent and starting to deteriorate again. You can only put so many band aids on wood before you have to totally replace it. Even if the windows were even close to being at a point to restore them, putting dutchman or some form of epoxy on them is surly just a band aid and will have to be redone sooner than one would want to. Replacement is a sure and lasting result. Gaston & Wyatt is totally in favor of repair and restoration rather than replacement when it makes sense. All of the conditions have to be "right" to warrant the restoration. This is not one of those cases.

Another reason that replacement would be the best course is, many of the joints that are holding the sash together have been "popped". Meaning that the glue and/or the fasteners that is holding the sash together has come loose. When this happens it is very difficult to get glue back in the joint without totally taking the sash apart which most of time proves to be such a chore that the parts get damaged during the process, requiring replacement.
