BAR 19-07-01  
603 Lexington Avenue  
Tax Parcel 520167000  
Richard Zeller, Owner/Applicant  
Rear Shed Demolition and Replacement

**CITY OF CHARLOTTESVILLE  
BOARD OF ARCHITECTURAL REVIEW  
STAFF REPORT  
July 16, 2019**

# Existing Conditions Report

Garden Shed at 603 Lexington Ave.

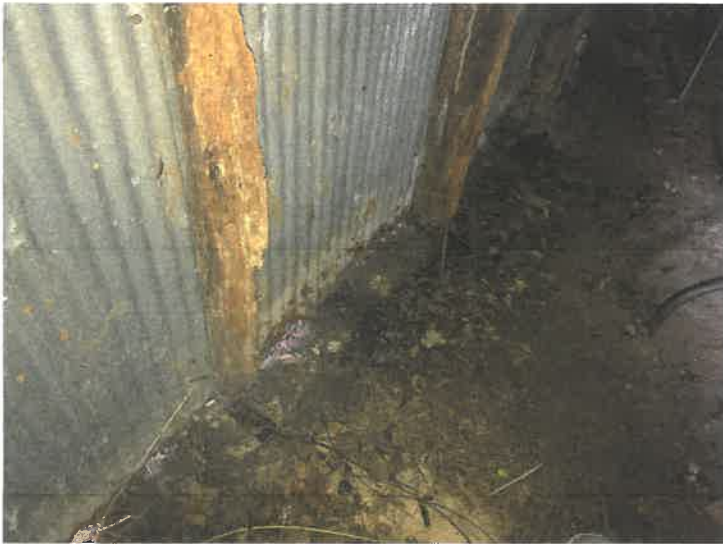
The existing shed sits on a concrete slab. Drainage issues along the north facade of the existing shed has done structural damage to the existing wood framing. The bottom plate along this facade faced significant rot and is no longer present. Many original studs on all facades have rotted through completely and are held in place only by the attachment to the existing metal siding.

*Rotting/water infiltration along north facade*

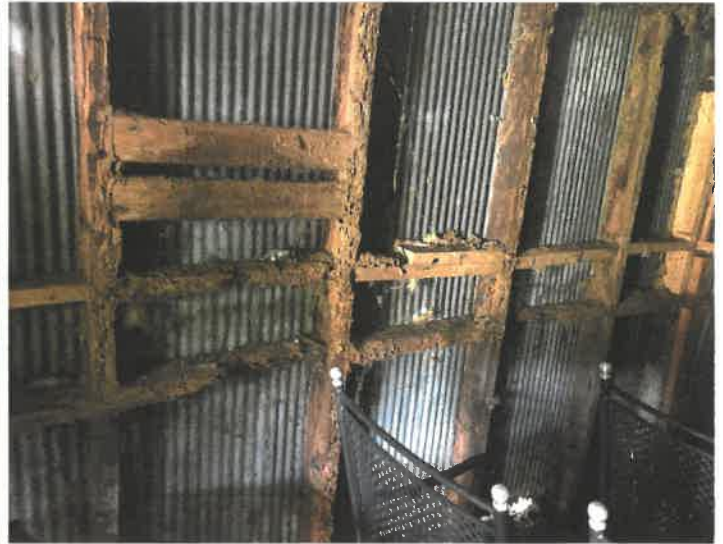
*Rotting in original stud wall framing*

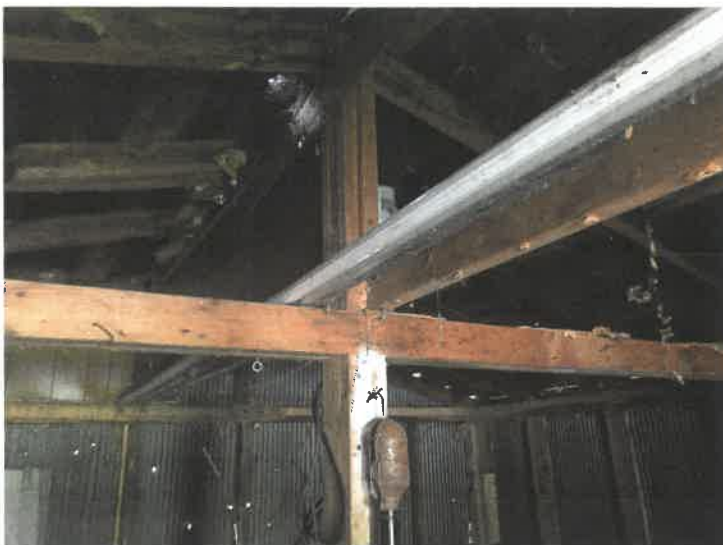
Significant reinforcement with new wood framing has been added throughout the structure's lifespan. Shoring via a new middle post and beam support the roof framing and ridge. Many of the original roof rafters have significant rot damage and are no longer serving a structural purpose.

*New shoring at existing ridge / roof structure*

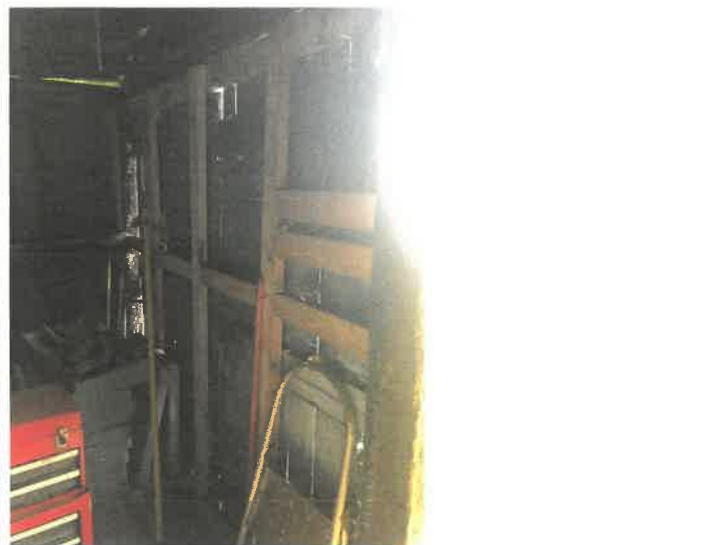
On the western facade, new wood framing required to support the wall has rendered three of the four existing doors non-functional. It appears the doors had originally been painted red, before being painted green to match the corrugated metal siding.

*New reinforcement framing at exterior doors*

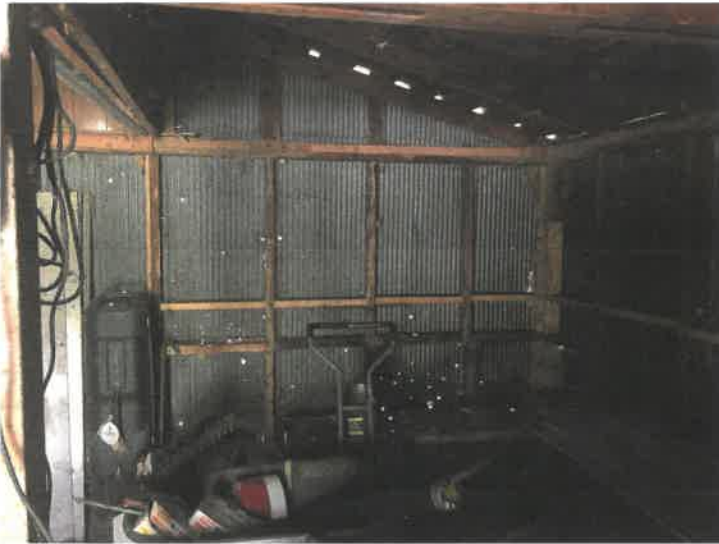
The existing corrugated metal siding has significant damage from both drainage issues and previous owners. Along the north facade, the siding along the ground has rusted away where grade has accumulated on the facade and has been subject to water infiltration. On the east facade, the siding is rife with what appear to be bullet holes from previous owners.

*Numerous bullet holes and various penetrations*

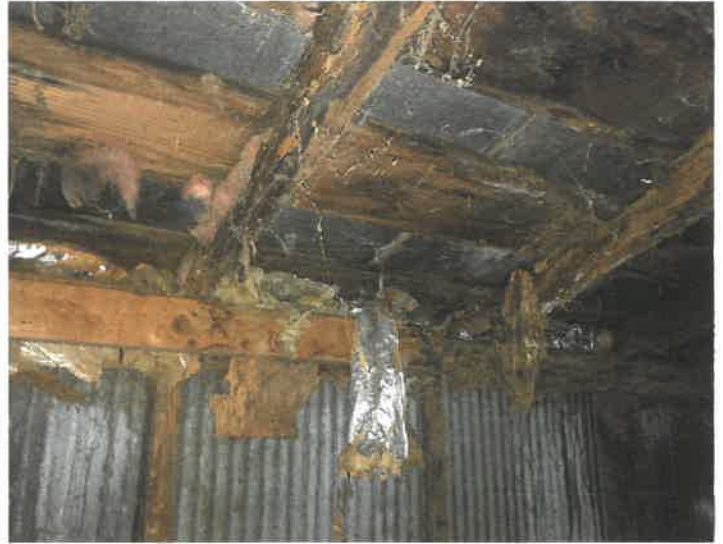
*Substantial rot in existing wood framing*

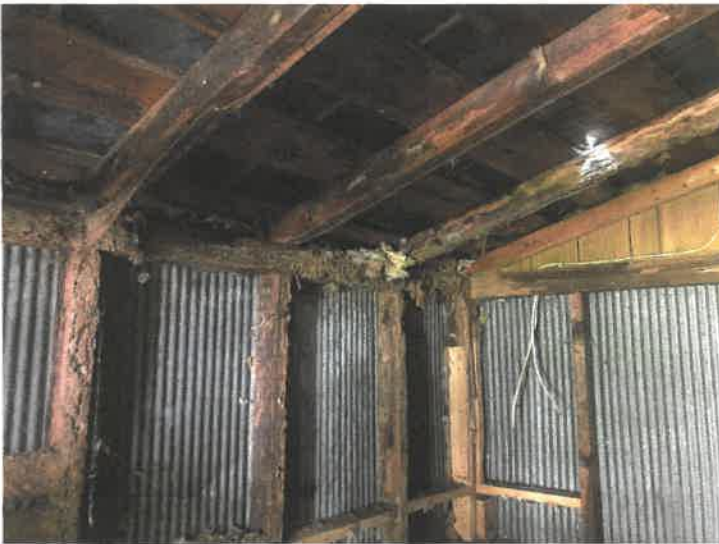
The existing metal sheet roofing is past its lifespan and has rusted through in several locations. Attached to original 1 x 6 sleepers spanning the original roof rafters, holes in the existing metal roofing have accelerated the rot in the existing structure by allowing consistent water infiltration. The metal roof appears to have been installed over thin strips of wood blocking to create the illusion of standing seam. The sheet metal has curled up off the wood structure in several locations, allowing for water, insect, and rodent infiltration.

*Holes visible through roofing*

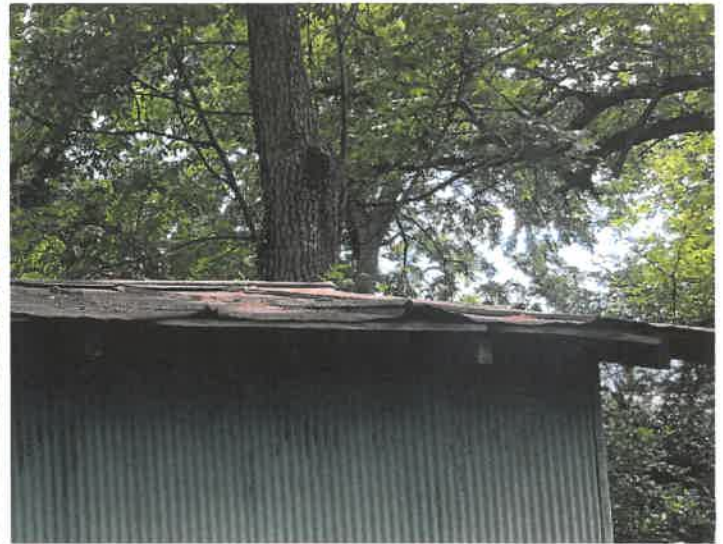
*Damaged sheet metal roofing*

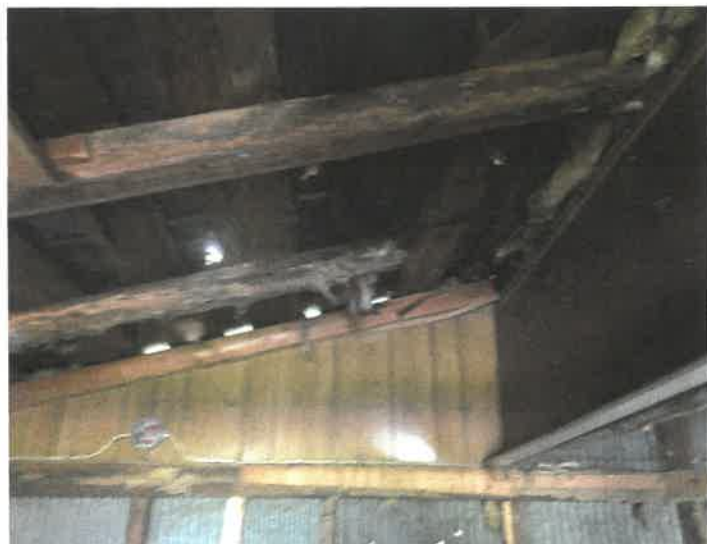
*Rotted Roof Rafters*

Repairing the shed would be intense, from labor, material, and financial perspectives. All exterior siding and roofing is in need of replacement. All existing original wood framing is in need of replacement. New doors would be required if they are desired to be functional. The slab appears to be in sufficient condition to remain for a shed use. As both a neighbor and someone familiar with the intent of the City of Charlottesville Conservation District, I would support demolition and replacement of this existing structure.

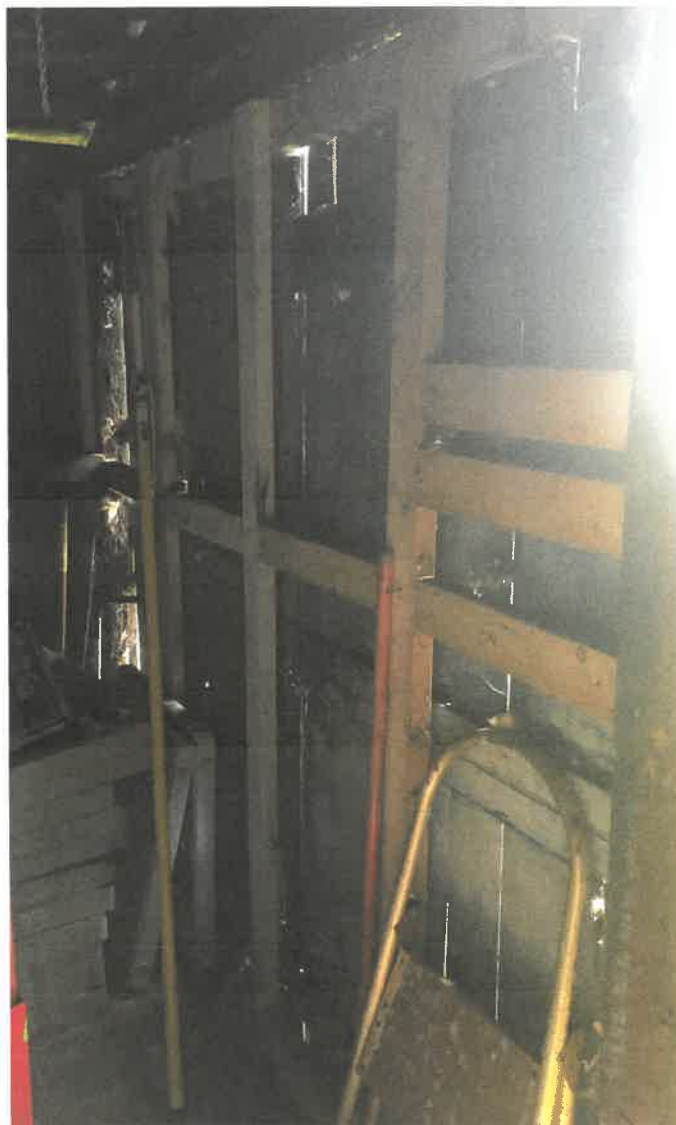
*New supporting framing at existing doors.*
