Certificate of Appropriateness
BAR #25-0079
759 Belmont Ave, TMP 580172000
North Downtown ADC District
Owner: Viewmont Associates LLC
Applicant: Dan Bracey on behalf of Elaine Oakey
Project: Chimney removal

**City of Charlottesville
Board of Architectural Review
Staff Report
May 20, 2025**

BAR #25-0079

Project: Chimney removal

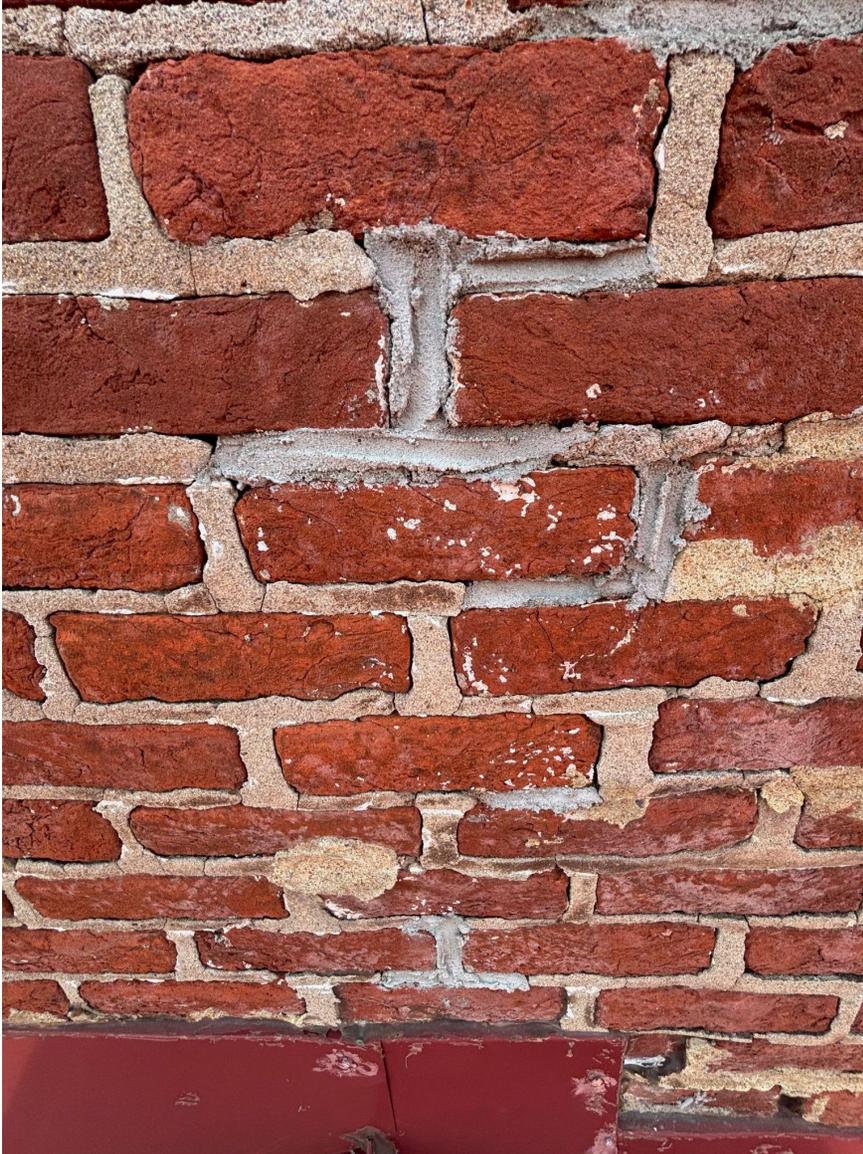
My assessment of the chimney in question is that it is in very poor condition. The mortar joints have no structural integrity at this point and have actually turned into dust in most of the chimney causing the brick to slowly lean approximately 4 inches towards the house. It is positioned on the gable end and while there's little to no danger of the chimney falling towards the driveway, it will inevitably fall onto the roof if it is not addressed in the immediate future.

Mortar Detail & Repairs

Our plan is to remove the chimney down to the peak of the gable, capping it off with a metal dome and installing vents through the dome to allow the furnace to vent properly. Our removal process will involve scaffolding up to the chimney and removing the brick onto the scaffolding and lowering them down using a rope and pulley system.

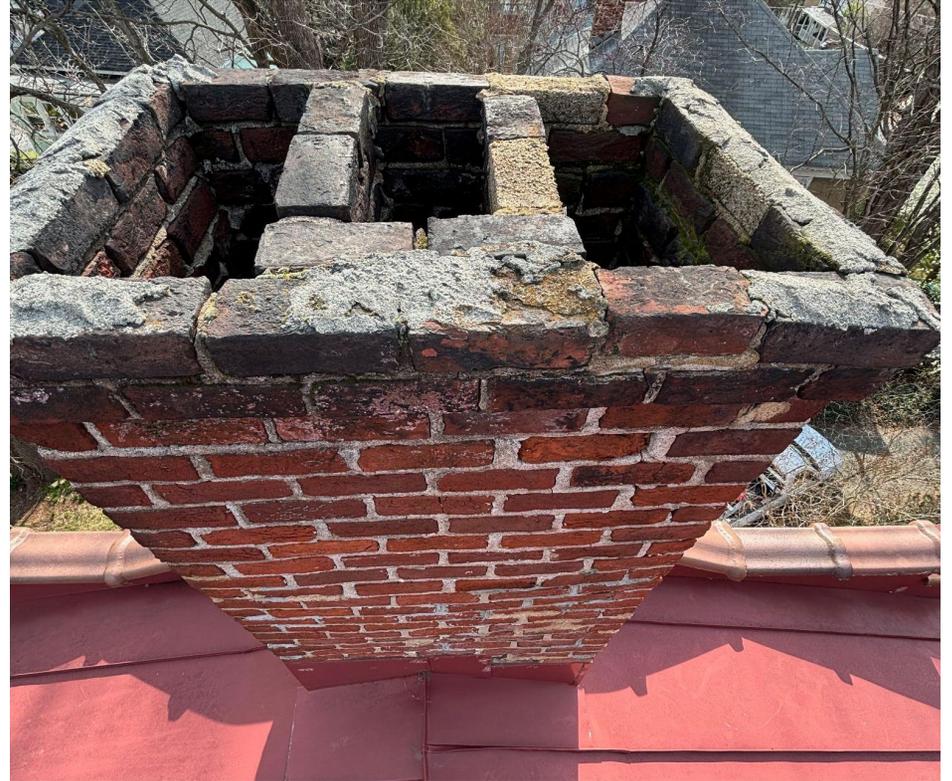
Cap Condition
