From: Scala, Mary Joy
Sent: Tuesday, December 07, 2010 4:47 PM
To: McHugh, Kathy
Cc: 'John Quale'; 'Marilyn W. Moedinger'
Subject: 608 Ridge Street

From: Scala, Mary Joy
Sent: Monday, December 06, 2010 4:24 PM
To: Brian Hogg; Candace DeLoach; Eryn Brennan (work); Eryn Brennan personal; Faxayres@gmail.com; Fred Wolf; Michael Osteen; Preston Coiner; Syd Knight; William Adams
Subject: 608 Ridge Street Eco ReMOD revision
Attachments: 608 Ridge Street.pdf

This regards the existing house on Ridge Street at the intersection of Elliott and Cherry that Eco MOD is refurbishing.

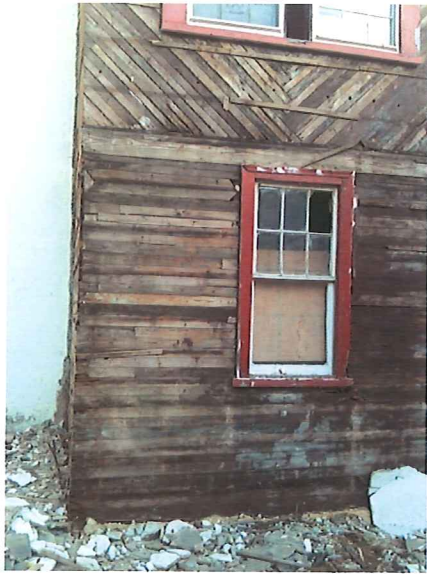
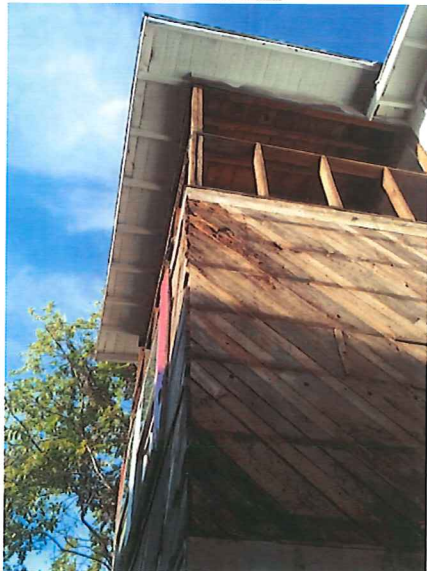
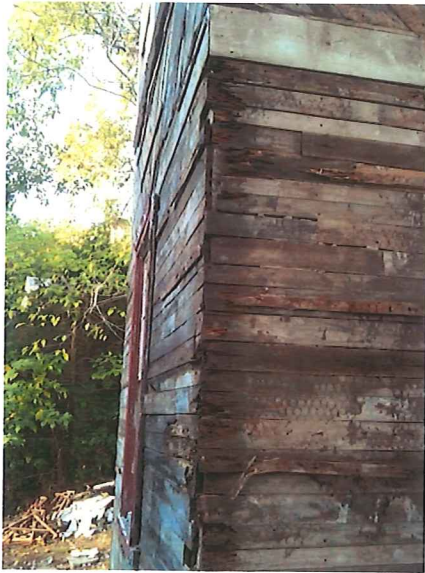
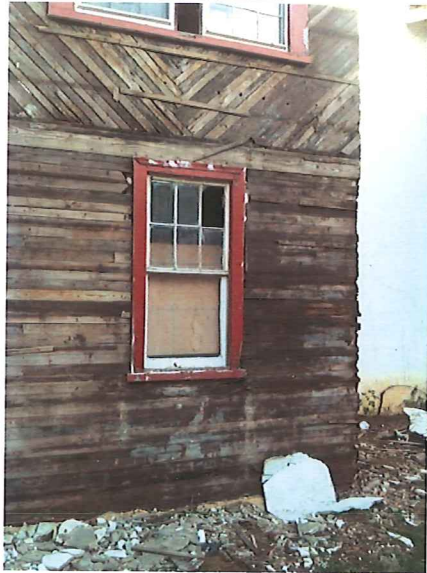
We have removed the stucco from the "tower" section to reveal a bunch of T&G sheathing. Due to the amount of rot, the narrow width, and the short lengths of the existing material I wanted to discuss the feasibility of the plan to reuse the old sheathing as siding. It seems that a more economical plan may be to remove and replace the rotten sections with new sheathing, wrap the existing structure / sheathing with house wrap, and construct a rain-screen with new material (new wood slats or another siding material). I just wanted to open this discussion and see if we are open to alternatives at this point now that we know the condition of the existing material.

The "album" link below shows the condition of the 1922 wood after exposed.

What they want to do instead of refinishing the wood is to use hardie smooth horizontal siding with 6" overlap, painted the same tan color as the stucco on the rest of the house. The rainscreen they mention consists of slats of wood under the hardie that will not be visible.

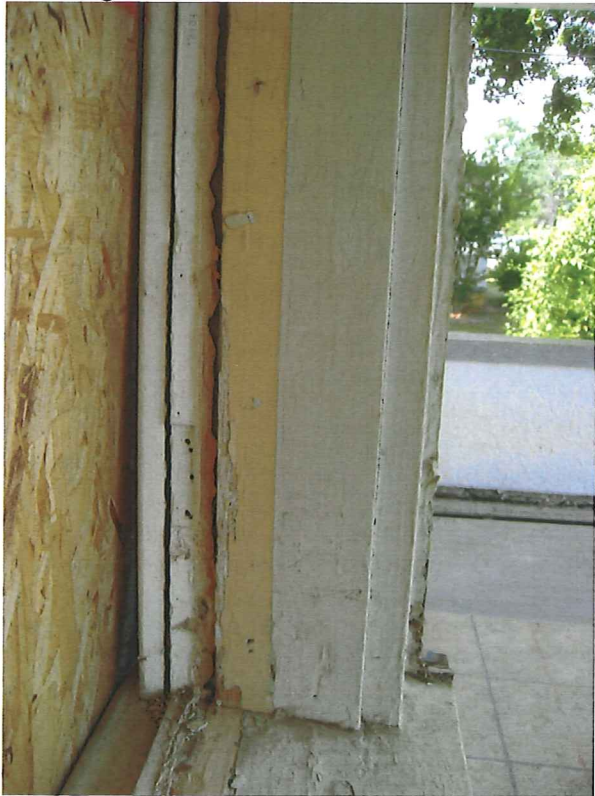
608 Ridge Street Front casement window frames

During demolition, we discovered evidence of hardware for double inswing casement windows in the front location, and no indication of weights or hardware for double hung windows in this location.

We propose windows A+B to now be Pella Architect Series double inswing casement windows, to replicate what was originally present in 1922. The house has a mix of both casement and double hung windows, and we feel it is important to the historic narrative of the house to replace the casement windows on the front of the house, rather than use double hungs as originally approved.

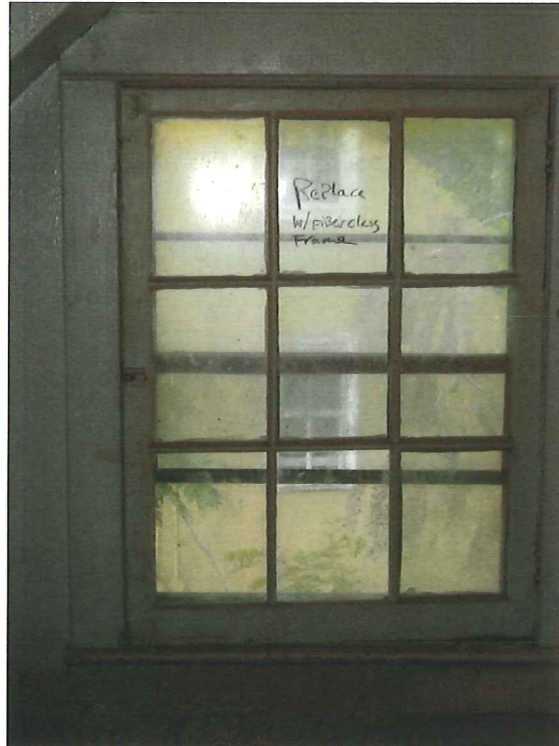
Bathroom window

Also, we're proposing switching a window on the south facade to a fiberglass unit, as this window is located in the shower. Allowing this window to be fiberglass will prolong its life, the life of the wall assembly, and prevent rot and decay in this area.

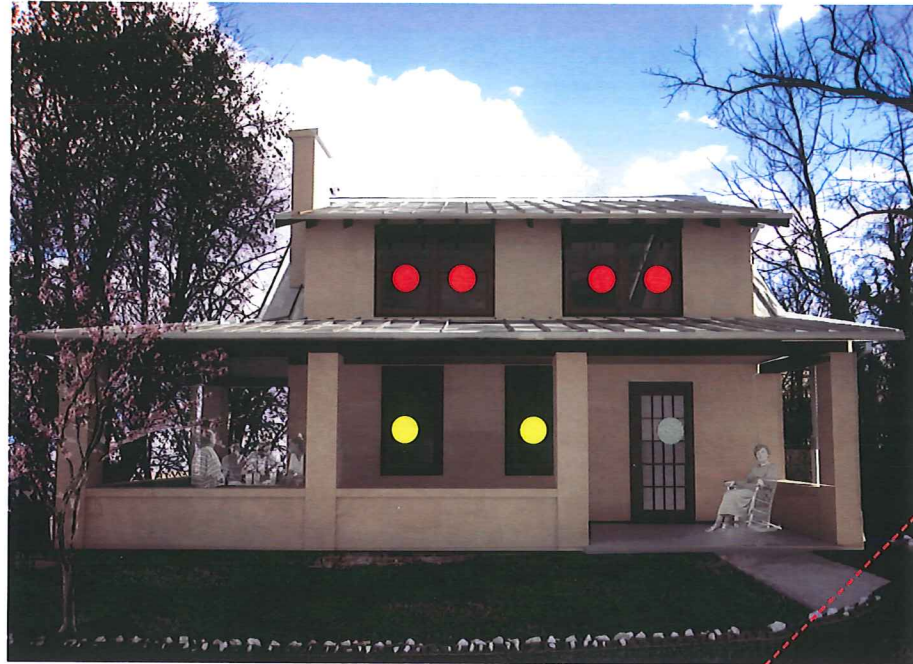
original proposal

The two front windows (yellow dots) were missing, so we originally proposed moving two c. 1922 windows (blue dots) from the south facade to the front location, and replacing the south facade windows with new windows.
