# VIRGINIA HISTORIC LANDMARKS COMMISSION

## SURVEY FORM

Street address or route number 128 Chancellor

DEPARTMENT OF HISTORIC RESOURCE  
RECONNAISSANCE SURVEY FORM

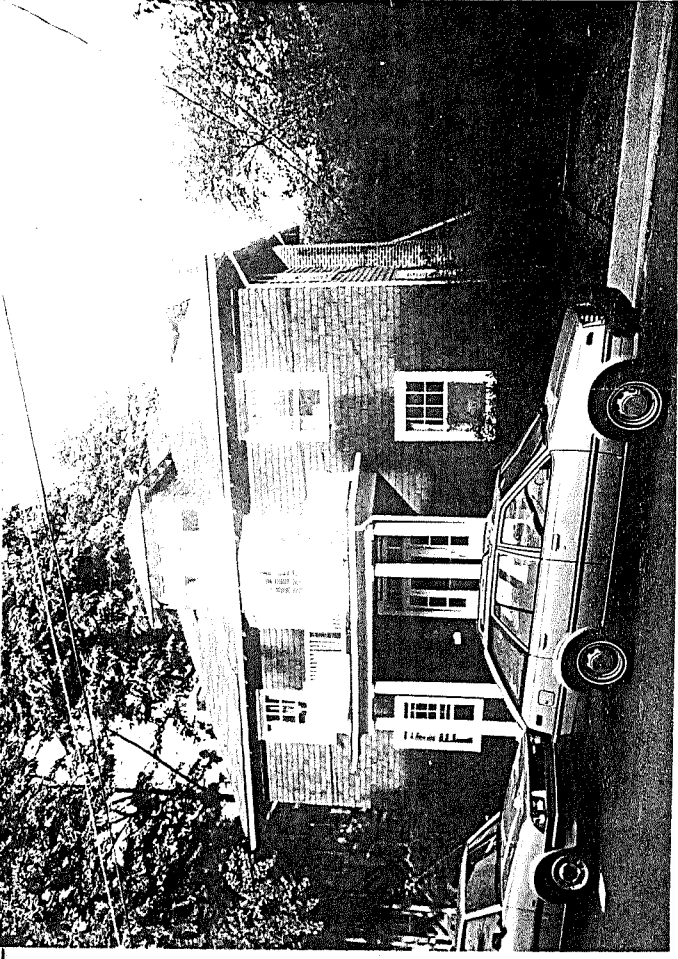
Porch	Stories	Bays	General description
<input checked="" type="checkbox"/> yes <input type="checkbox"/> no	<input checked="" type="checkbox"/> 1 <input type="checkbox"/> 3 <input type="checkbox"/> 2 <input type="checkbox"/> _____	<input checked="" type="checkbox"/> 1 (center) <input type="checkbox"/> 2 <input type="checkbox"/> 4 <input type="checkbox"/> 1 (side) <input type="checkbox"/> 3 <input type="checkbox"/> _____	<b>Front porch with balustraded upper deck and paired Roman Doric posts.</b>

Location and description of entrance **Central entry with top- and side-lights.**

This house features projecting eaves, a symmetrical facade, and a central 3-sided bay on the upper floor that opens out onto the porch deck. The house is located on a lot that slopes toward the rear.

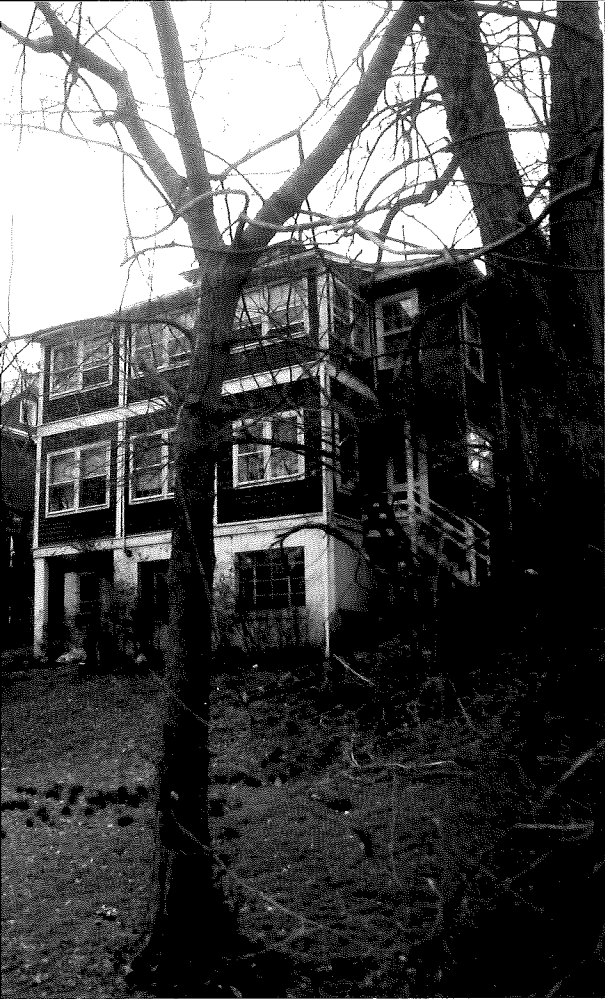
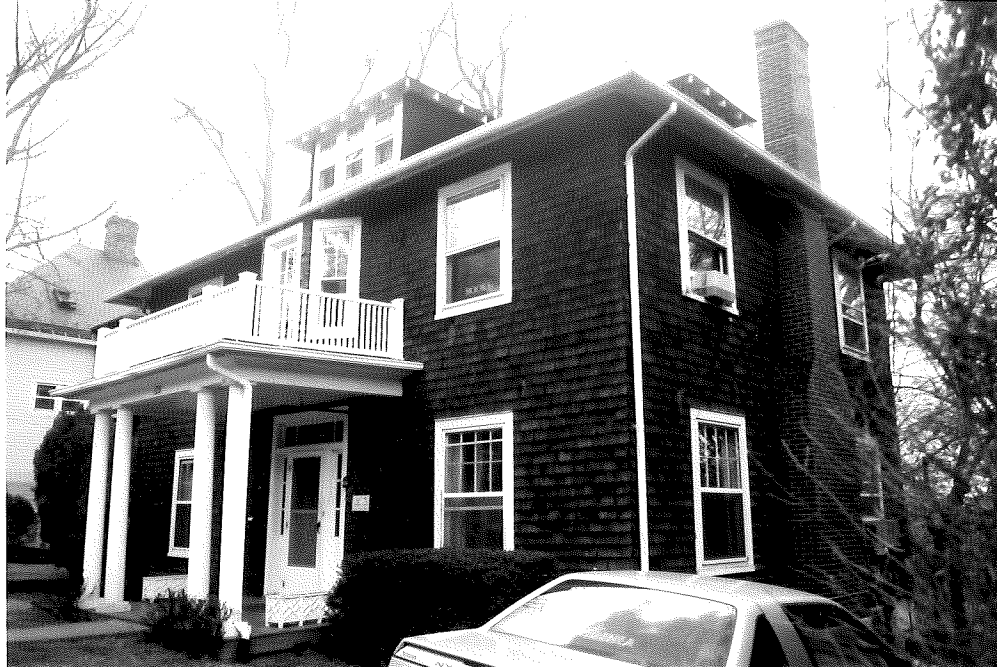
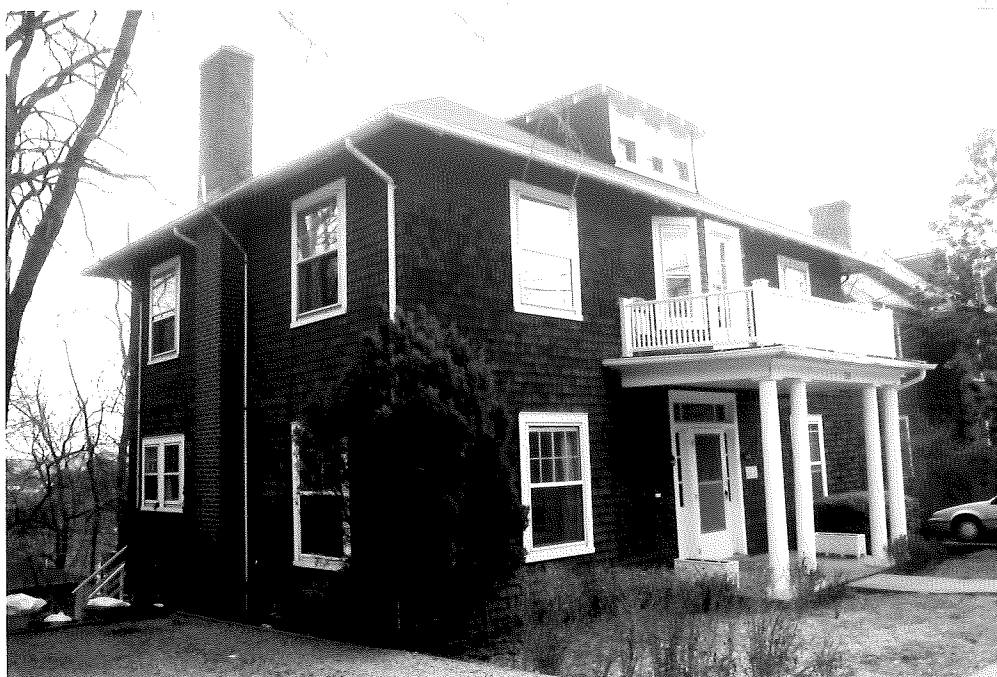
Contents 3 exterior views

Rectangular form, three-bay frame shingled dwelling with Craftsman and Colonial Revival stylistic elements. Front porch, one bay wide, one story with two levels, has paired Doric columns at corners, and wood balustrade on second level; central entrance has three-light sidelights and three-light transom; second-story center bay has bay window with multi-light entrance to upper level of porch in center. Dormers on front, rear, and southwest side are shingled, with three-part double-hung sash windows in each; house roof and dormers have exposed rafter ends. Rear of house has two-level enclosed porch (possibly designed as a sleeping porch) on raised rear basement.

Condition: Good-Excellent
