DEPARTMENT OF HISTORIC RESOURCE  
RECONNAISSANCE SURVEY FORM

DHR Identification Number: 104-0133-0017

| Delta Gamma Sorority House | Current |

| 138 - | Madison Lane | Current |

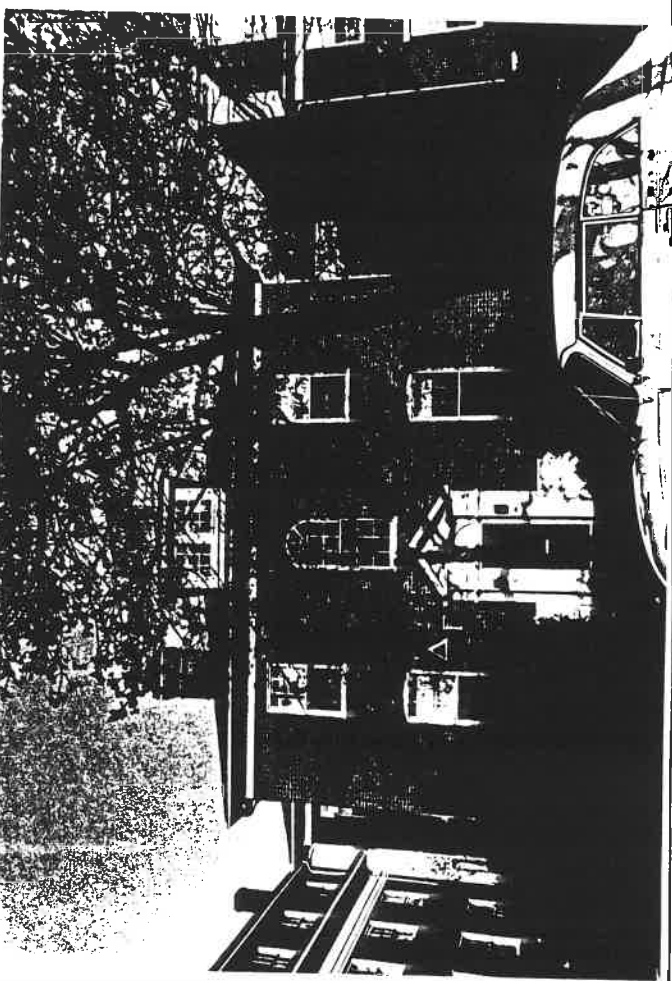
Location and description of entrance

This unaltered house features a round-arched central window and an elaborate pedimented doorway. Note the dentil cornice and brick window arches.

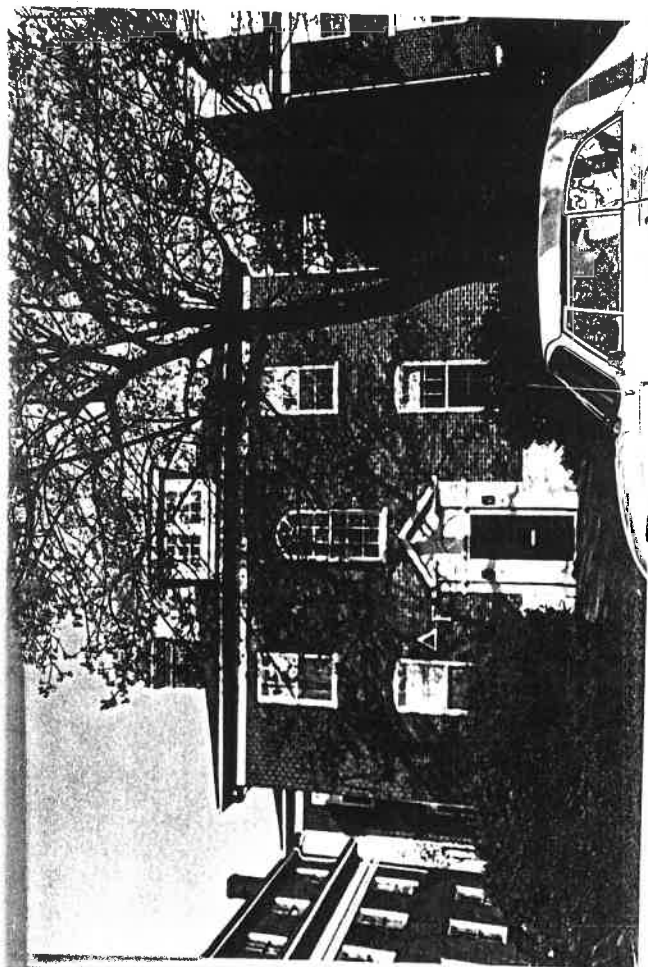
Location and description of entrance \_\_\_\_\_

**This unaltered house features a round-arched central window and an elaborate pedimented doorway. Note the dentil cornice and brick window arches.**

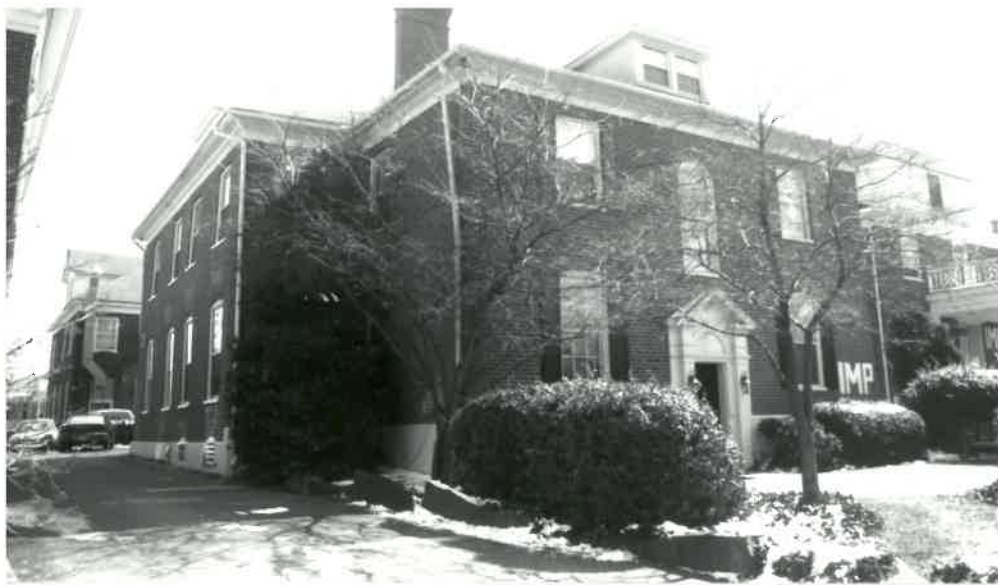
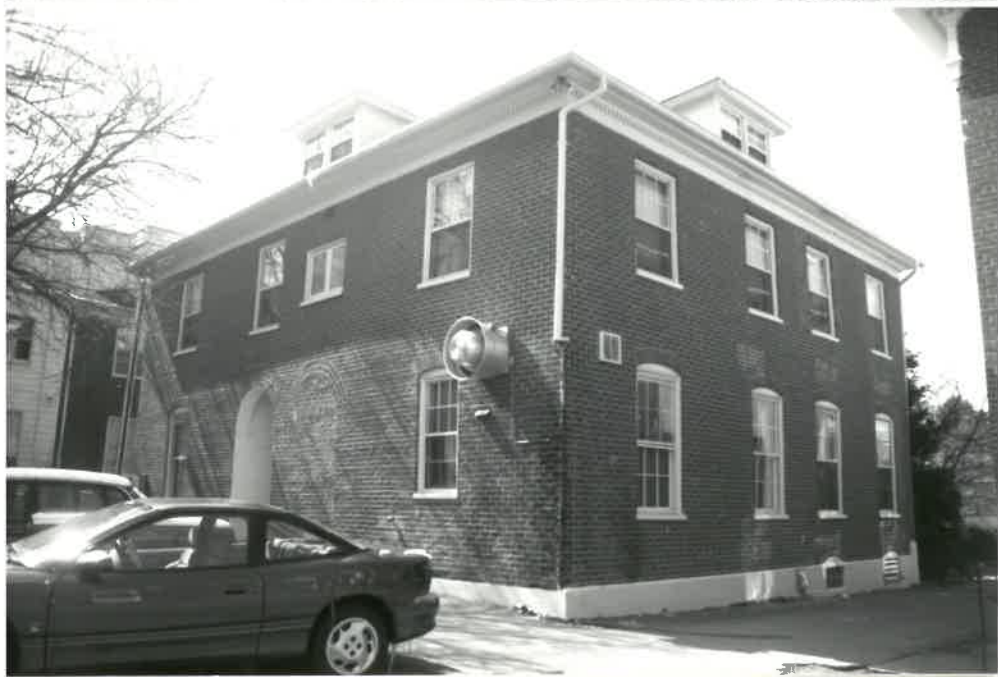
Date 5/9/96 File No. 104-133-17  
Name Delta Gamma Sorority House, 135 Madison Lane  
Town Charlottesville  
County \_\_\_\_\_  
Photographer S. F. Smead  
Contents 2 exterior views  
\_\_\_\_\_  
\_\_\_\_\_

Classical Revival dwelling with slightly irregular form, caused by shallow projecting section on northeast side; hipped roof; and three-bay front facade. Central entrance has Classical Revival surround, with pilasters and pediment; second level above has high round-arched window that extends below flanking second-floor window units. First-floor windows have segmentally-arched lintels; second-floor windows have jack arches. Hip-roofed dormers on each side have paired four-over-one double-hung sash windows.
