VIRGINIA HISTORIC LANDMARKS COMMISSION

SURVEY FORM

Historic name County/Town/City <u>Charlottesville, Va.</u> Street address or route number <u>1121 Wertland St.</u>	Common name Date or period <u>c. 1895</u> Architect/builder/craftsmen Source of name Source of date Stories Foundation and wall const'n Roof type
USGS Quad <u>Charlottesville, East, Va</u> Original owner Original use Present owner Present owner address Present use <u>residence</u> Acreage

1121 WERTLAND STREET

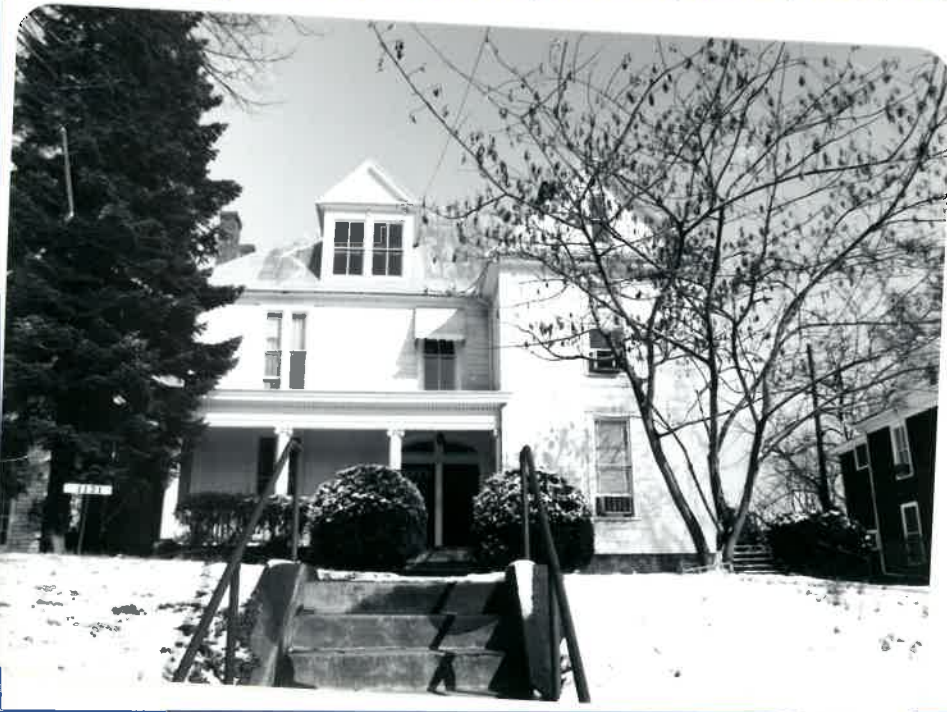
1121: asbestos shingle siding. 2½ story. hipped roof with intersecting gable with 1 pedimented dormer, standing seam metal roof. 3 bay. 1 story 2 (western) bay Ionic porch. *Colonial Revival Queen Anne.* c. 1895. full Ionic entablature and turned ballustrade on porch, shingles in pediment of dormer and gable, pent roof in front gable. central bay entrance. east bay: 1/1DHS on both stories with thin 1/1DHS in pediment; central bay: 2 separate door entrance with bisected oval fan light, 2/2DHS; west bay: 2 side by side 1/1DHS on both floors, 2 2/2DHS in dormer. 2 interior end chimneys and 1 interior chimney. 1 story rear addition.

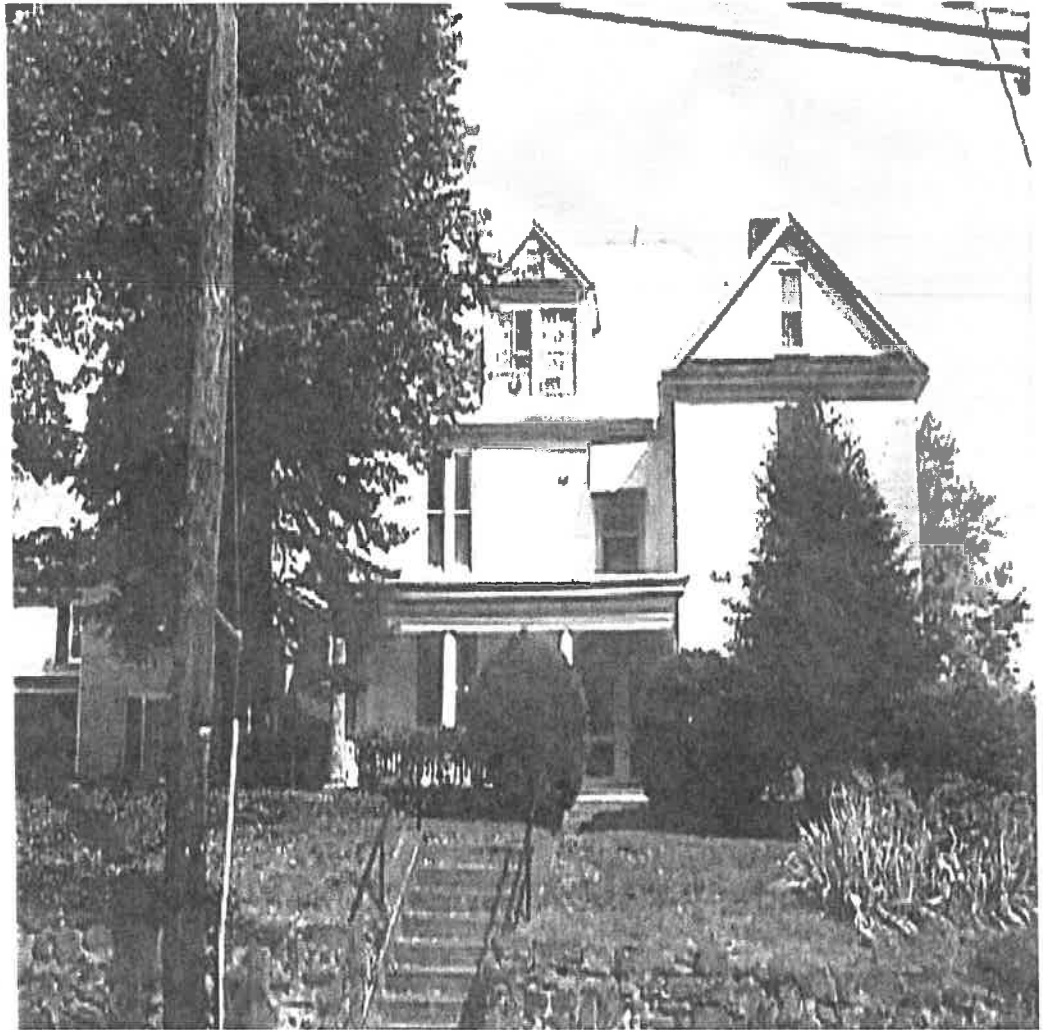
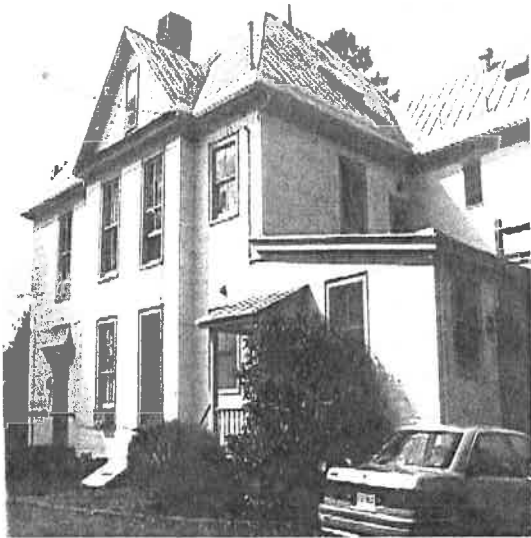
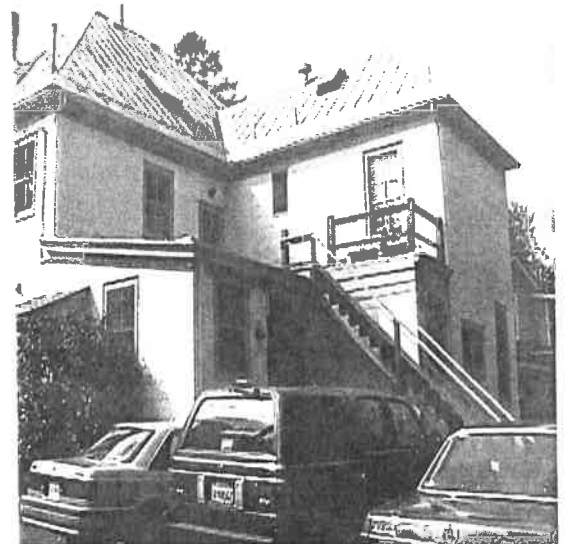
The Hill House is a 2½-story, 3-bay Victorian house with a projecting bay at the eastern end of the facade. The walls are faced with asbestos shingles, probably over original weatherboarding. The high-pitched standing-seam metal hipped roof has gables over the projecting bays on the facade and east side and centered over the western elevation. There is an over-sized, pedimented dormer on the facade, and there are three interior chimneys. Windows are tall, double-sash, one-over-one light. There are paired, half-width windows in the western bay of the facade. The massing and most details of the building are Victorian, but the Ionic columns and entablature and turned balustrade of the one-story, two-bay verandah are Colonial Revival, suggesting that it might represent an early twentieth century remodeling. A driveway on the eastern side of the house leads to a one-story wooden-shingled garage with an asphalt-shingled hipped roof. A stone retaining wall runs along the sidewalk.
