VIRGINIA HISTORIC LANDMARKS COMMISSION

SURVEY FORM

1213 WERTLAND STREET

RECONNAISSANCE LEVEL SURVEY REPORT

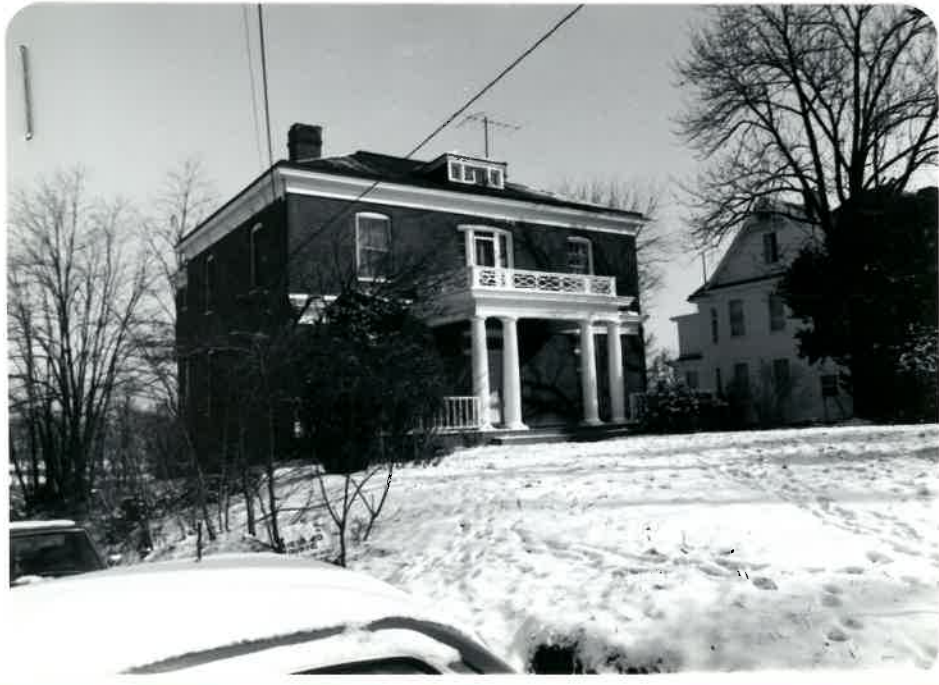
State condition of structure and environs **excellent**

1213: brick (stretcher bond). 2½ story. hipped roof with flat section on top with asphalt shingles, hipped front dormer. 3 bay. 1 story 1 bay Doric porch. ~~Jeffersonian Rev~~ *W. Revival* 1900. full entablature on 1st story front and at cornice; chinoiserie railing on top of porch. central bay entrance. 6/6 DHS, french doors with transom light on 1st floor, segmental arches over window, side and transom lights around front door with diamond panes, french doors on 2nd story with side lights. interior symmetrical chimneys. 2 story rear addition.

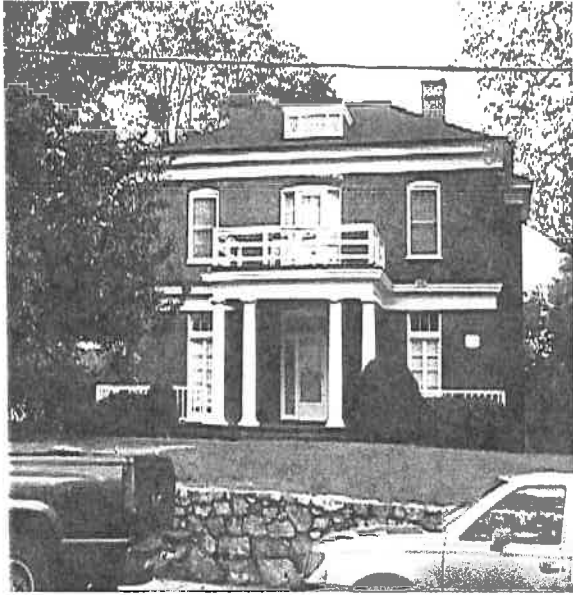
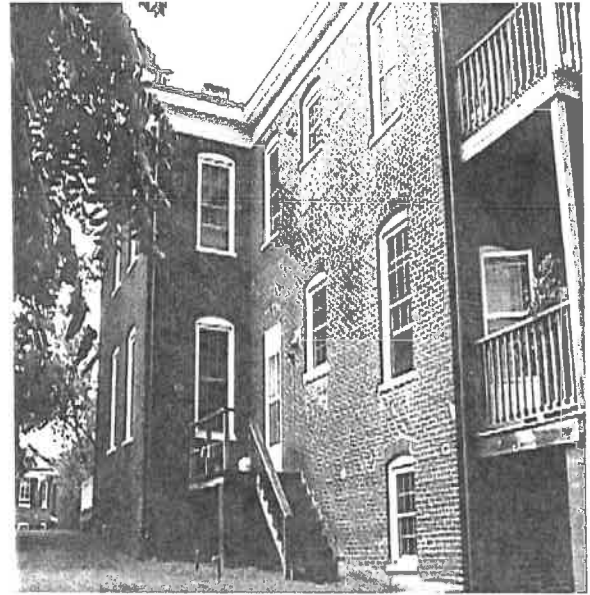
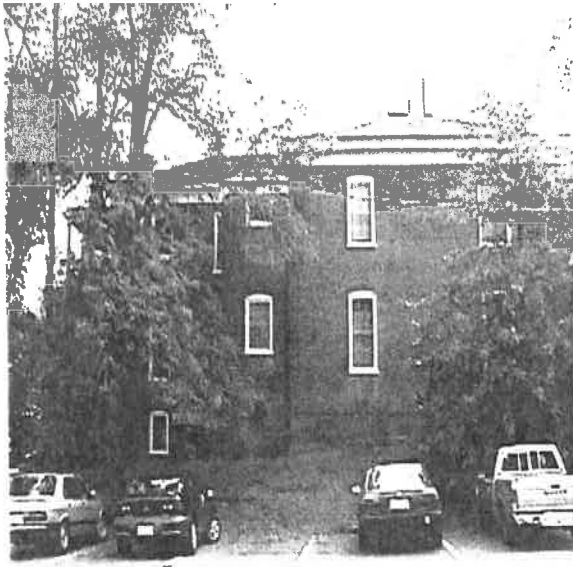
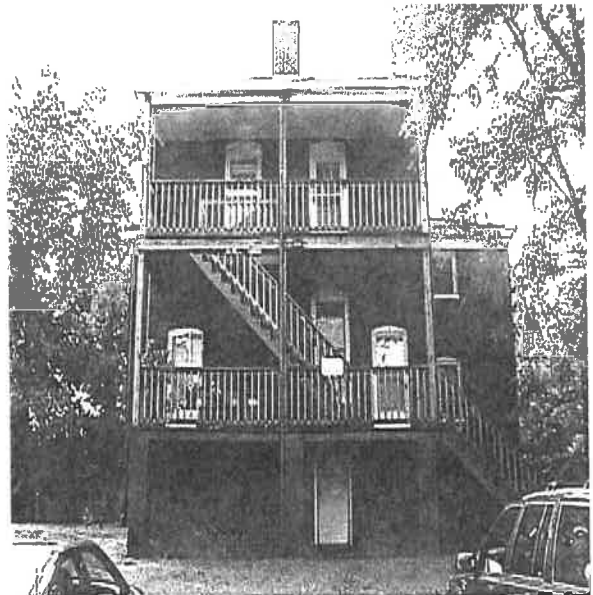
This is a two-story, three-bay, double-pile brick (stretcher bond) Colonial Revival house. Its truncated hipped roof is covered with asphalt shingles and has a full entablature. There are two interior chimneys. A low dormer centered on the facade has a tripartite diamond-paned window. Windows are segmentally arched, double-sash, 6-over-6 light. There is a pair of French doors in each side bay of the facade. A one-story, one-bay entrance porch with coupled Tuscan columns covers the central bay of the facade. A Chinese Chippendale porch roof balustrade was replaced c. 1990 with a plain horizontal balustrade. A full entablature runs around the porch roof and extends to the ends of the facade. This entablature and the French doors combine to create the impression that a one-story verandah once extended across the whole facade. The Sanborn maps, however, show that the house has always had only a one-bay entrance porch. The porch floor does now extend to the ends of the facade, but those extensions rest on new wooden and cinderblock supports. There are segmentally arched central entrances with diamond-paned transoms and sidelights at both first and second story levels. There is an integral two-story rear wing with a later two-story back porch. A granite retaining wall runs along the sidewalk.

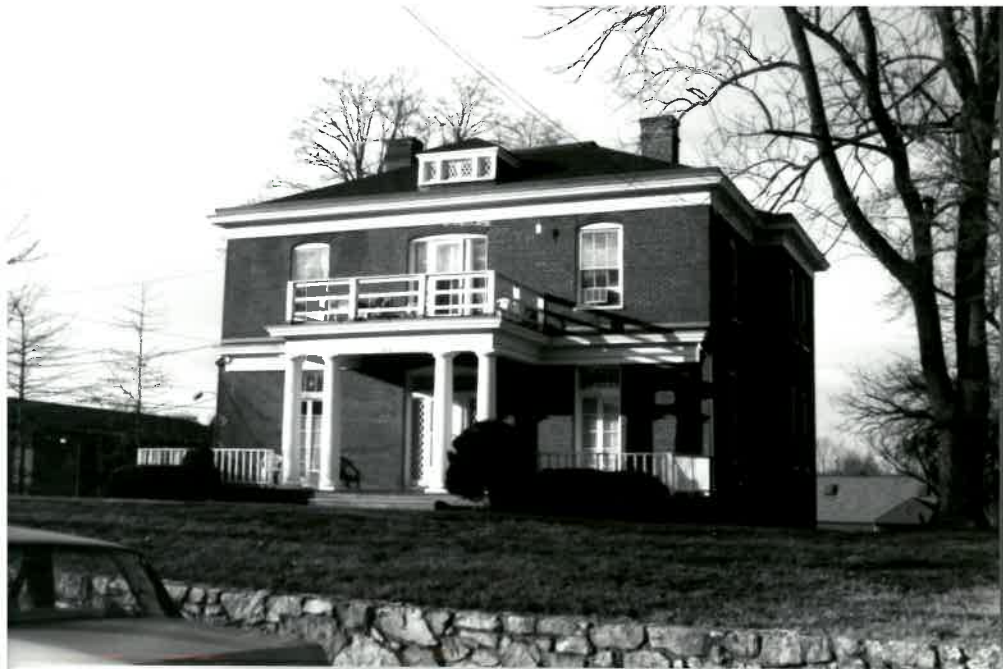
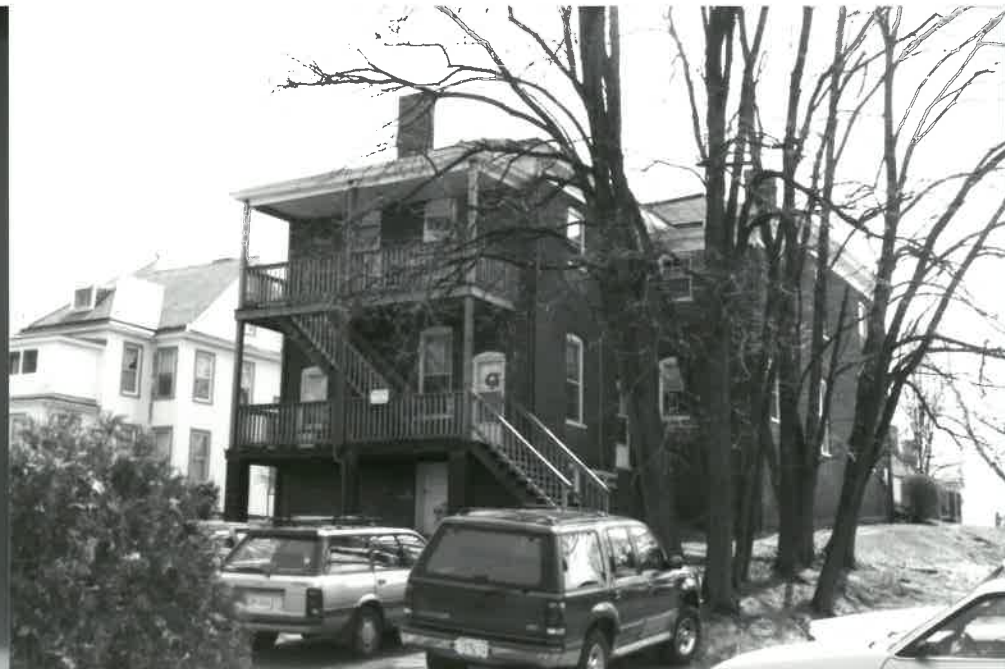
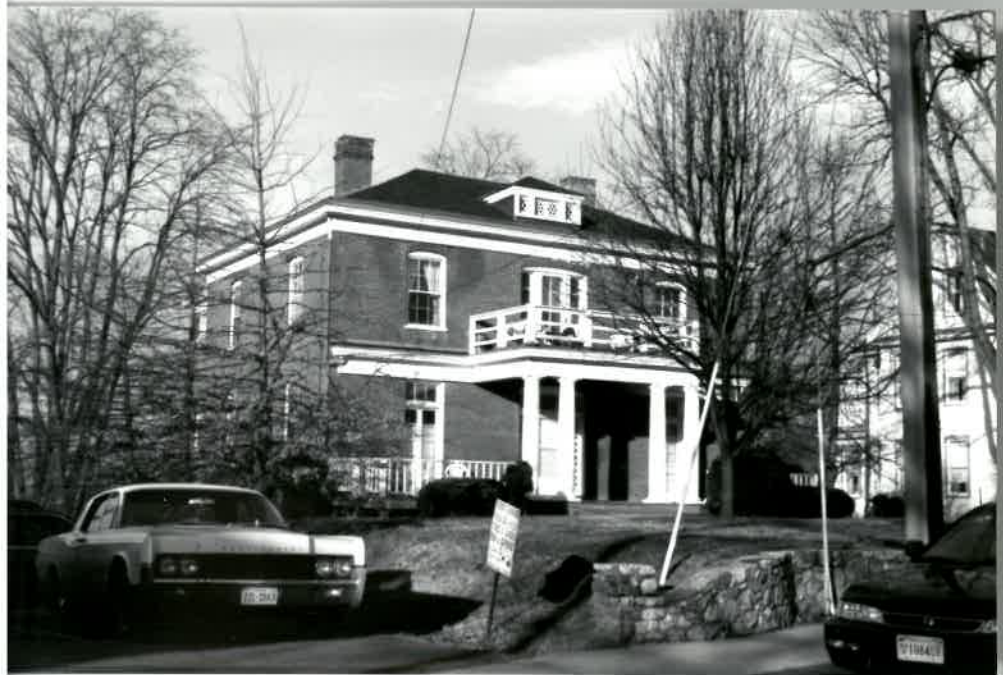
Date 2+3. 1996 File No. 104-136-18

Description
Among earliest on st, single sym'l form.
fr. entry w/ diamond-paned sides + trans
1st-st front facade w/one sq'd WMS.
Prill w/ heavy pane cols (remking of formerly more extensive porch?)

Contents 3 ext. views
