VIRGINIA HISTORIC LANDMARKS COMMISSION

SURVEY FORM

Historic name	Common name Red Gate Interiors
County/Town/City Charlottesville, Va.	
Street address or route number 1252 Wertland St.

STREET ADDRESS: 1252 Wertland Street
MAP & PARCEL 10-24
VDHR FILE NUMBER: 104-0136-0020
CITY FILE NUMBER:
PRESENT ZONING: B-3
ORIGINAL OWNER:
ORIGINAL USE: Residence
PRESENT USE: Residential Rental Property
PRESENT OWNER: Wertland, LLC
ADDRESS: P. O. Box 3344
Charlottesville, VA 22903
HISTORIC NAME:
DATE/PERIOD: c.1925
STYLE: Vernacular
HEIGHT IN STORIES: 2 Stories
DIMENSIONS AND LAND AREA: 48' x 145' (7,105 sq. ft.)
CONDITION:
SURVEYOR: Bibb
DATE OF SURVEY: Fall 1998
SOURCES: City Records
Sanborn Map Co. - 1920, 1929-57

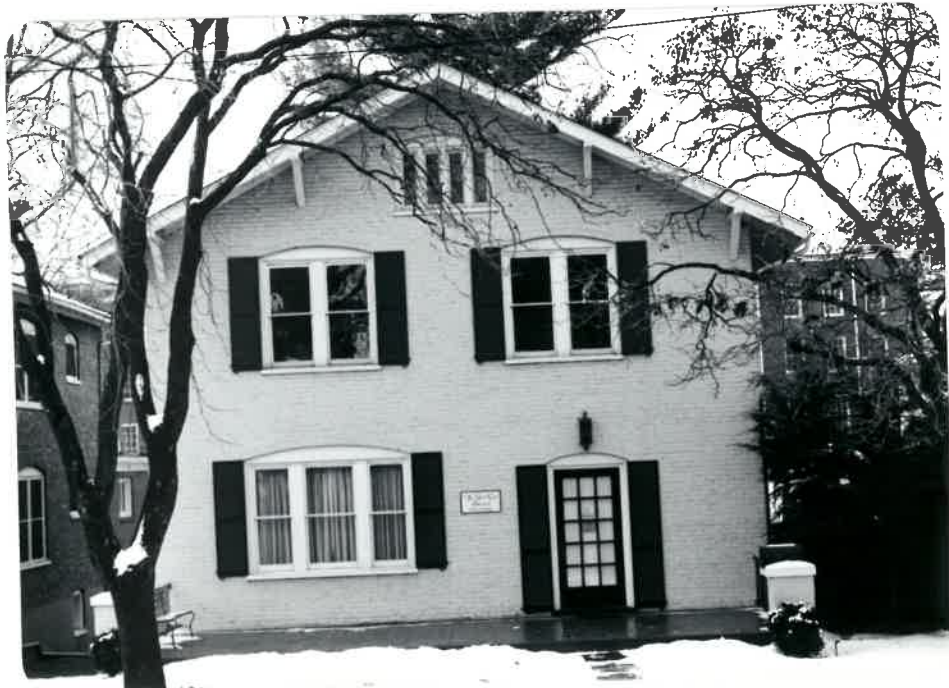
State condition of structure and environs good

1252: brick (stretcher bond). 2½ story. gable roof with asphalt shingles. 2 bay. Federal Rev. c. 1920. brackets under gable. west bay entrance. 1st story: triple 1/1 DHS, door with blinds, 2nd story: double 1/1 with blinds, 2½ story: vertical 4-paned fixed window, all openings have segmental arches. 1 interior chimney.

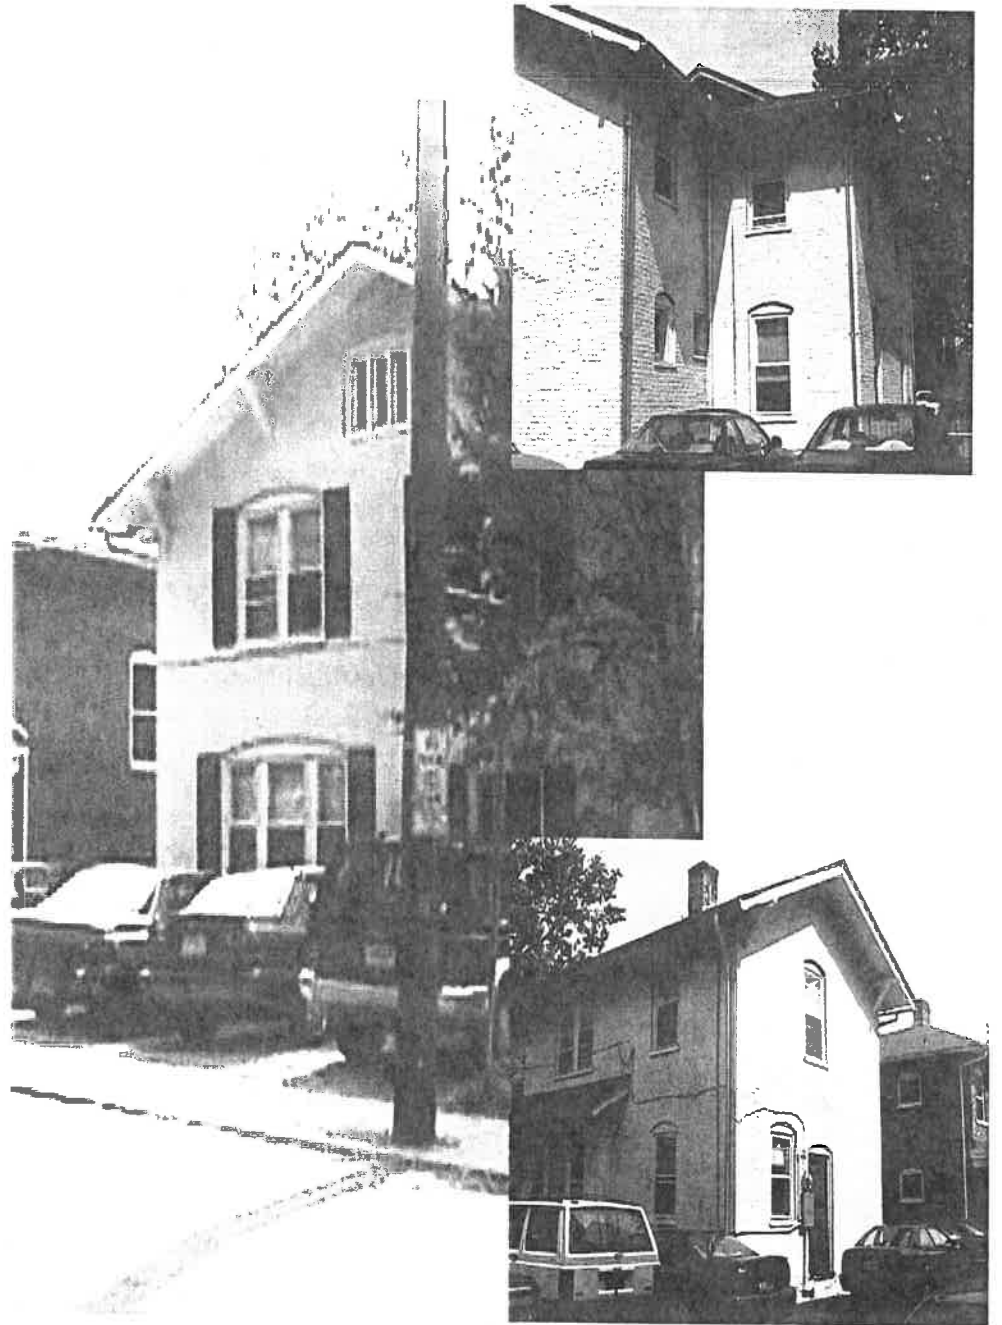
1252 WERTLAND STREET

This two-storey, two-bay brick (stretcher bond) house exhibits the unusual combination of the American foursquare form with a gable-front roof. The asphalt-shingled roof has a deep overhang with brackets and shaped rafter ends. There is one interior chimney. Windows are segmentally arched, single-paned, double-sash. Those on the facade are arranged in pairs. There is a band of four very narrow attic windows in the gable. There is a multi-paned entrance door in the western bay of the facade. Although the Sanborn maps do not support this, it appears that a one-story verandah has been removed, leaving behind a concrete floor and brick pedestals for columns. There is an original two-story rear wing with a one-story back porch with turned posts and simple balustrade.

This house and those on either side were probably built c. 1921-1926, according to the Sanborn maps and city directories. An apartment complex was built in the back yards in 1998.

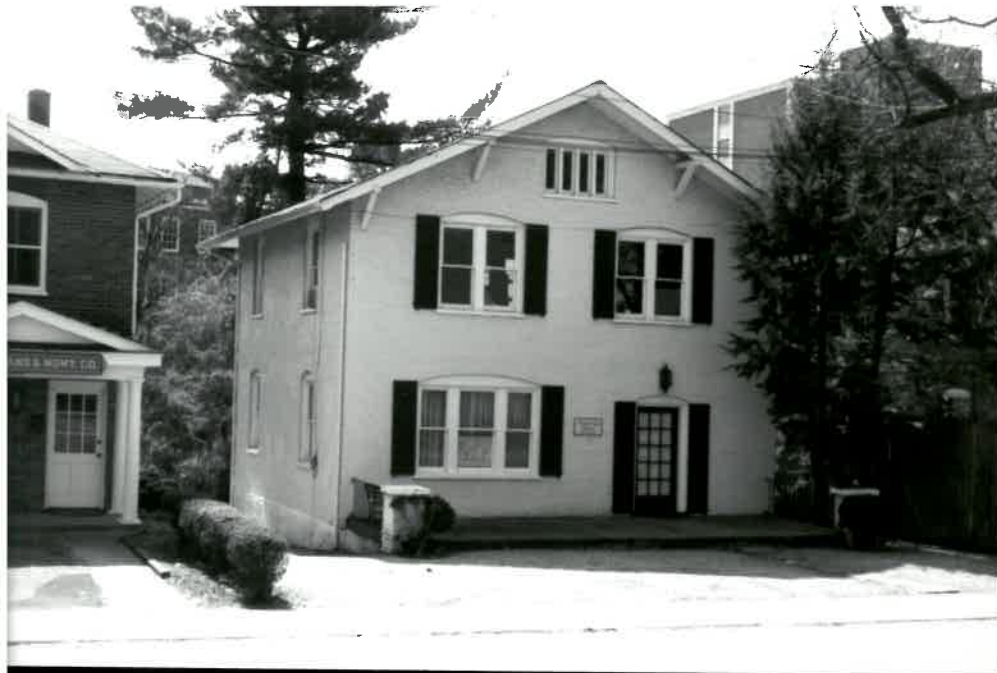
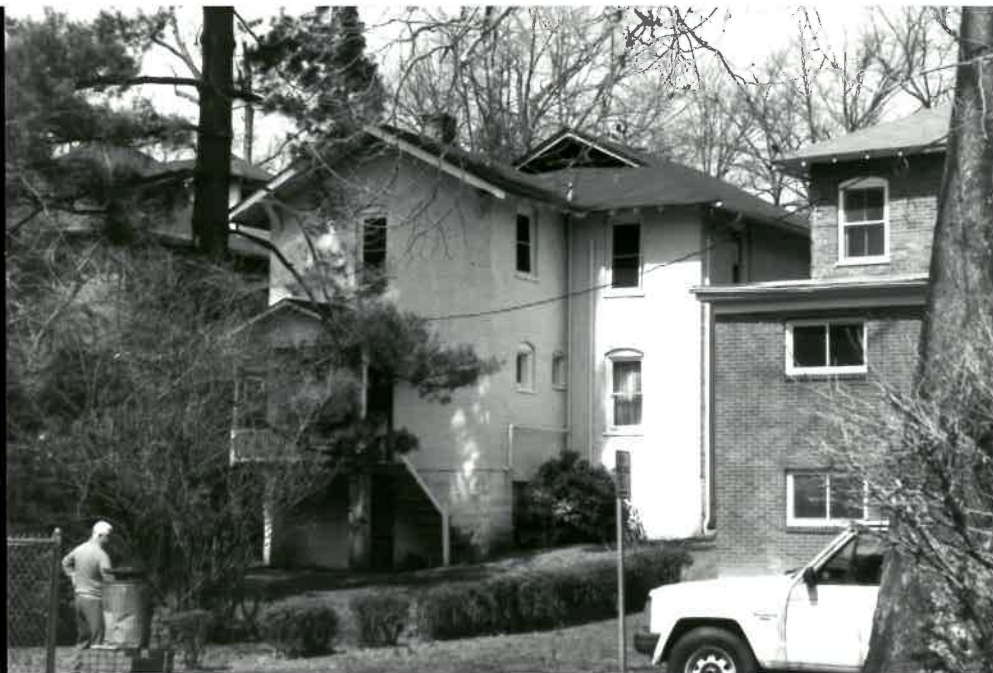
14704

Unusual combination of foursquare form with gable-front roof. Roof has deep overhag supported by Craftsman brackets and with shaped rafter tails in the eaves. Other features include segmental-arched door and window openings, a brick flue, and an integral two-story ell with a gable roof and a one-story gabled porch with turned posts and square balusters.

What appears to have been a one-story Craftsman porch has been removed leaving brick porch column bases and a masonry floor.

Contents 2 ext. views
