**VIRGINIA**  
**HISTORIC LANDMARKS COMMISSION**  
**SURVEY FORM**

| Street address or route number 1310 Wertland St. | |

RECONNAISSANCE LEVEL SURVEY REPORT

| House (1310 Wertland St.) | Function/Location |

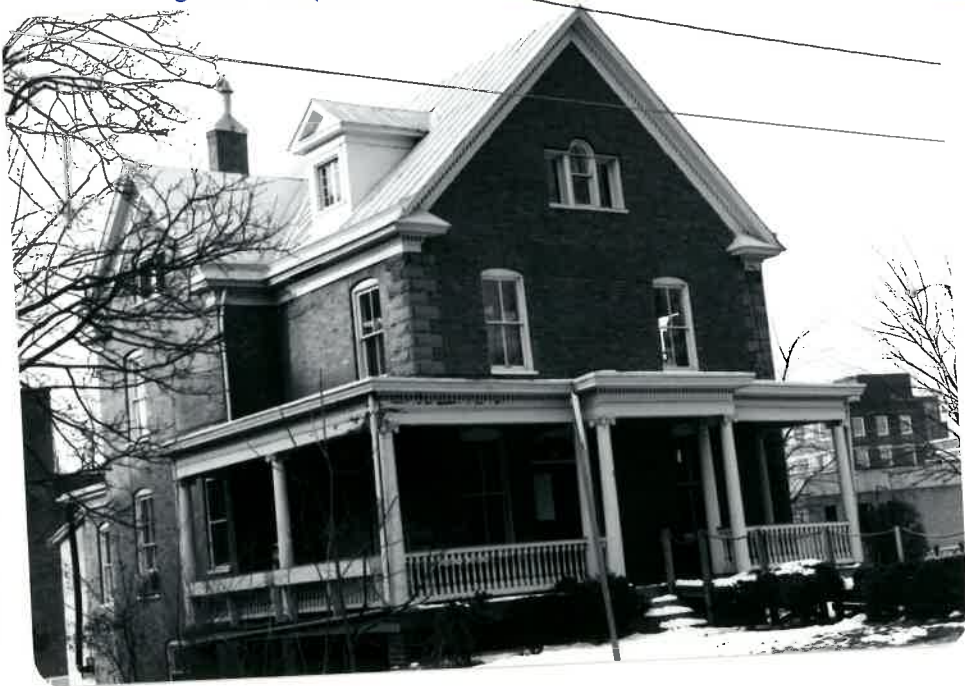
1310: brick (stretcher bond) with limestone quoins. 2½ story. steep front gable roof with intersecting side gable with pedimented east side dormer, standing seam metal. 2 bay. 1 story L-shaped Ionic porch. Georgian Rev. c. 1900. fluted Ionic columns and full Ionic entablature with turned ballustrade on porch, dentilwork cornice on porch and gable end. east bay entrance. 2/2 segmental arch windows, double door with oval fanlight, Palladian window in front gable end. 1 interior chimney. 1 story rear addition.

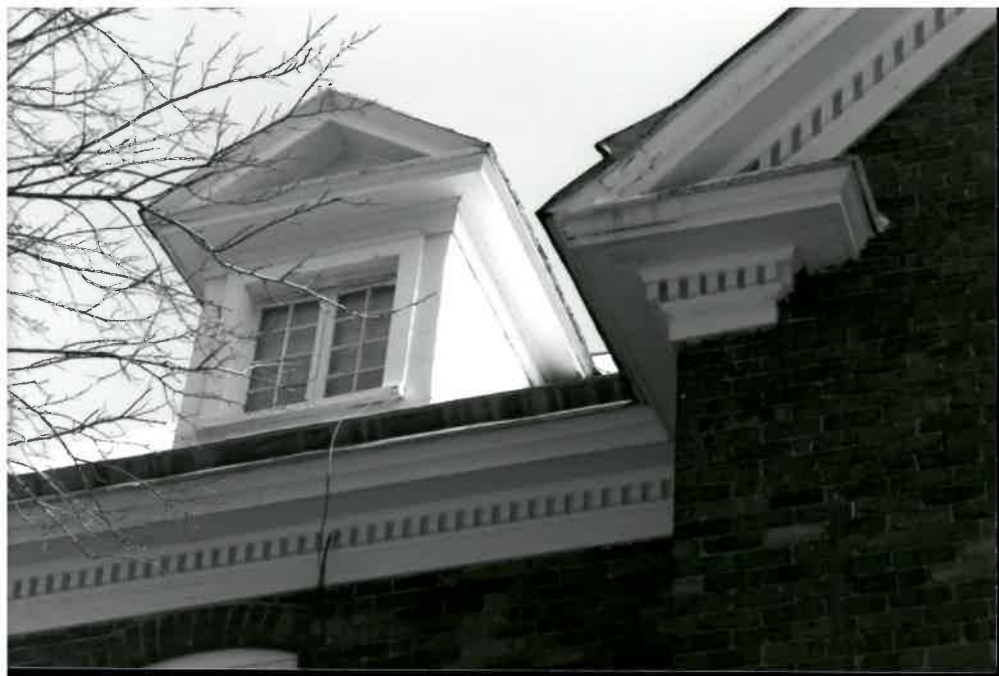
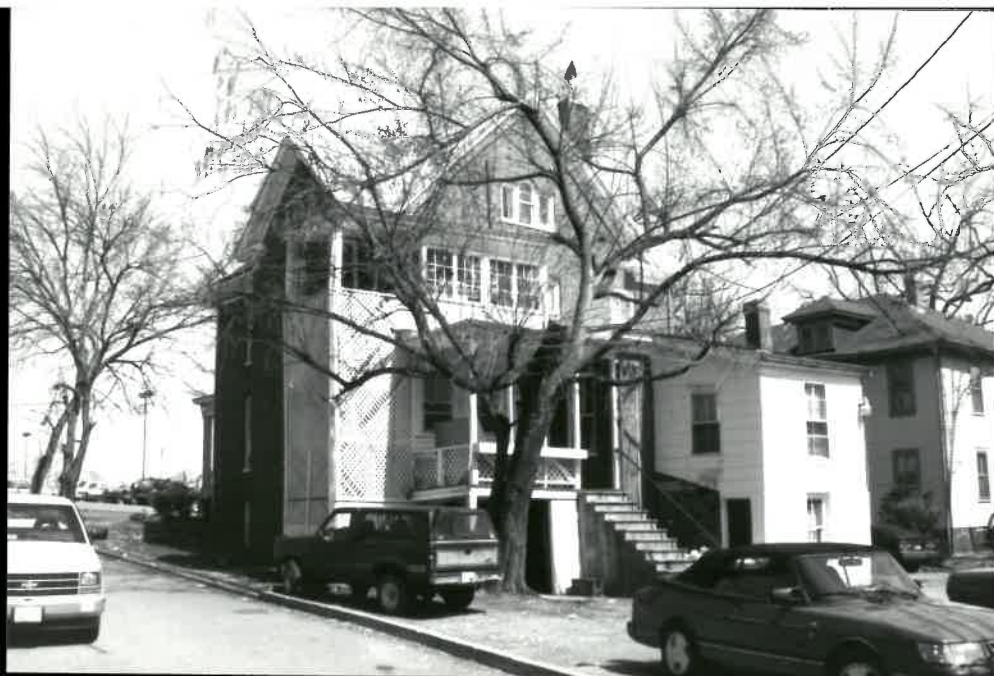
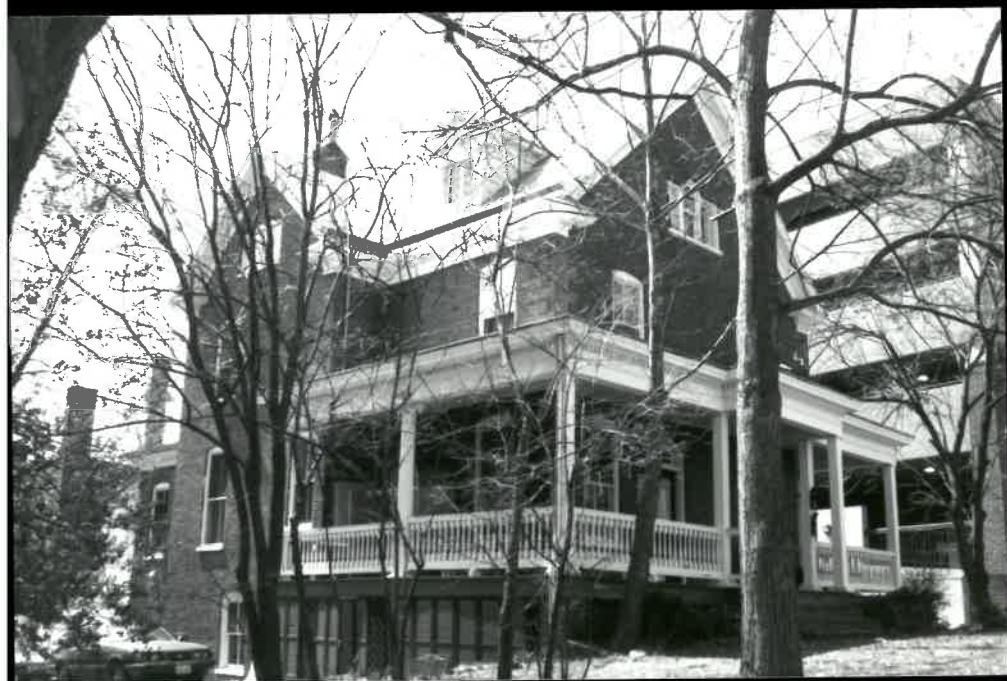
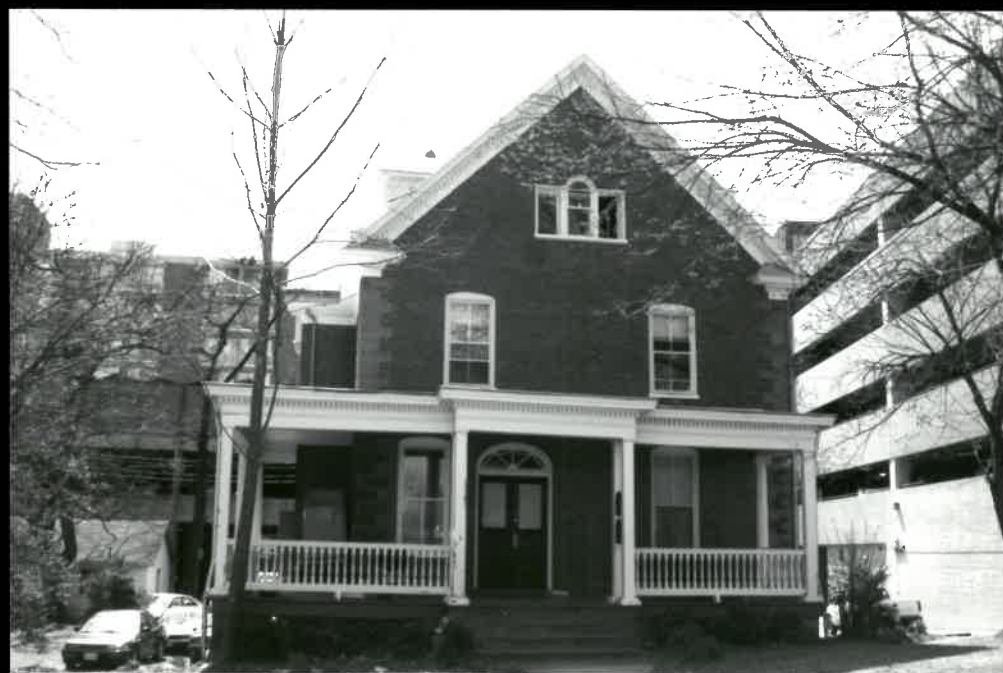
Name House (1310 Westland St.)

Contents 4 ext. views
