Certificate of Appropriateness Application

BAR 19-07-02
150 Chancellor Street
Tax Parcel 090109000
John J. Gottschall, Owner/Tressie E. Daniels, Applicant
Cornice Repair/Replacement

**CITY OF CHARLOTTESVILLE
BOARD OF ARCHITECTURAL REVIEW
STAFF REPORT
July 16, 2019**

Cornice Repair/Replacement

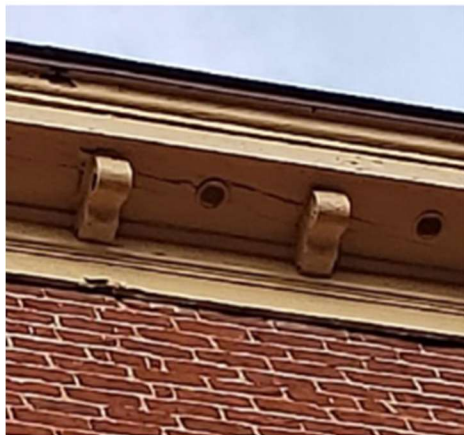
Additionally, the existing cornice is composed of at least six trim pieces plus the modillions. (Attached is a very rough sketch I made from the photos. It is not to scale and the profiles are only for context.) To consider the request to replace the entire cornice, the BAR we will need more information, including measured details showing what will be replaced—including the modillions--and how closely the new will match the existing.

Photo of cornice.

Tressie: The proposed new modillions do not appear to match the existing. In fact, from the information provided it is impossible to tell. In June I shared information on a company that, to my understanding, can replicate the original design and dimensions. (I assume there are others that can do the same, so I wasn't directing you only to that company.)

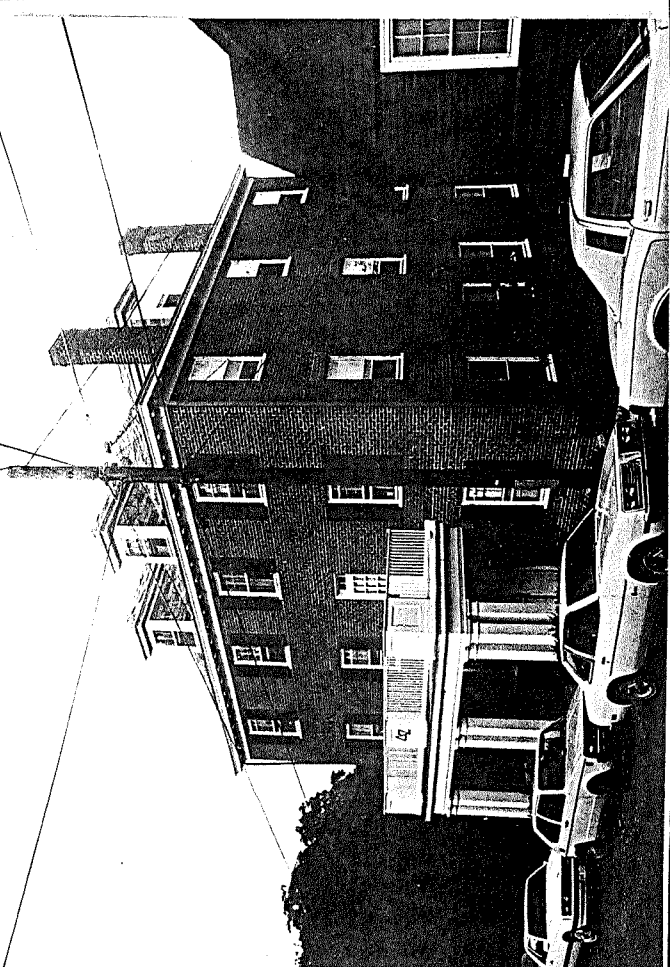
This very large and plain foursquare brick house may have been specifically erected to serve as a student boarding house. The building stands on a sloping site, and entry is at ground level. The house was recently renovated by the present occupants.

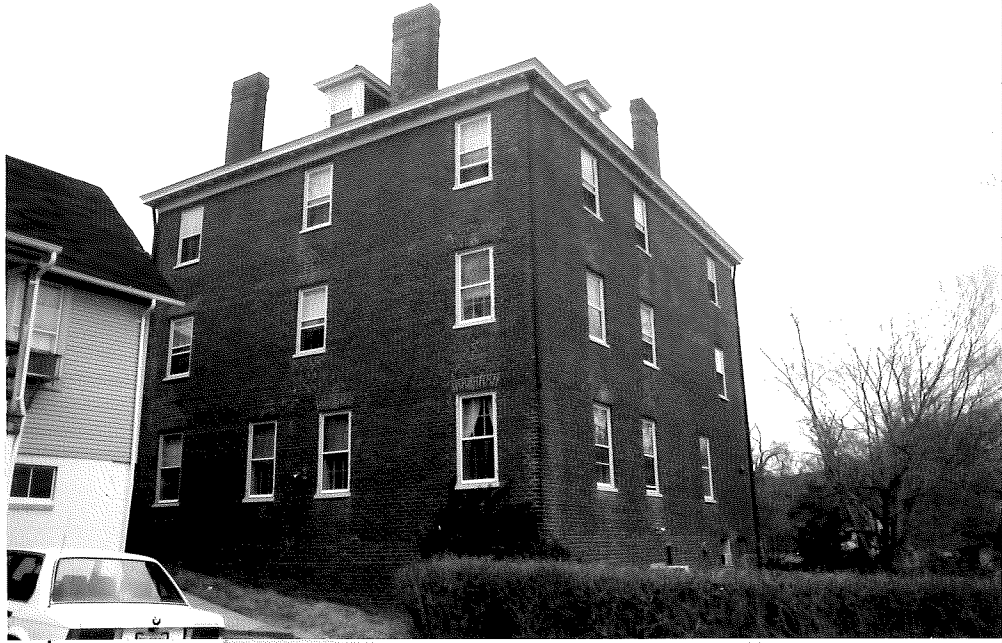
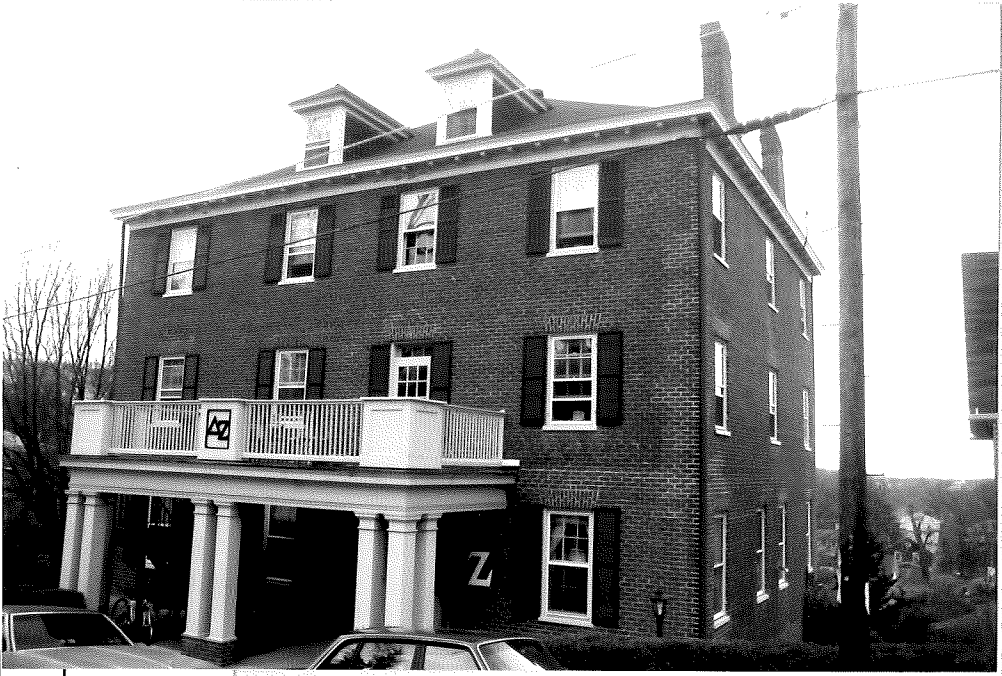
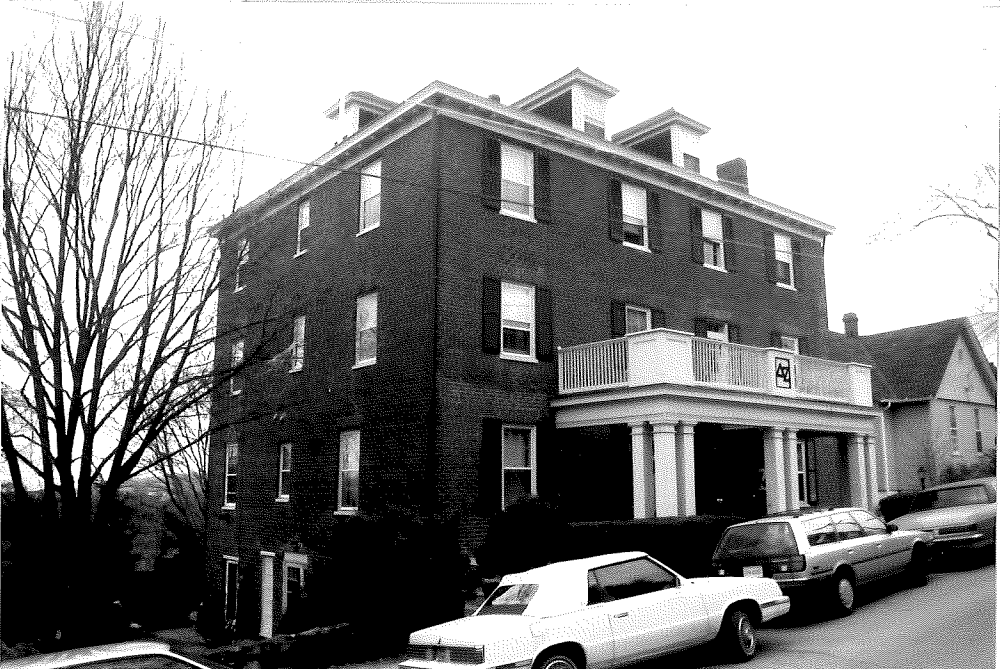
Date 3/2/96 File No. 104-133-66

Contents 3 exterior views
