Certificate of Appropriateness

BAR 19-08-06 209 2nd Street SW Tax Parcel 280077000 Same Street LLC, Owner/Tim Burgess, Applicant Site Alterations and Rehabilitations

CITY OF CHARLOTTESVILLE BOARD OF ARCHITECTURAL REVIEW STAFF REPORT August 20, 2019

Certificate of Appropriateness Application BAR 19-08-06 209 2nd Street SW Tax Parcel 280077000 Same Street LLC, Owner/Tim Burgess, Applicant

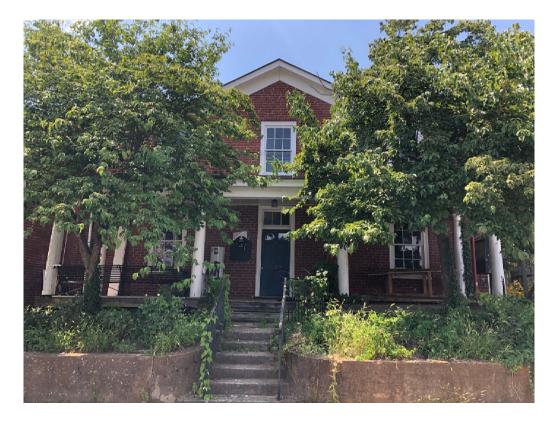
EXISTING - FRONT FROM SIDEWALK

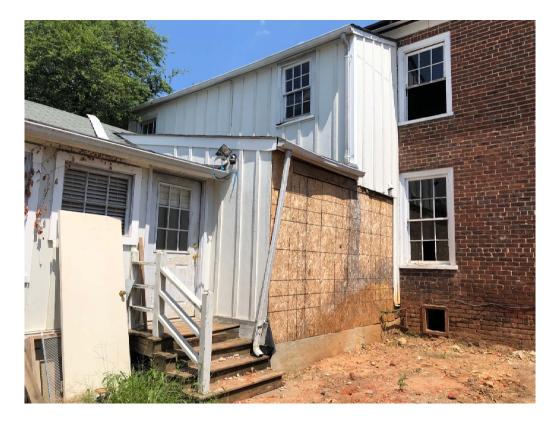
EXISTING - PROPOSED PATIO AREA

Additionally, a CMU wall covered with white stucco has been proposed to enclose the property. The remaining area inside will function as a garden. The fence will be 3 feet in height and 38 feet long. The rear portion of the wall will have a series of perforations. A solid wall of the same material will extend out 9 feet to allow space for trash cans. This allows slightly over 6 feet of entrance into the rear garden/patio space from a parking lot.

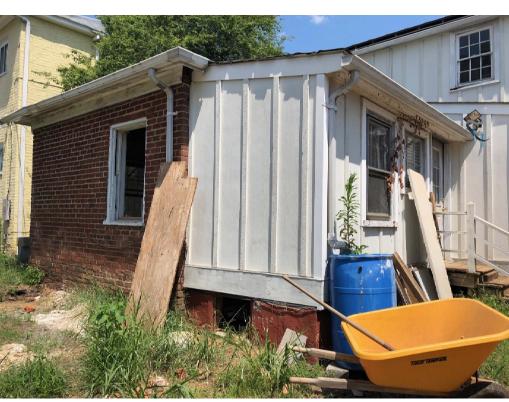
EXISTING - REAR, PROPOSED PIZZA OVEN AREA

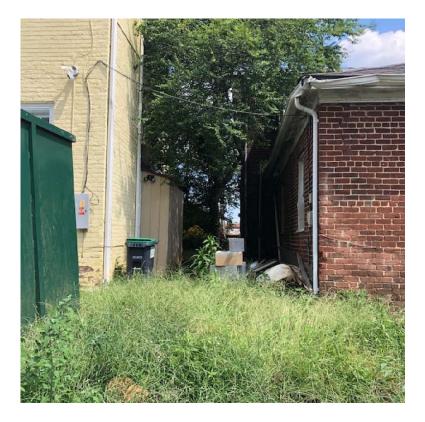
EXISTING - SIDE YARD FROM REAR

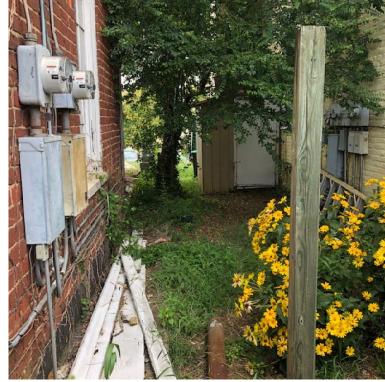
EXISTING - SIDE YARD FROM FRONT

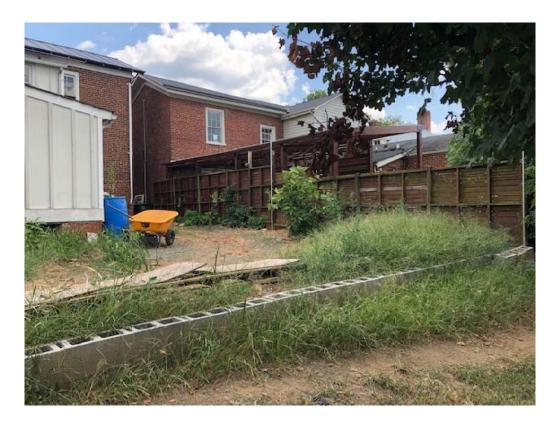
EXISTING - PROPOSED GARDEN AREA

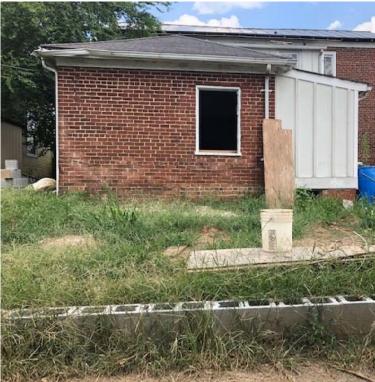
EXISTING - REAR, PROPOSED PIZZA OVEN ARI

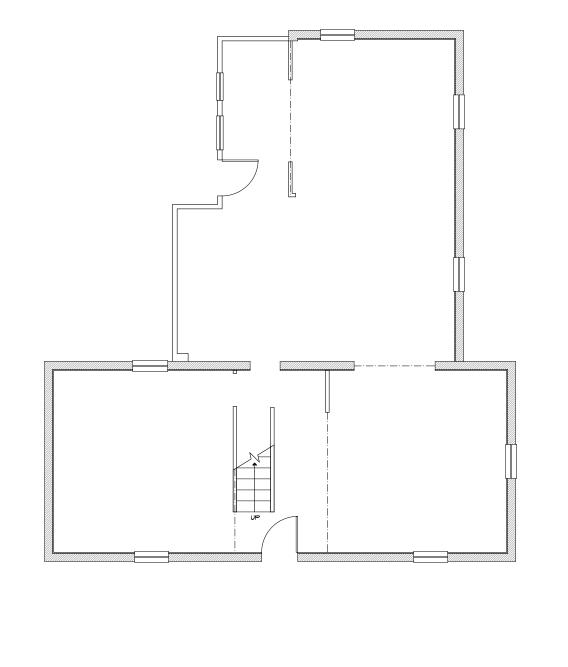
EXISTING FIRST FLOOR PLAN

THE PROPOSED DESIGN STAYS WITHIN THE EXISTING BUILDING FOOTPRINT, MINUS THE TEMPORARY WALK-IN COOLER ON THE RIGHT SIDE. THE EXTERIOR RENOVATION INCLUDES NEW WINDOWS AND DOORS IN THE REAR ADDITIONS, REPAIR AND PAINT OF EXISTING WOOD WINDOWS AND NEW EXTERIOR PAINT THROUGHOUT. THE EXISTING BRICK AND SIDING WILL BE PAINTED WHITE AND THE EXISTING AND NEW WINDOWS AND DOORS WILL BE A DARK BRONZE (SEE ELEVATION LABELS FOR MORE DETAILED SPECIFICATIONS).
