# ROCK HILL

## LANDSCAPE TREATMENT PLAN

**Prepared by**  
AECOM Technical Services  
Charlottesville, VA

March 2012

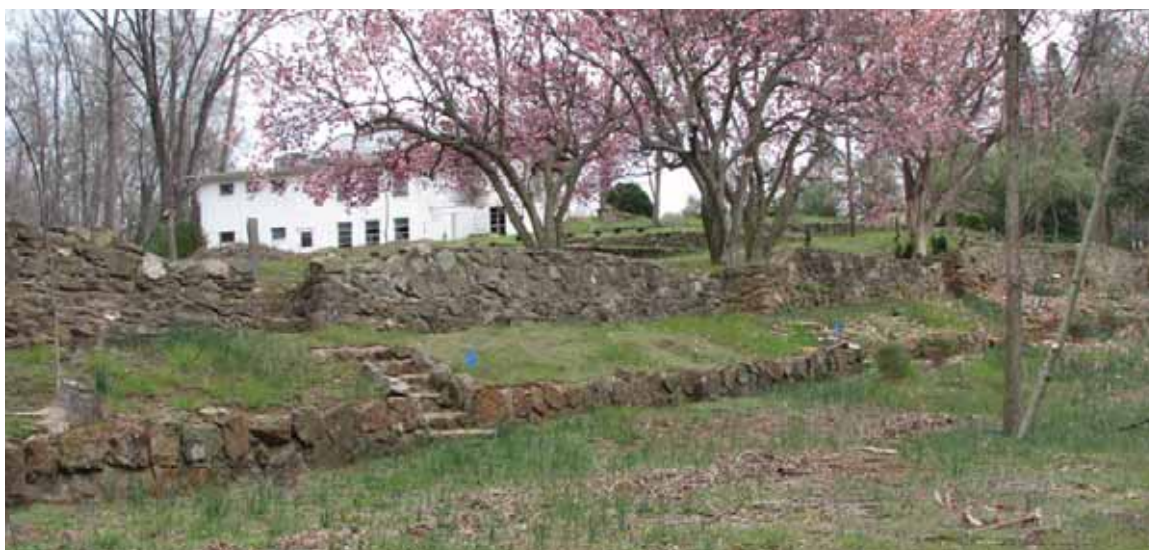
*Terraced gardens on the hillside after clearing (March 2011).*

and Structures,” below, for more information on the terraces) extend roughly 220 feet down the southwestern face of the hillside to a level area adjacent to the Route 250 Bypass. As a result of the construction of the Route 250 Bypass, a small area of the Rock Hill property adjacent to the terraces was lost.

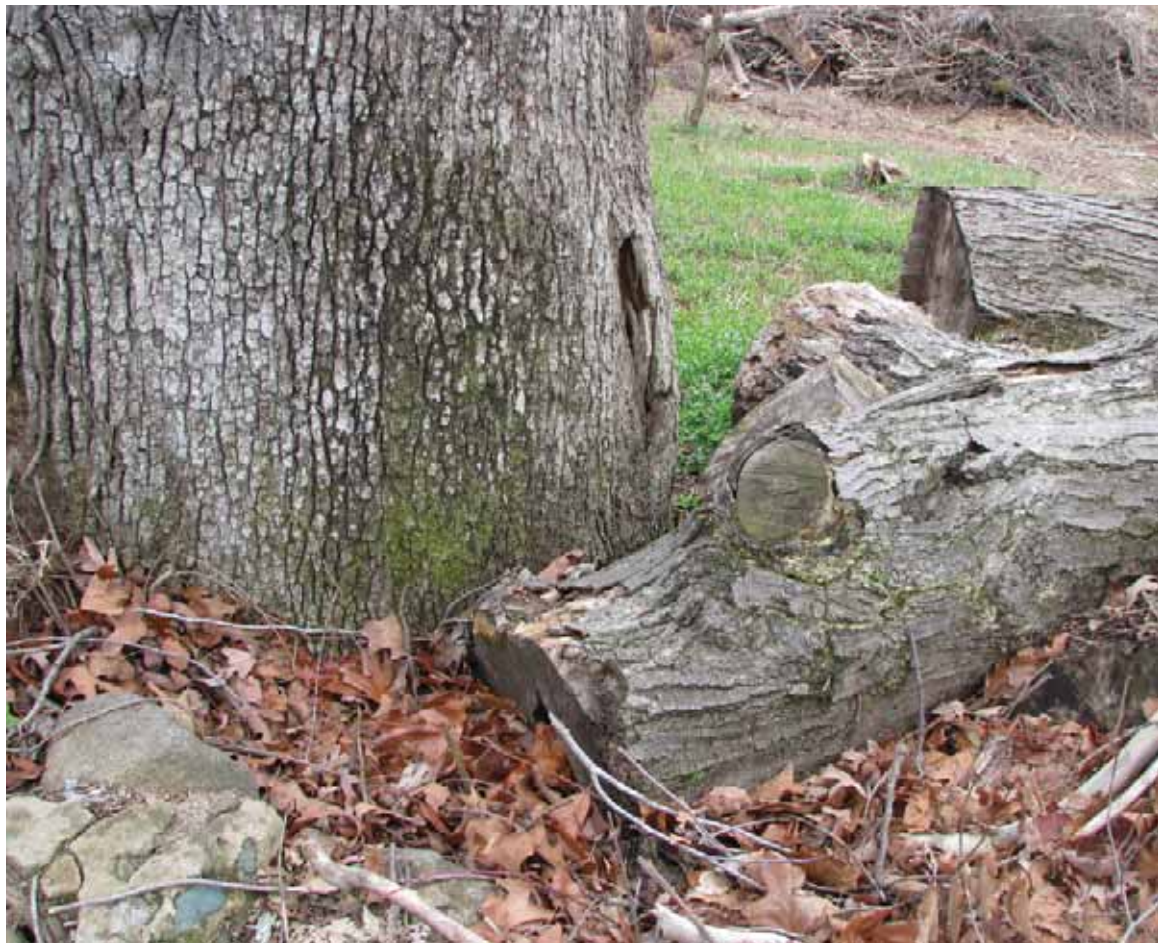
*Mature oak near entry drive circle with heavy debris at its base (March 2011). Heavy debris piled on tree roots can damage mature trees.*

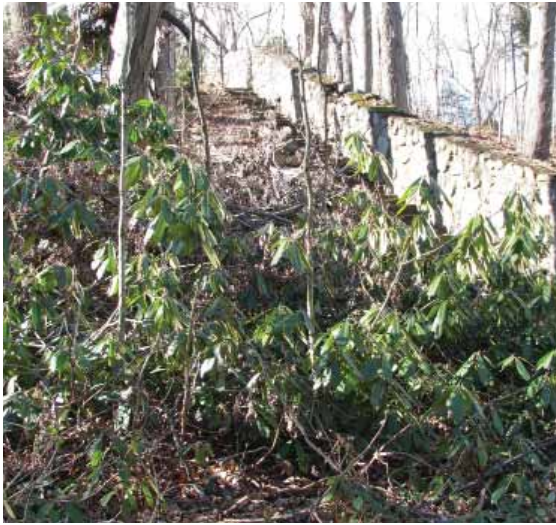
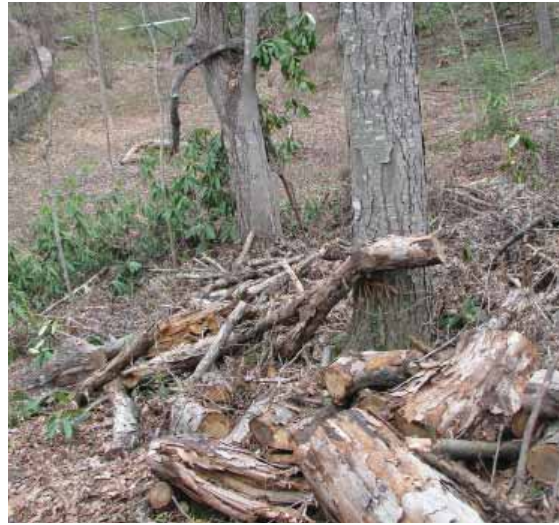
*Rhododendrons near the stone steps (February 2011) and (March 2011).*

A grove of mature rhododendrons is present at the toe of the slope in the woodland area. Several rhododendrons appear to be badly damaged by recent tree felling at the top of the slope; logs have been left along the slope and have crushed several rhododendrons.

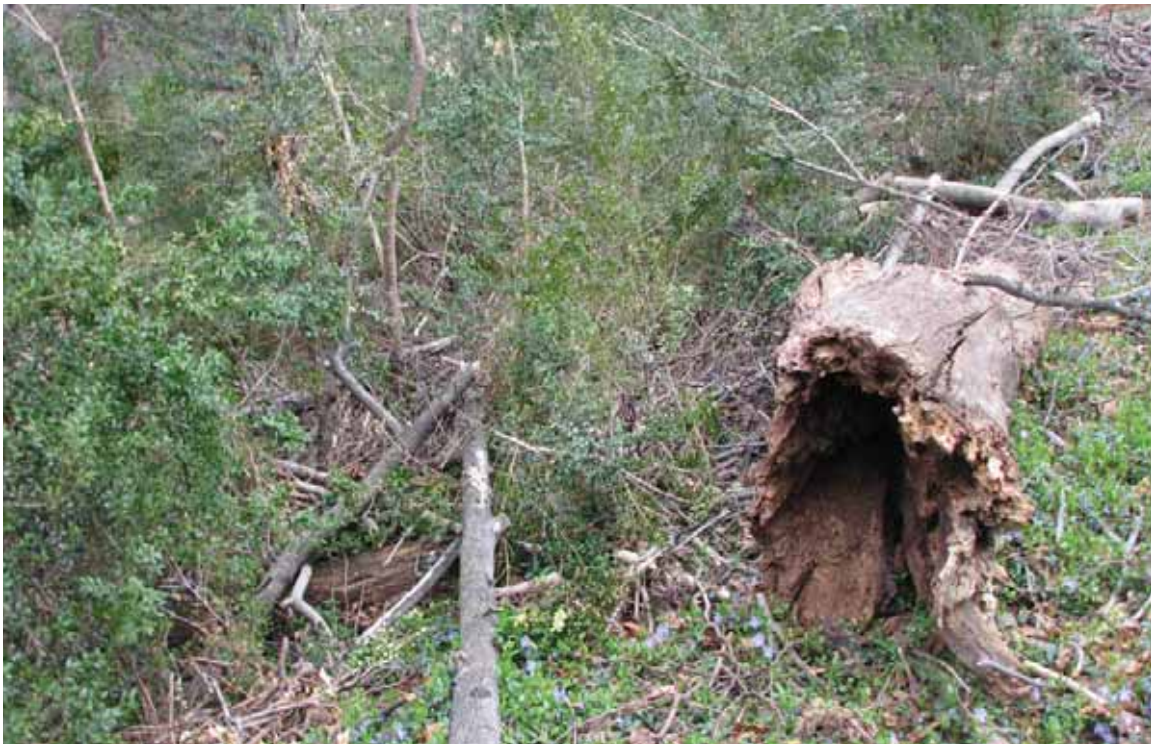
*Debris laid on  
boxwood in  
woodland area  
(March 2011).*

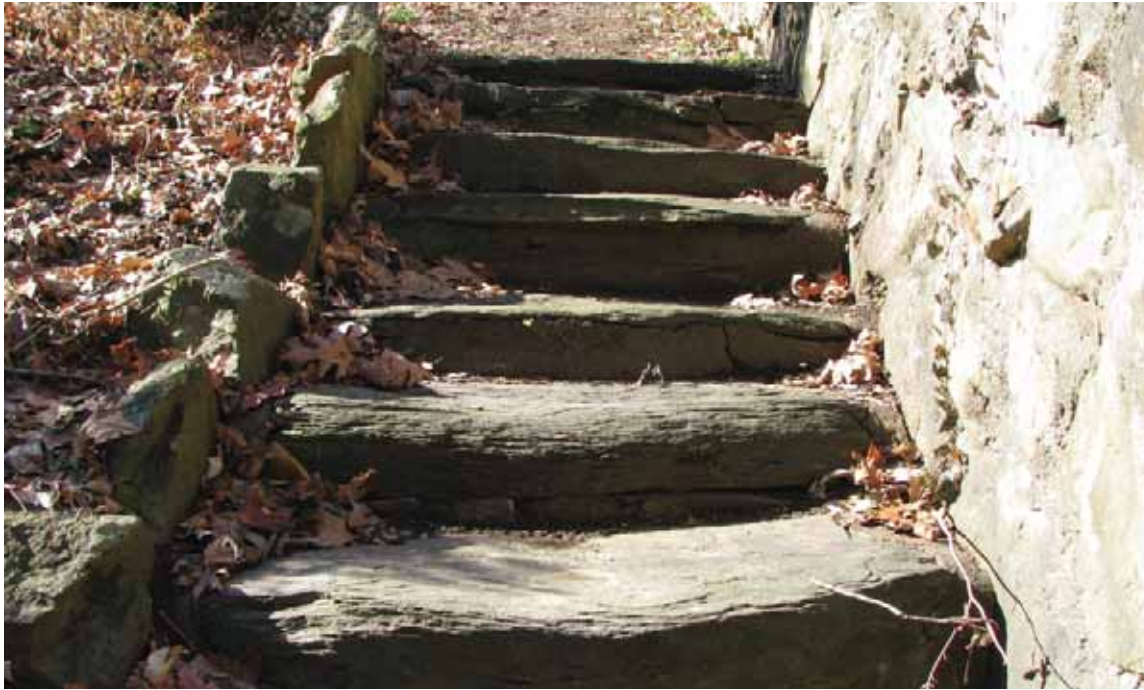
*Stone stairway to woodland garden area. Note mortar deterioration (February 2011).*

There are two sets of stone steps in the woodland area. There are stone steps along the western wall that descend from the garden area into the woodland area, which are roughly 100 feet long from top to bottom. The treads are typically 4-feet long and 2-feet deep with a rise of approximately 6 to 8 inches. Another set of stone steps, whose treads are similar in dimension to the first, negotiates the steep western slope of Rock Hill, creating a meandering switchback path. Both sets of steps have a stone edging on one side, with substantially deteriorating mortar. Additional stone steps are discussed with their associated stone terrace walls under “Buildings and Structures.”

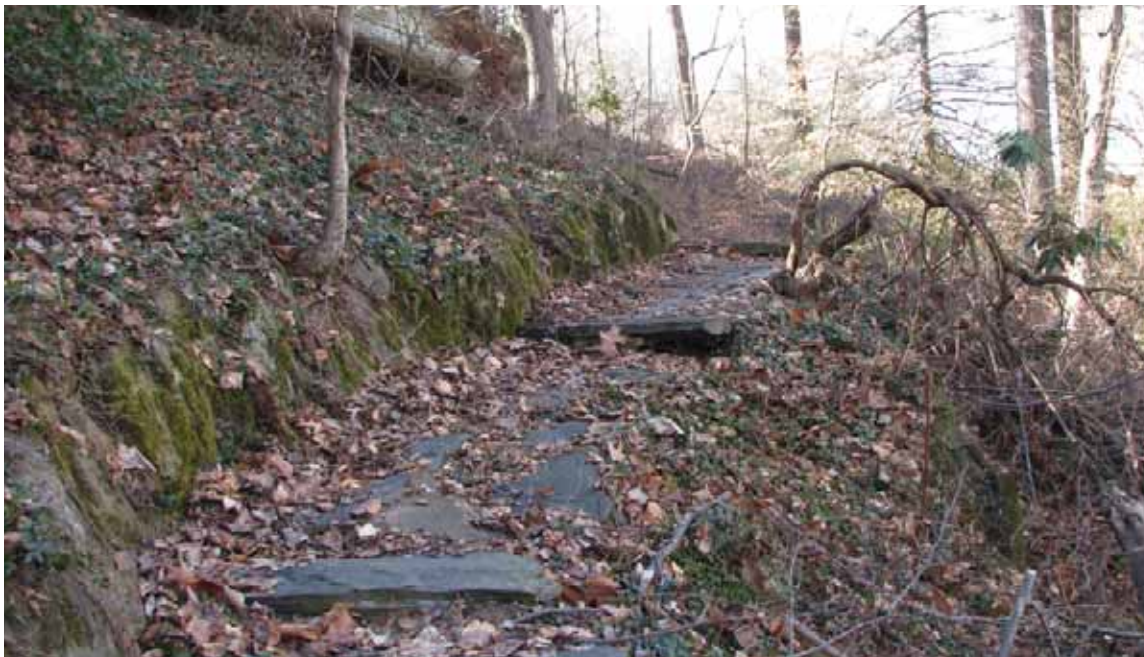
*Curvilinear switchback path in woodland garden area. (February 2011).*

Historic circulation features traverse the entire property and include the original entrance drive from the missing Rugby Road, the garden paths near the terraces, and the switchback woodland path. The switchback woodland path includes low stone steps as it negotiates the hillside.

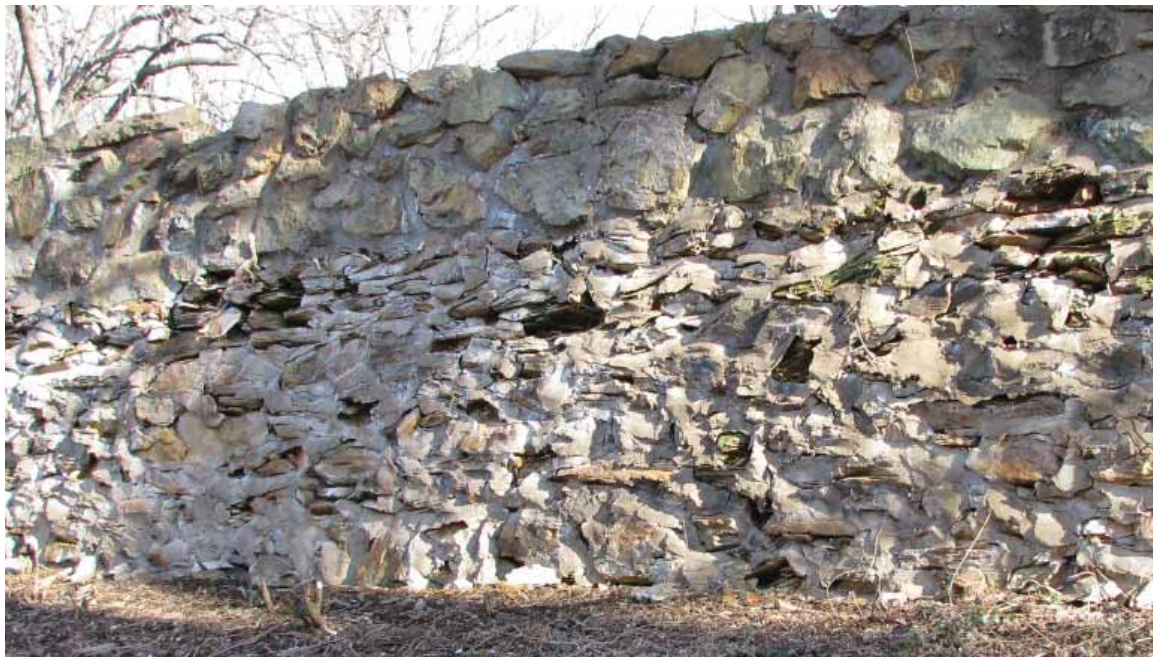
*Contrasting stonework on terrace wall (February 2011).*

Crumbling mortar and dislodged stones were noted on both site visits. In particular, on the February 8, 2011 site visit, the southern wall on terrace 1, adjacent to the steps, appeared to be in danger of failing. On a March 25th site visit, the same wall had collapsed, posing a threat both to safety and to the structural integrity of the remainder of the terrace wall.

Along the eastern wall at terrace 2 adjacent to the steps, the retaining walls are deteriorating, and there appear to be other areas of potential wall failure throughout the terraces. Vegetation removal around the walls appears to have led to a weakening of the masonry; erosion and poor drainage may have also contributed to the generally poor condition of the retaining walls.

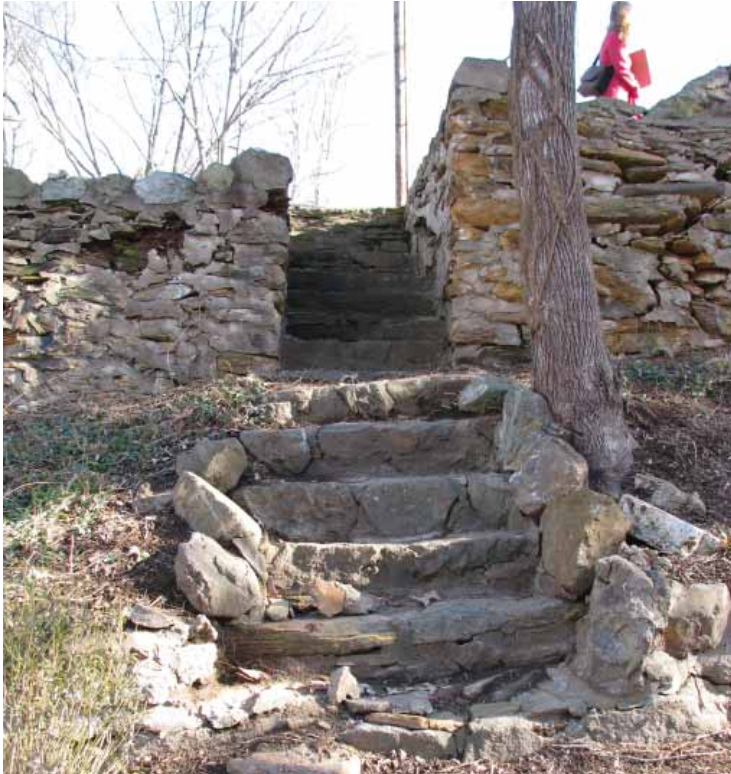
*Deteriorating terrace  
1 stairs and walls in  
February, 2011.  
Note the wall  
condition on the right.*

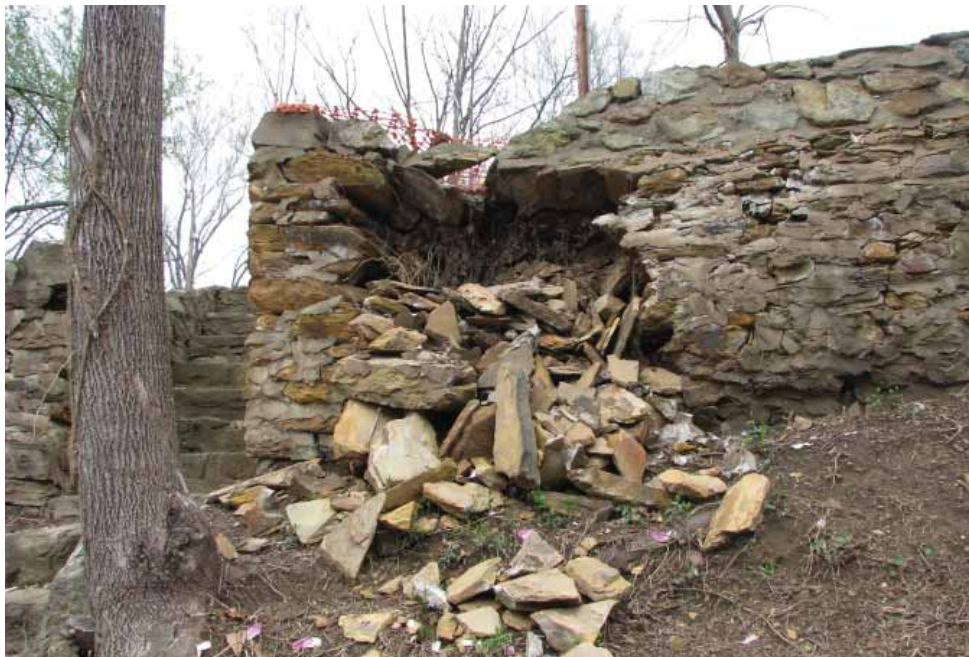
*Failure of the same  
terrace 1 wall in  
March 2011.*

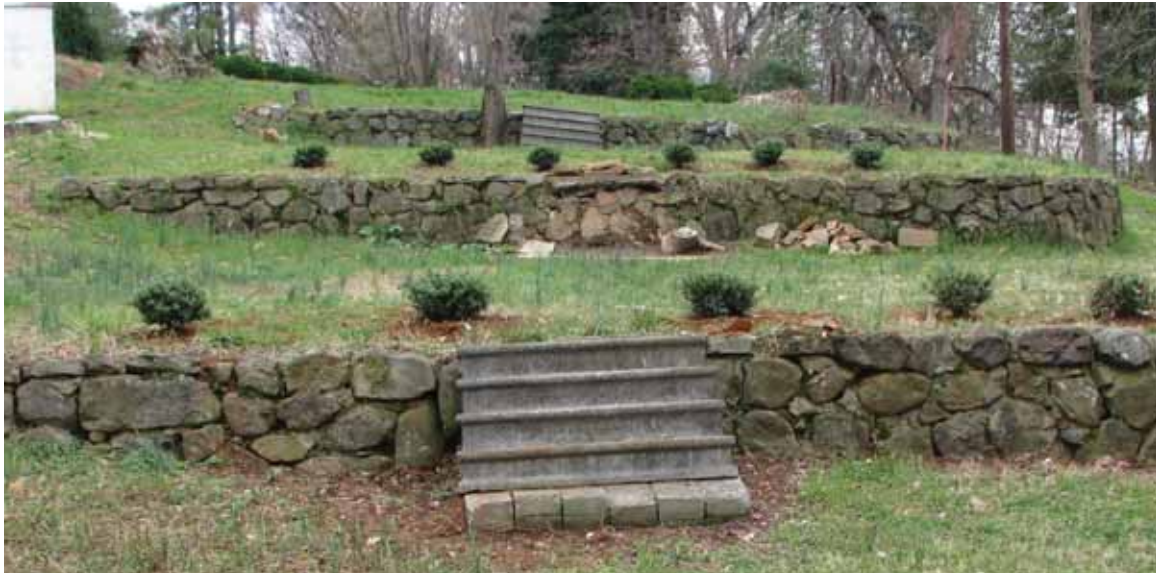
*Upper terraces. Note missing stairs on central terrace. Building in upper left is an unused lunchroom likely associated with Rock Hill Academy (March 2011).*

There are three uncoursed rubble masonry wall terraces located north of the lower terraces. The walls support three grass-covered terraces measuring approximately 35 feet by 45 feet, each with a rounded corner on the southwest edge. The walls are approximately two feet high and 150 feet long. Unlike the lower terraces, these have cast concrete steps rather than mortared stone steps. One set of steps, which was present during an archeological assessment in 2007, is now missing.

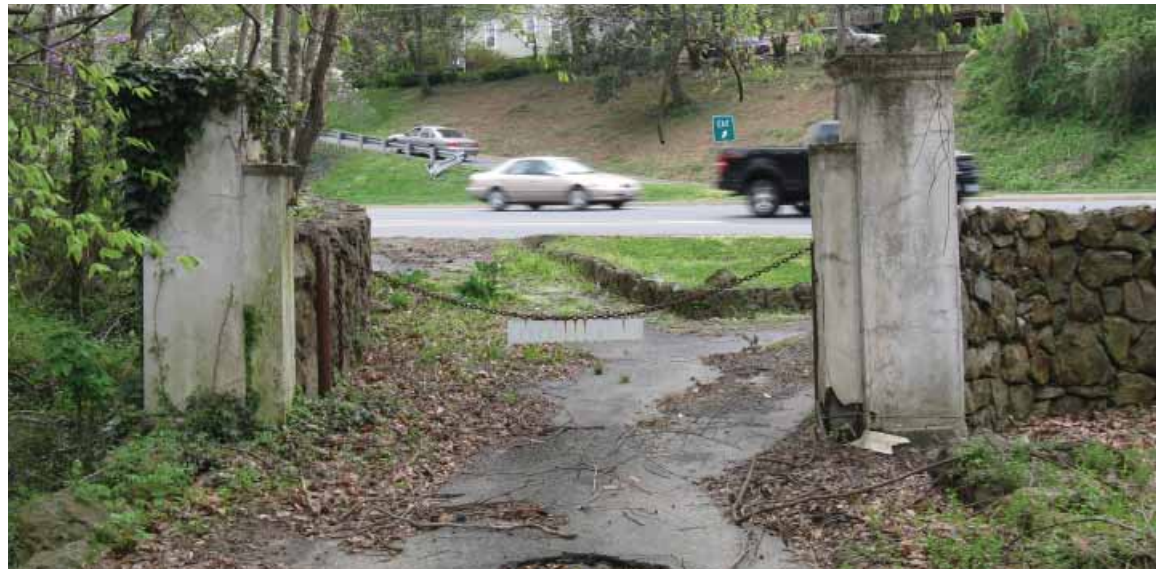
*Entry gate columns (RKK).*

Two columns mark the historic entry to the Rock Hill property. The columns are constructed of brick finished with stucco into which the name has been inscribed and painted white. The columns have cast concrete caps. The stucco on both columns is deteriorating. The mortar between the western column and stone wall appears to have completely deteriorated, and there is now an approximately two inch gap between the two.

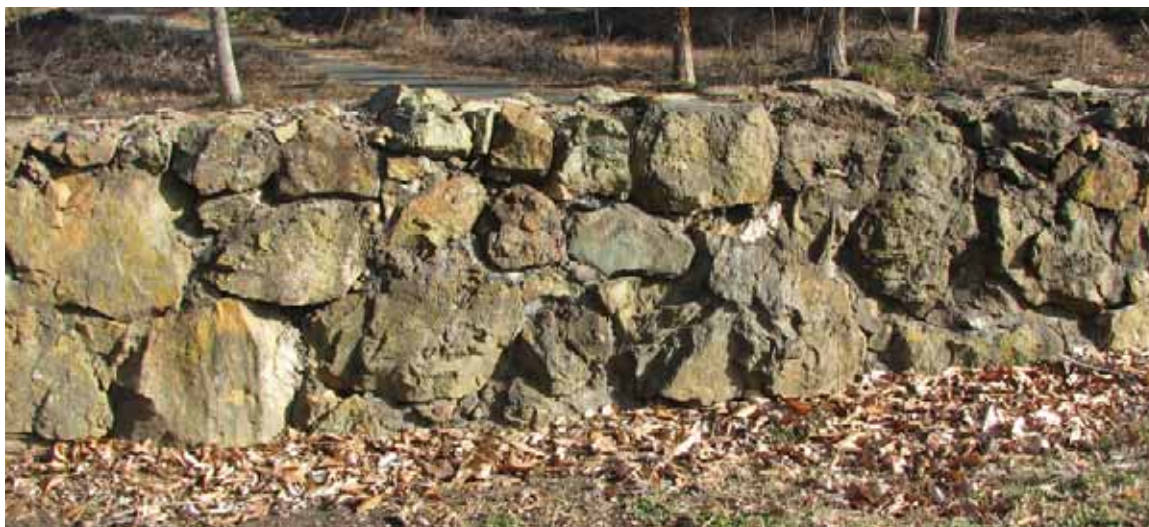
*Southern boundary wall, near western gate post (February 2011).*

The stone boundary wall marks the Rock Hill property boundary, and – with a few exceptions – is in good to fair condition. The stone boundary wall is a character-defining feature, and the goal for treatment is to preserve the majority of the wall, with the exception of the southern portion of the boundary wall that will be moved for the construction of the interchange ramp. In this area, the goal is to reuse the

stone from the existing southern boundary wall to construct a new wall within the adjusted property boundary.

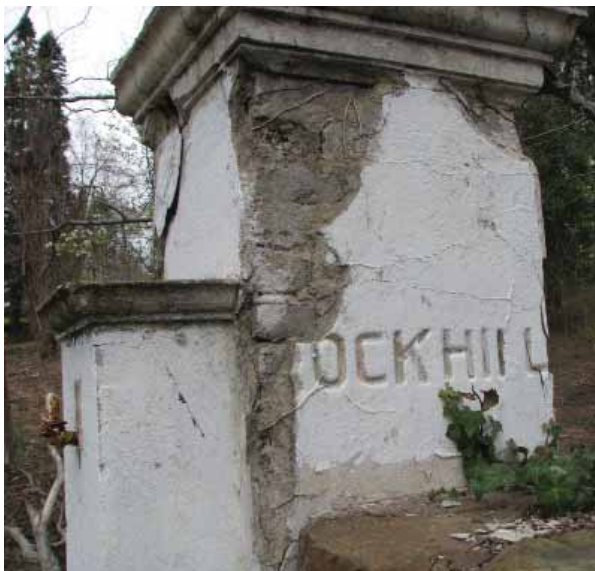
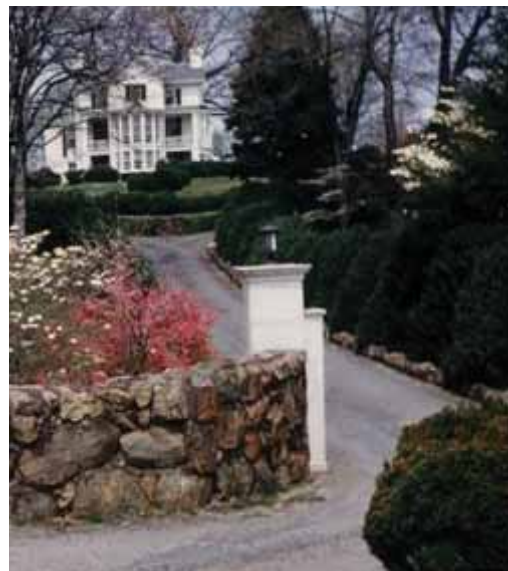
*Left: East gatepost, 2011. Note damaged stucco, brick and concrete, with partially damaged inscription.*

*Right: Photograph of west gatepost, post-1955, exact date unknown.*
