Certificate of Appropriateness
BAR # 22-10-01
1109 & 1121 Wertland Street (1025-1213), TMP 040305000
Wertland Street ADC District
Owner: Neighborhood Investments--WS
Applicant: Richard Spurzem
Project: Rehabilitate exterior siding and trim

**City of Charlottesville
Board of Architectural Review
Staff Report
October 18, 2022**

BAR # 22-10-01

Project: Rehabilitate exterior siding and trim

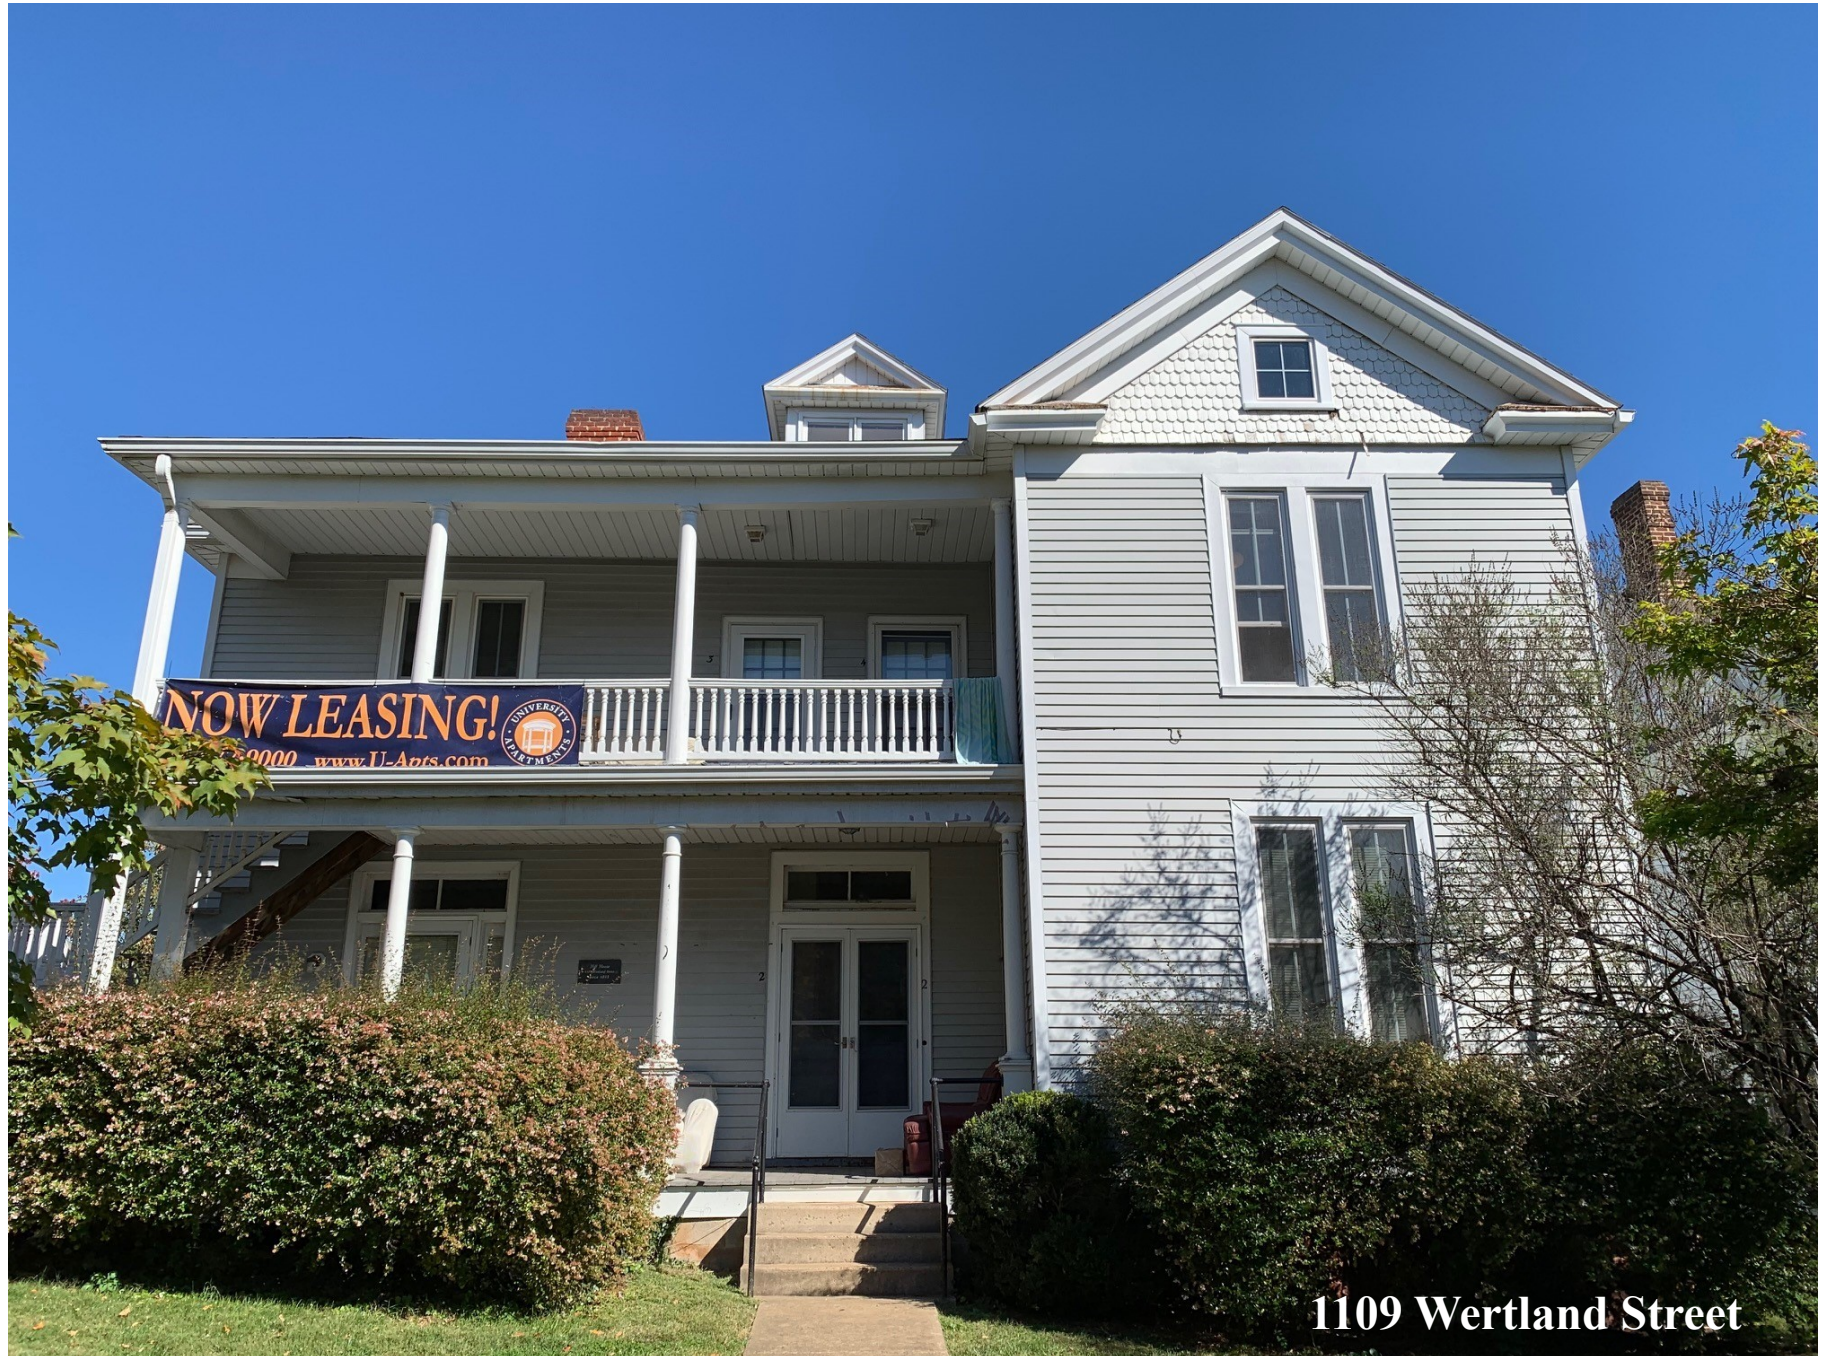
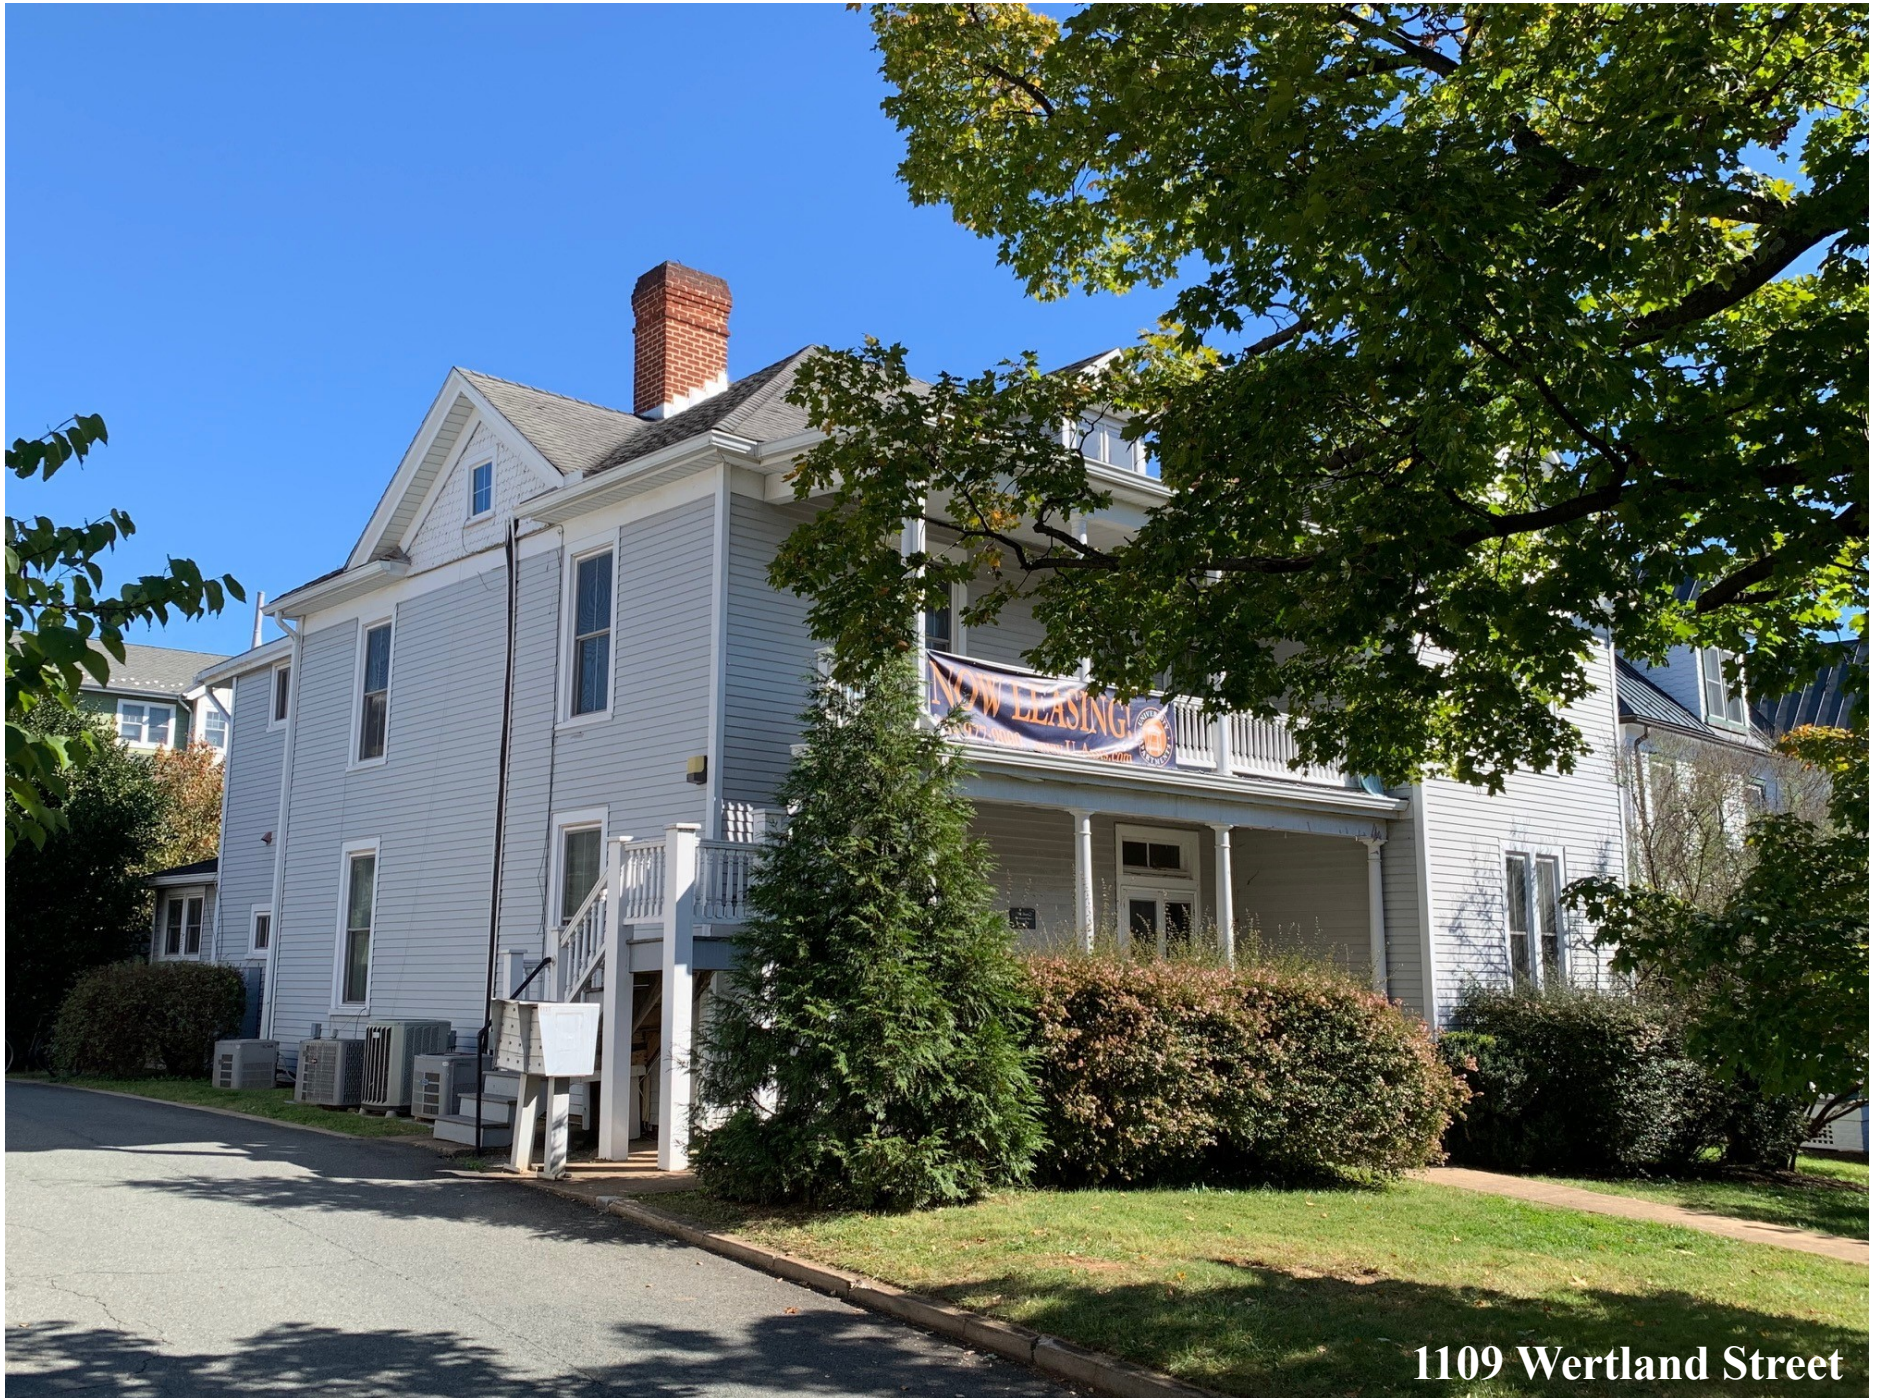
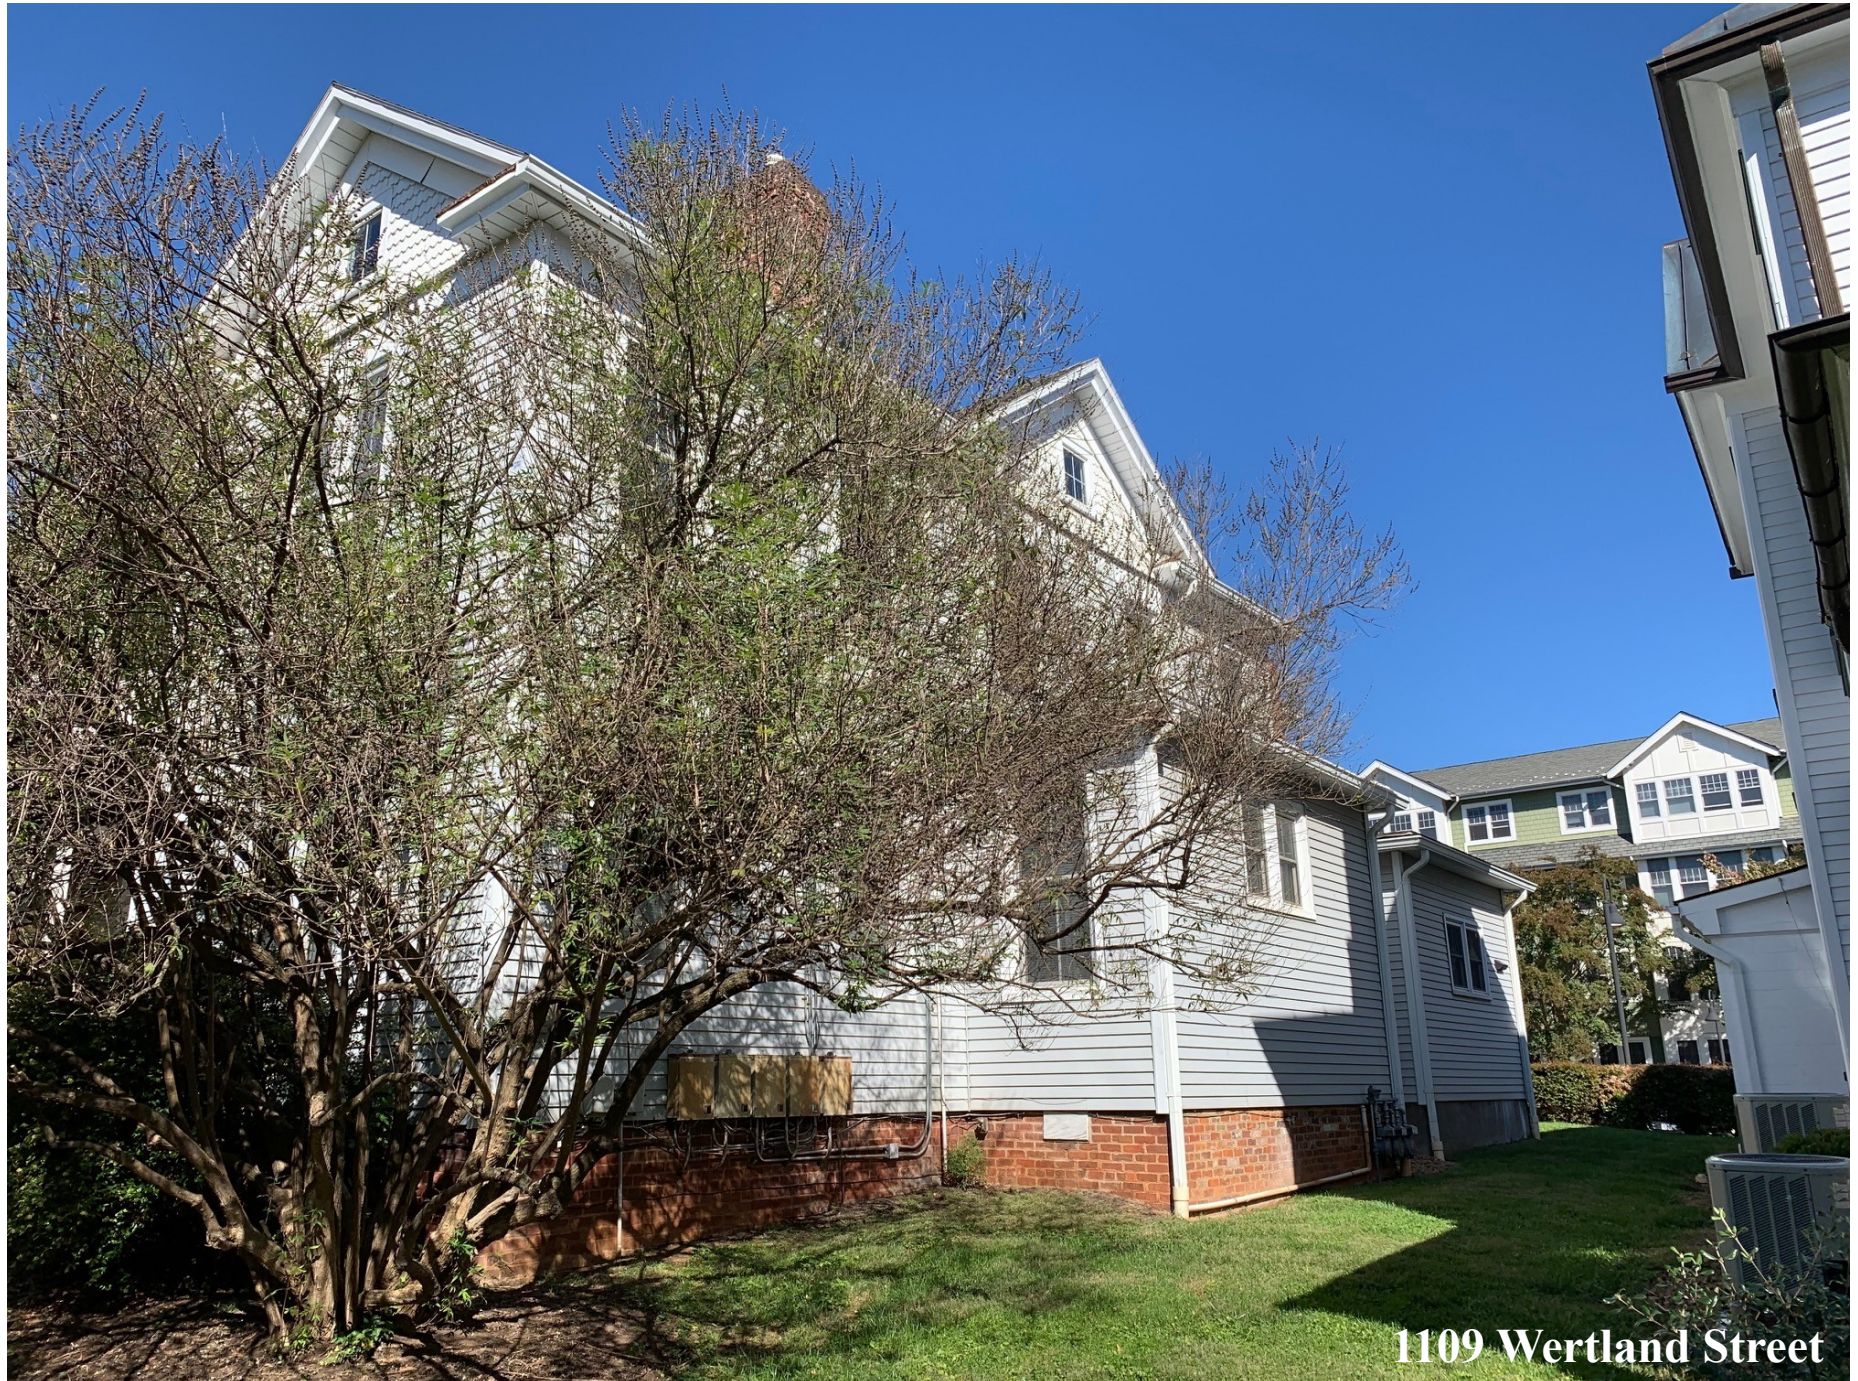
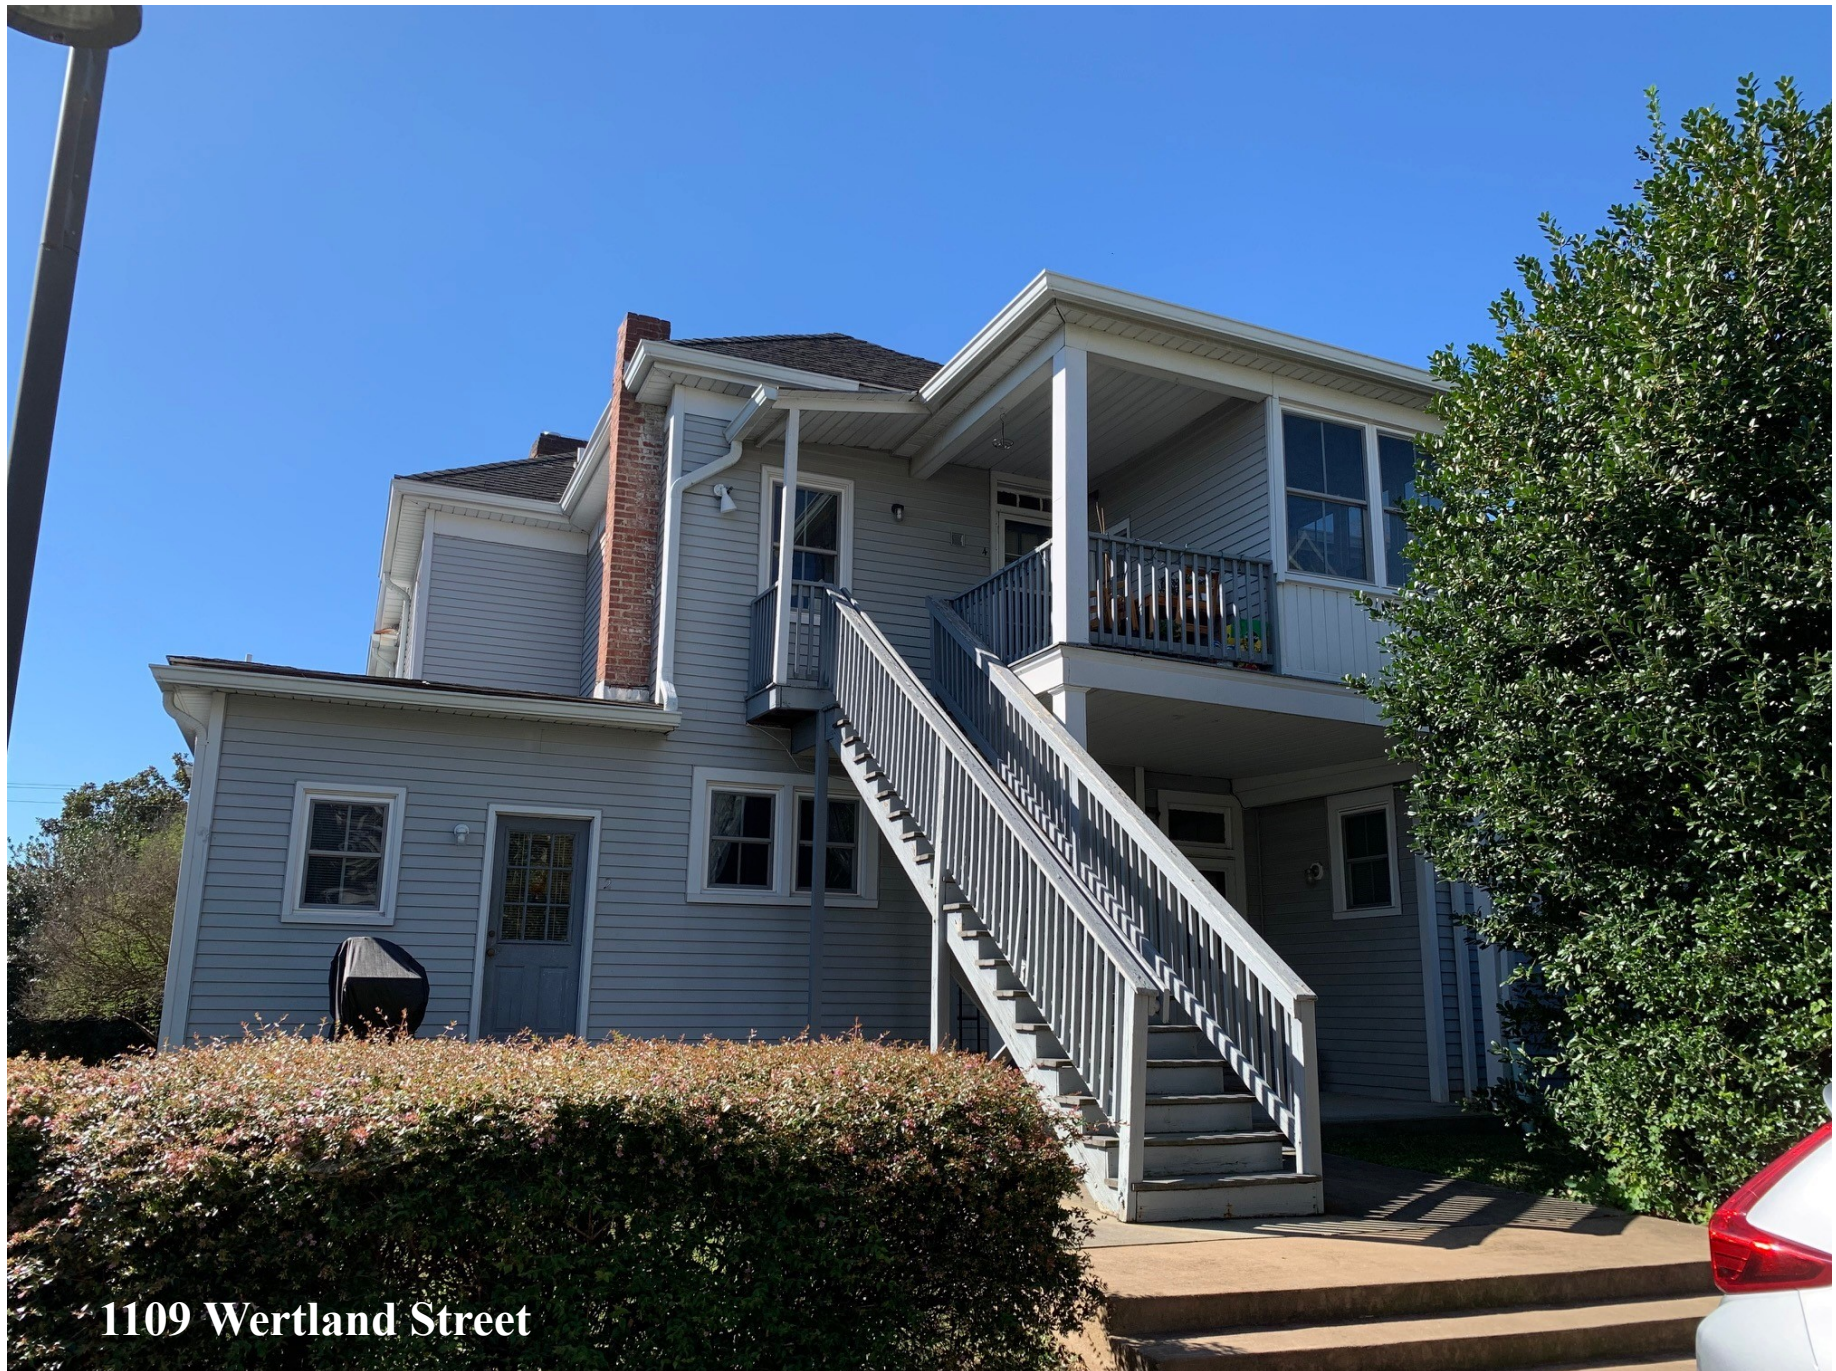
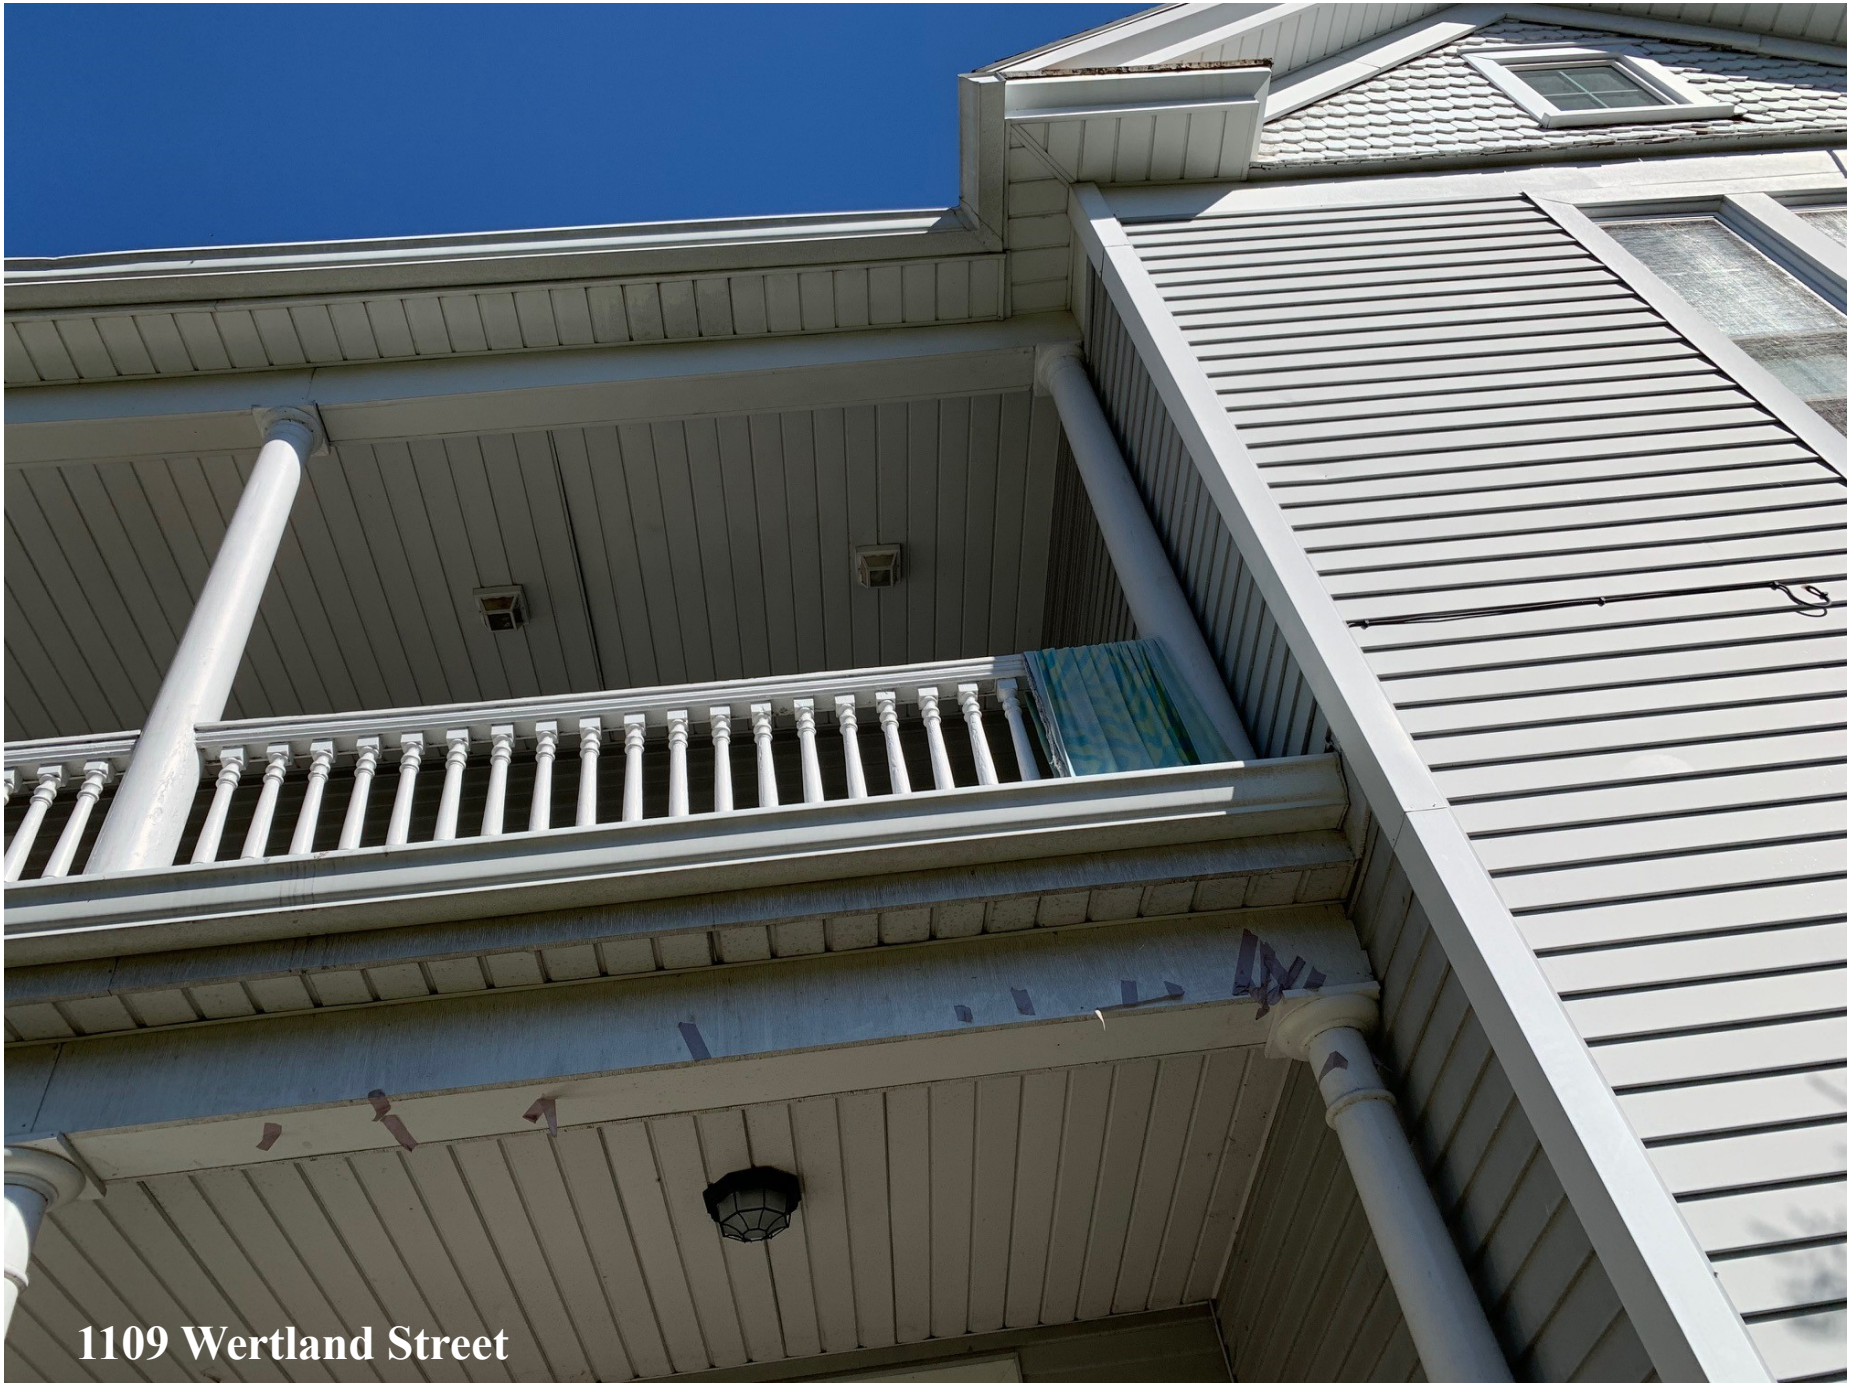
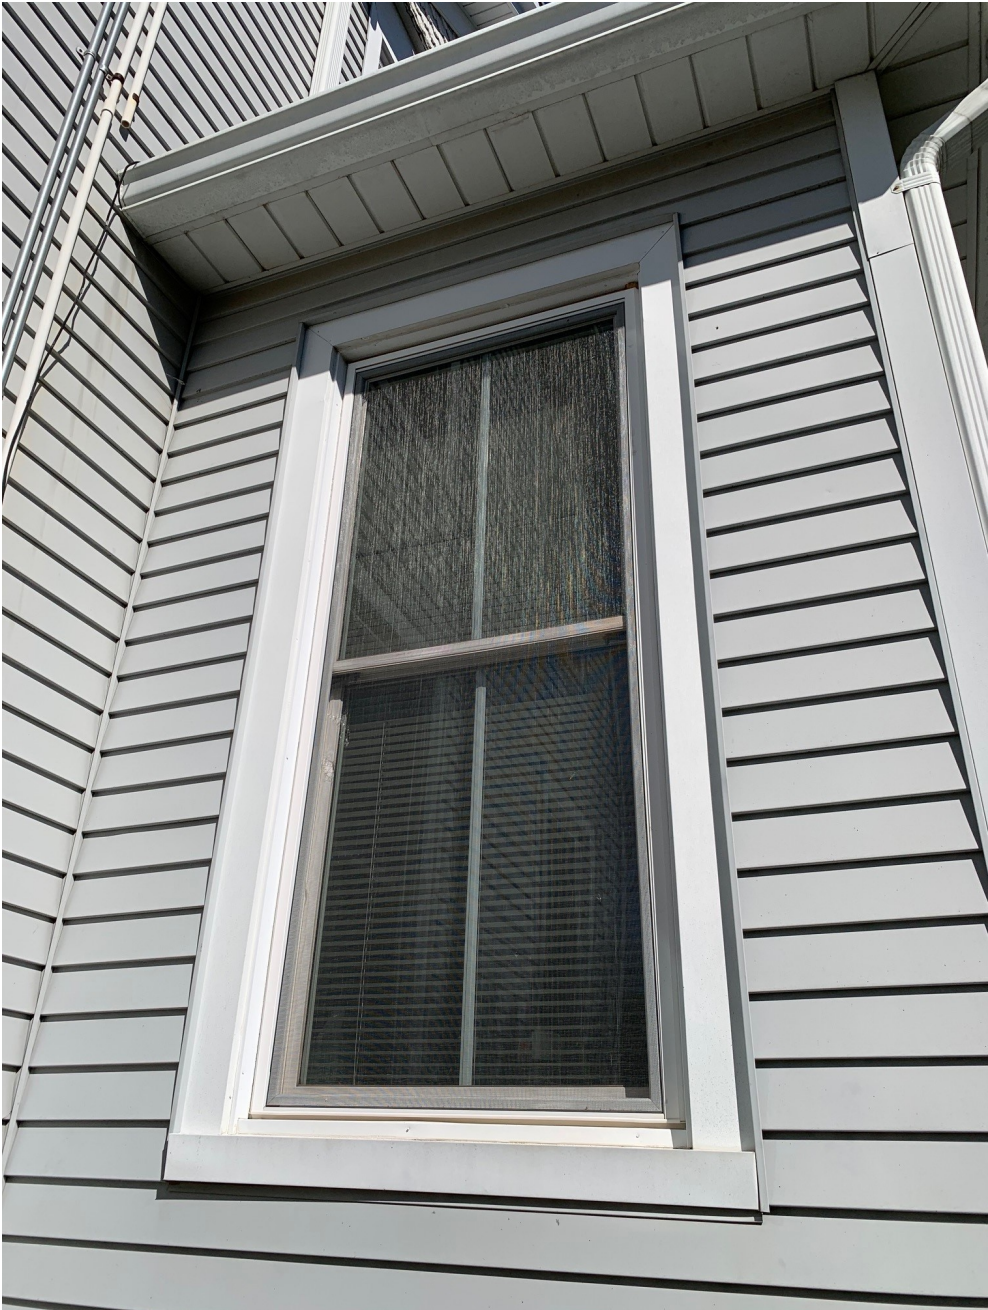
1109 Wertland Street

1109 Wertland Street: Remove aluminum siding and aluminum trim/panels at window trim and sills, soffits, and porches. Repair/replace the presumably wood lap siding, wood window trim/sills, wood trim at soffits/eaves, and install beaded-board at porch ceiling.
