Certificate of Appropriateness
BAR # 22-10-01
1109 & 1121 Wertland Street (1025-1213), TMP 040305000
Wertland Street ADC District
Owner: Neighborhood Investments--WS
Applicant: Richard Spurzem
Project: Rehabilitate exterior siding and trim

**City of Charlottesville
Board of Architectural Review
Staff Report
October 18, 2022**

BAR # 22-10-01

Project: Rehabilitate exterior siding and trim

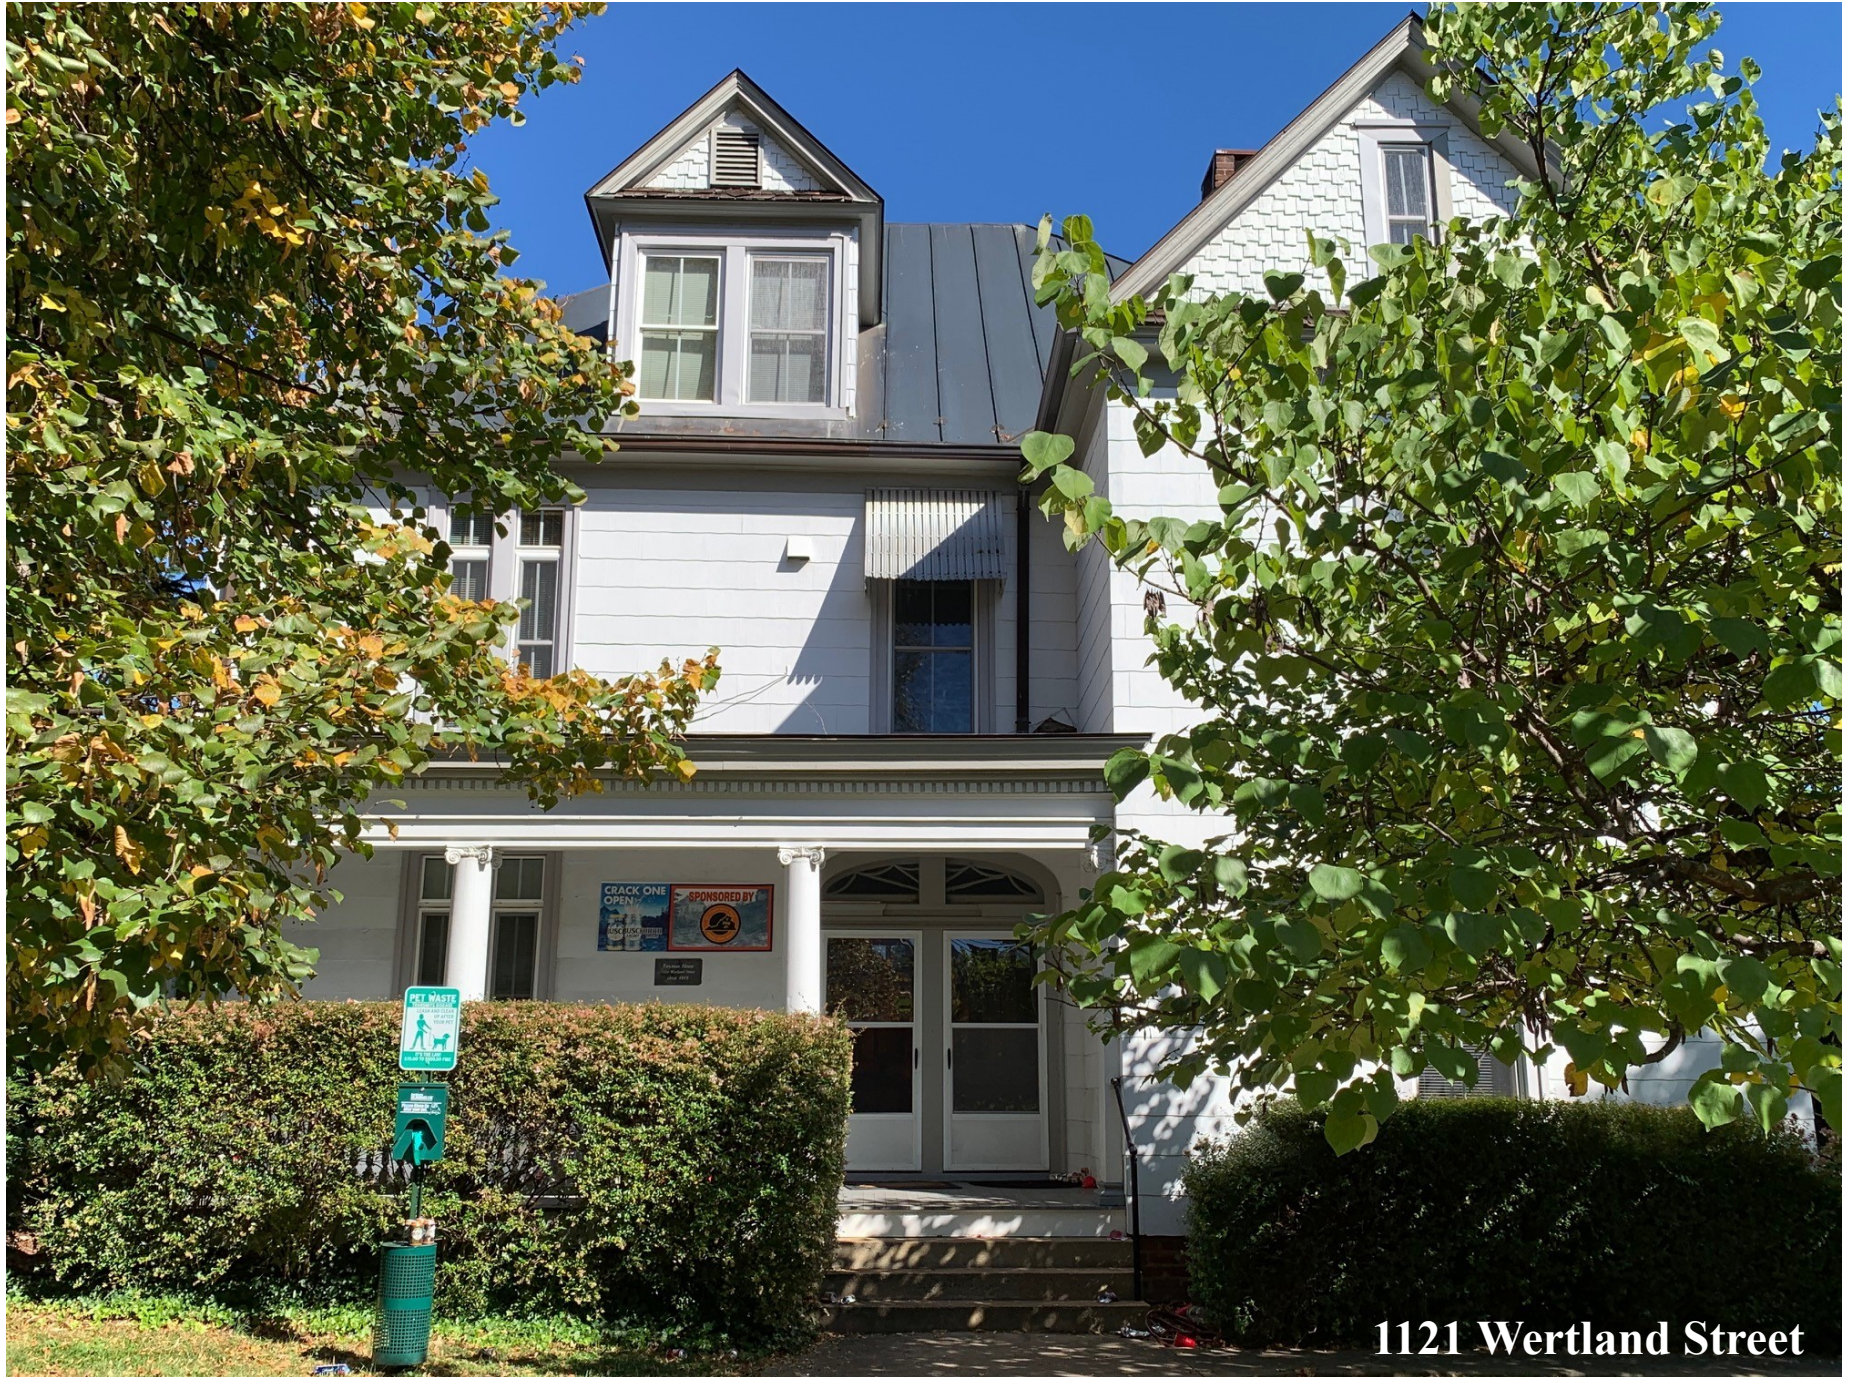
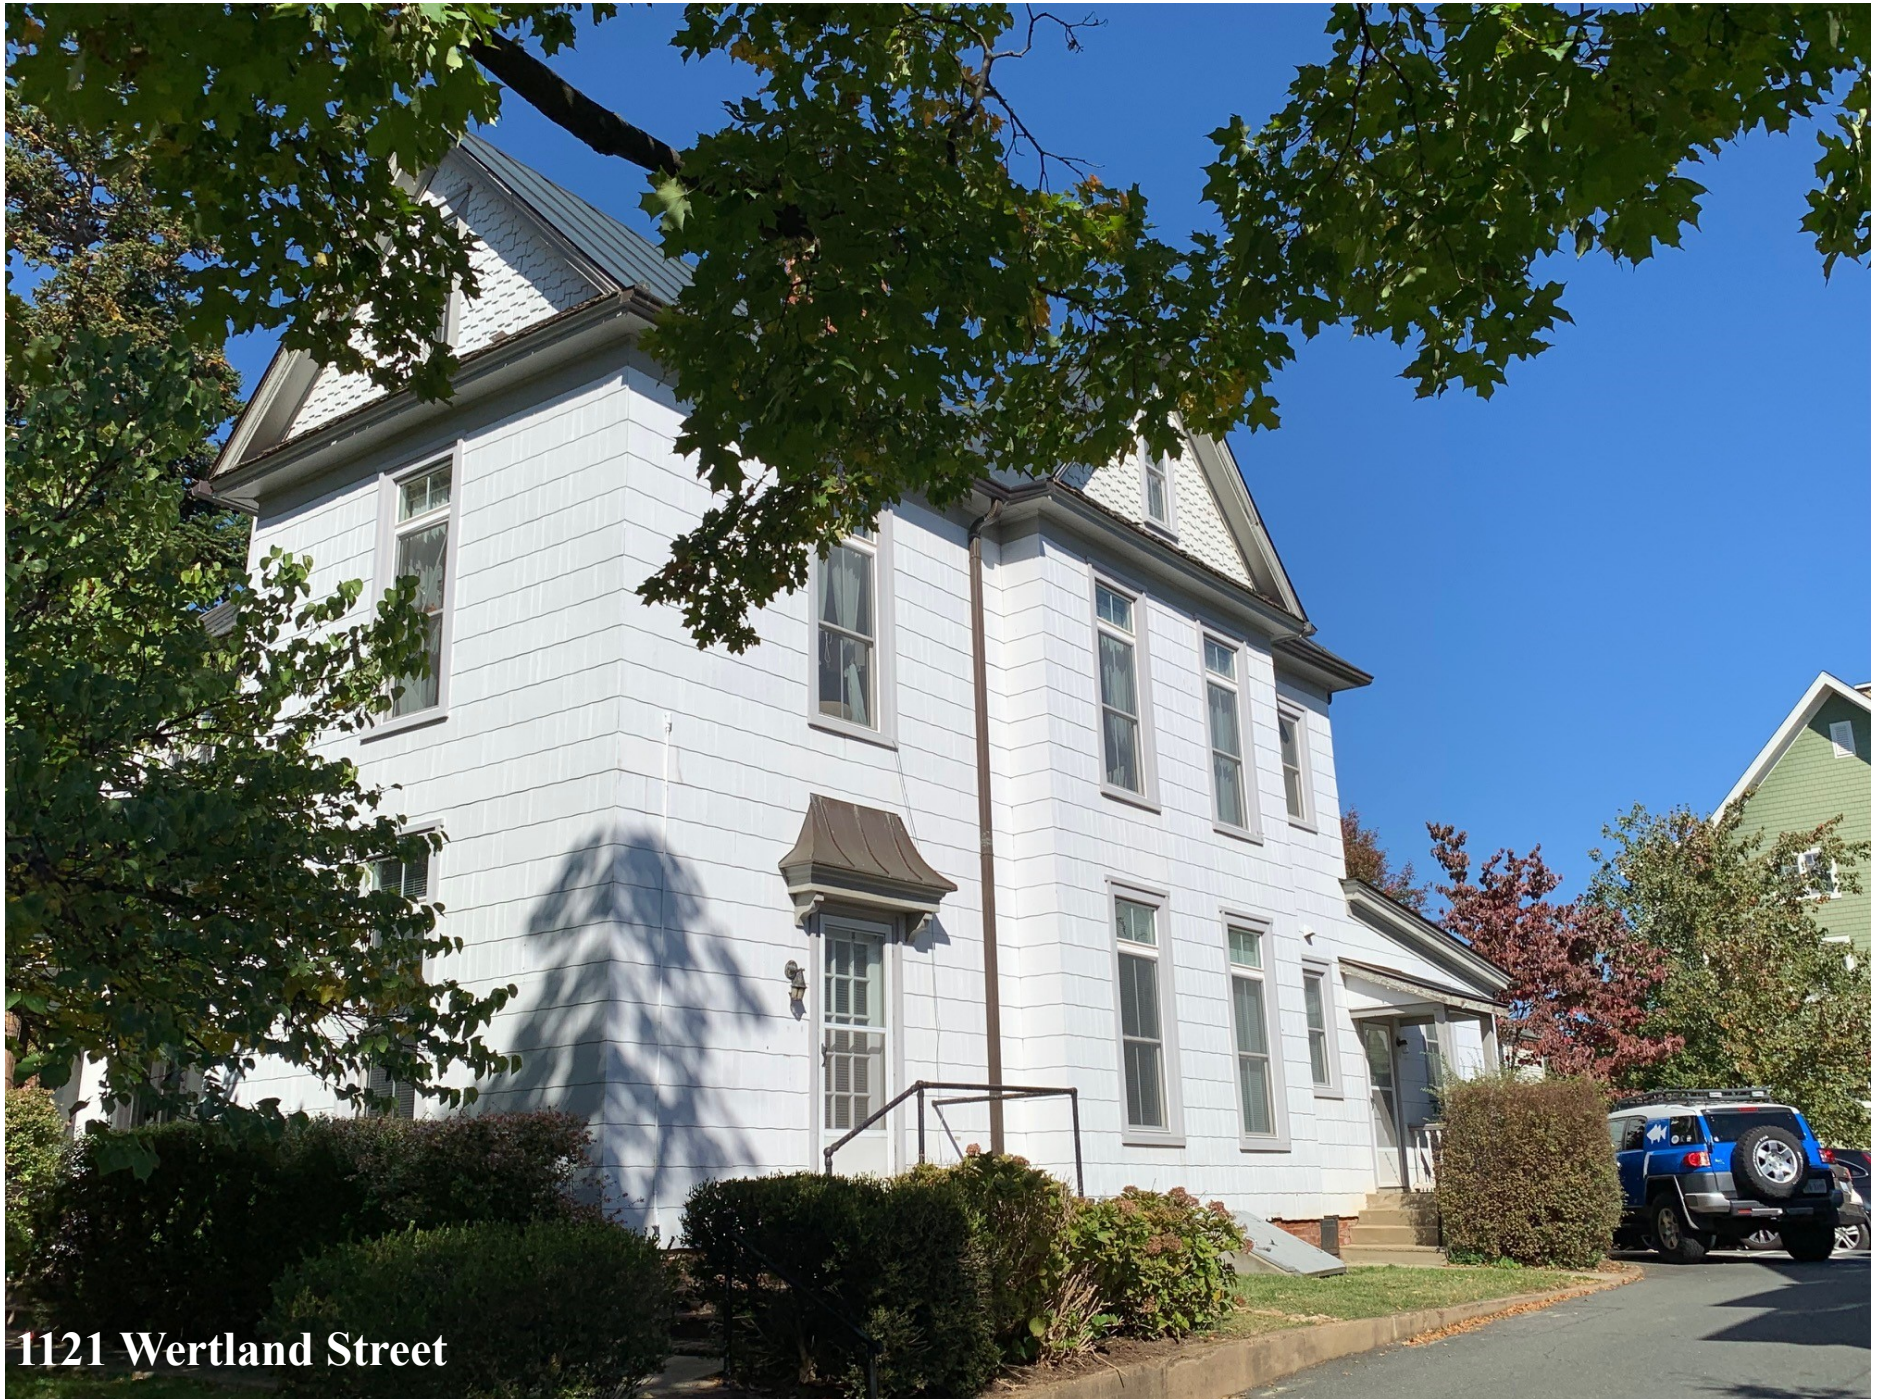
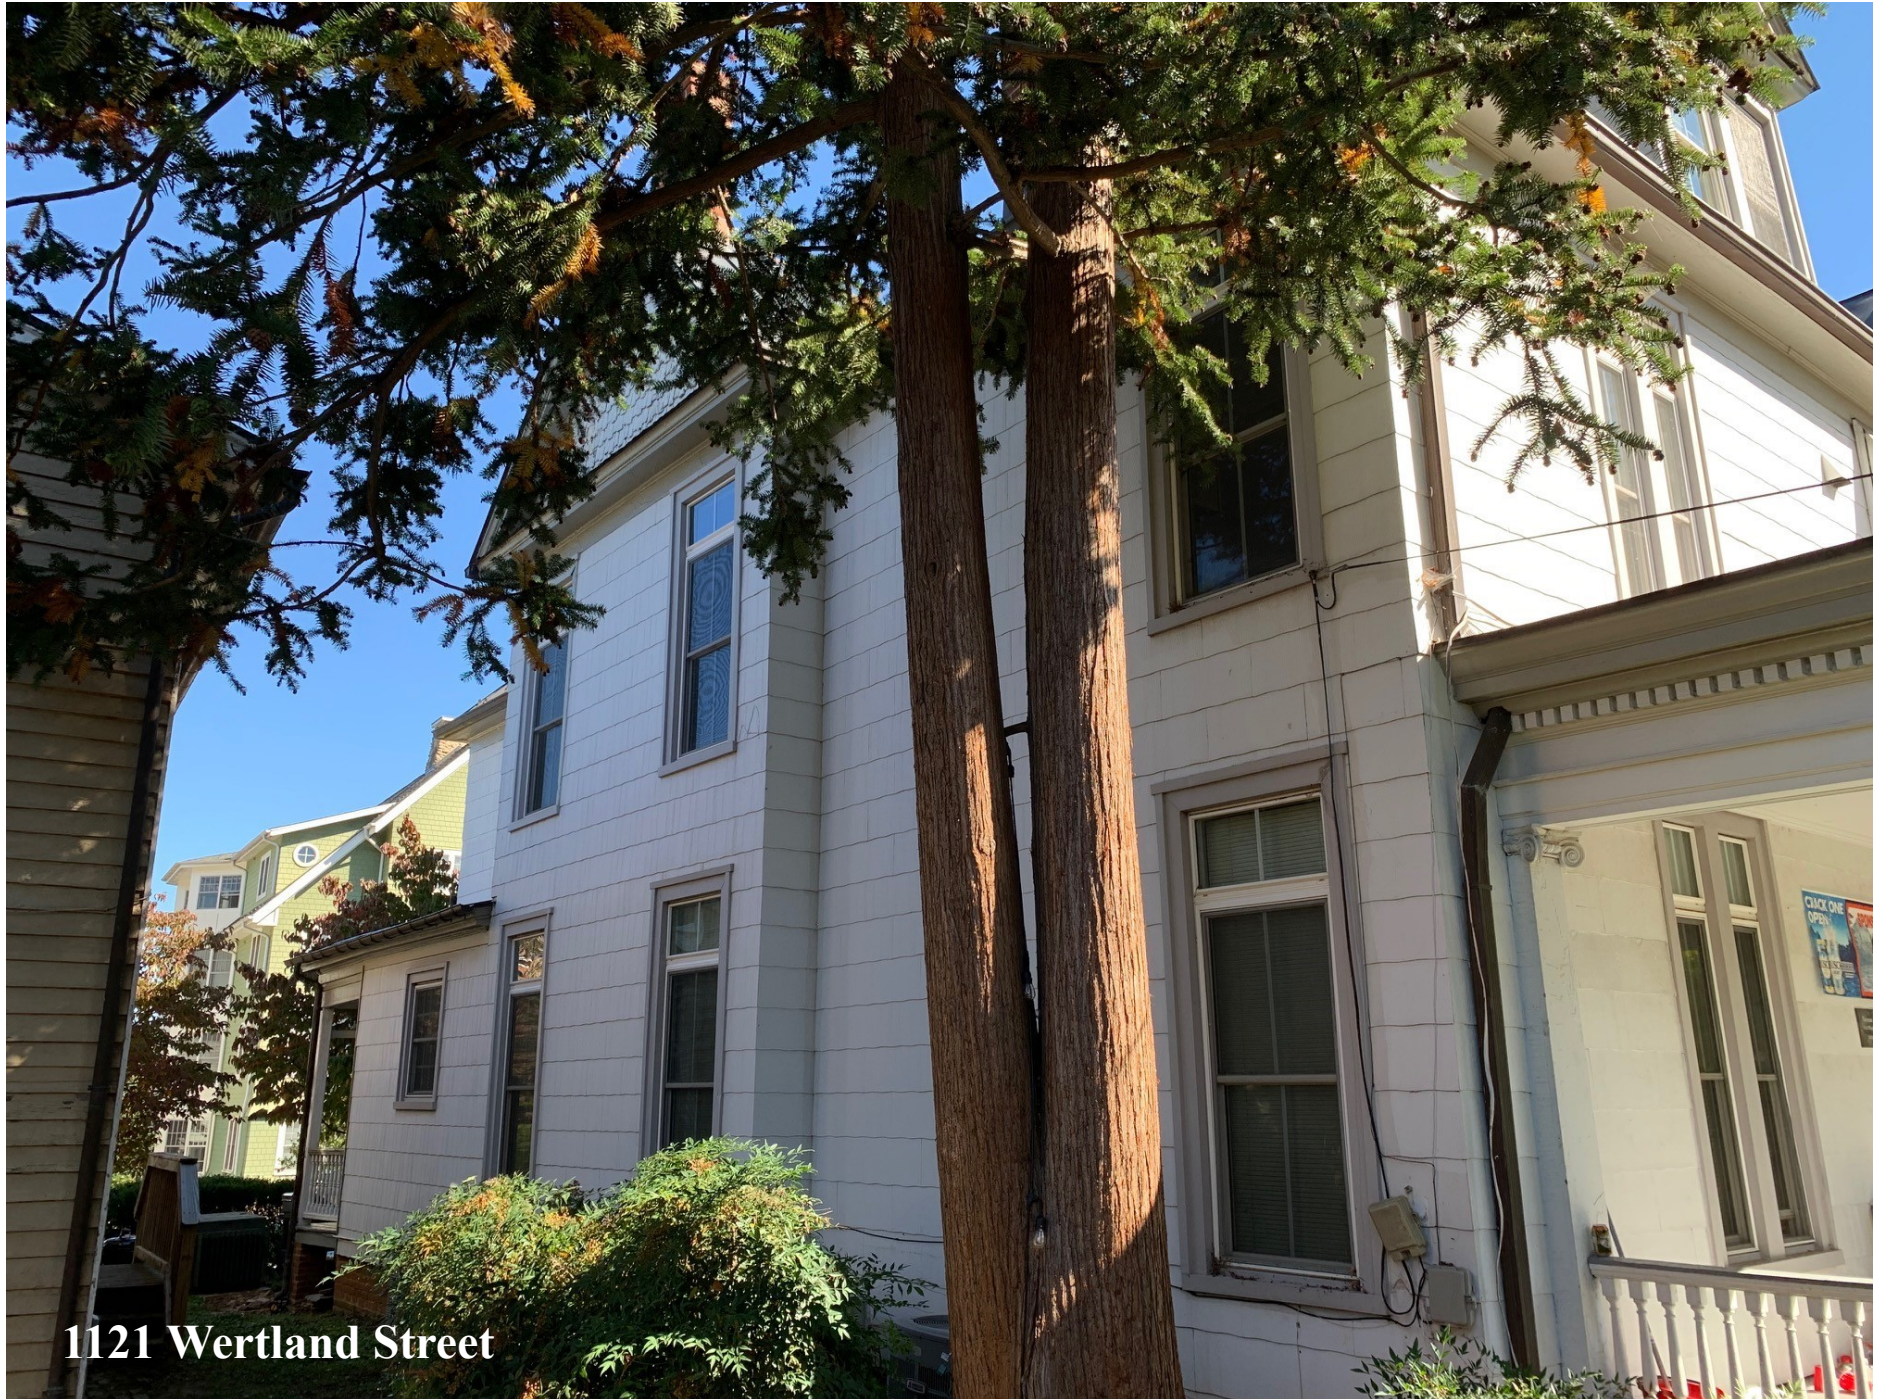
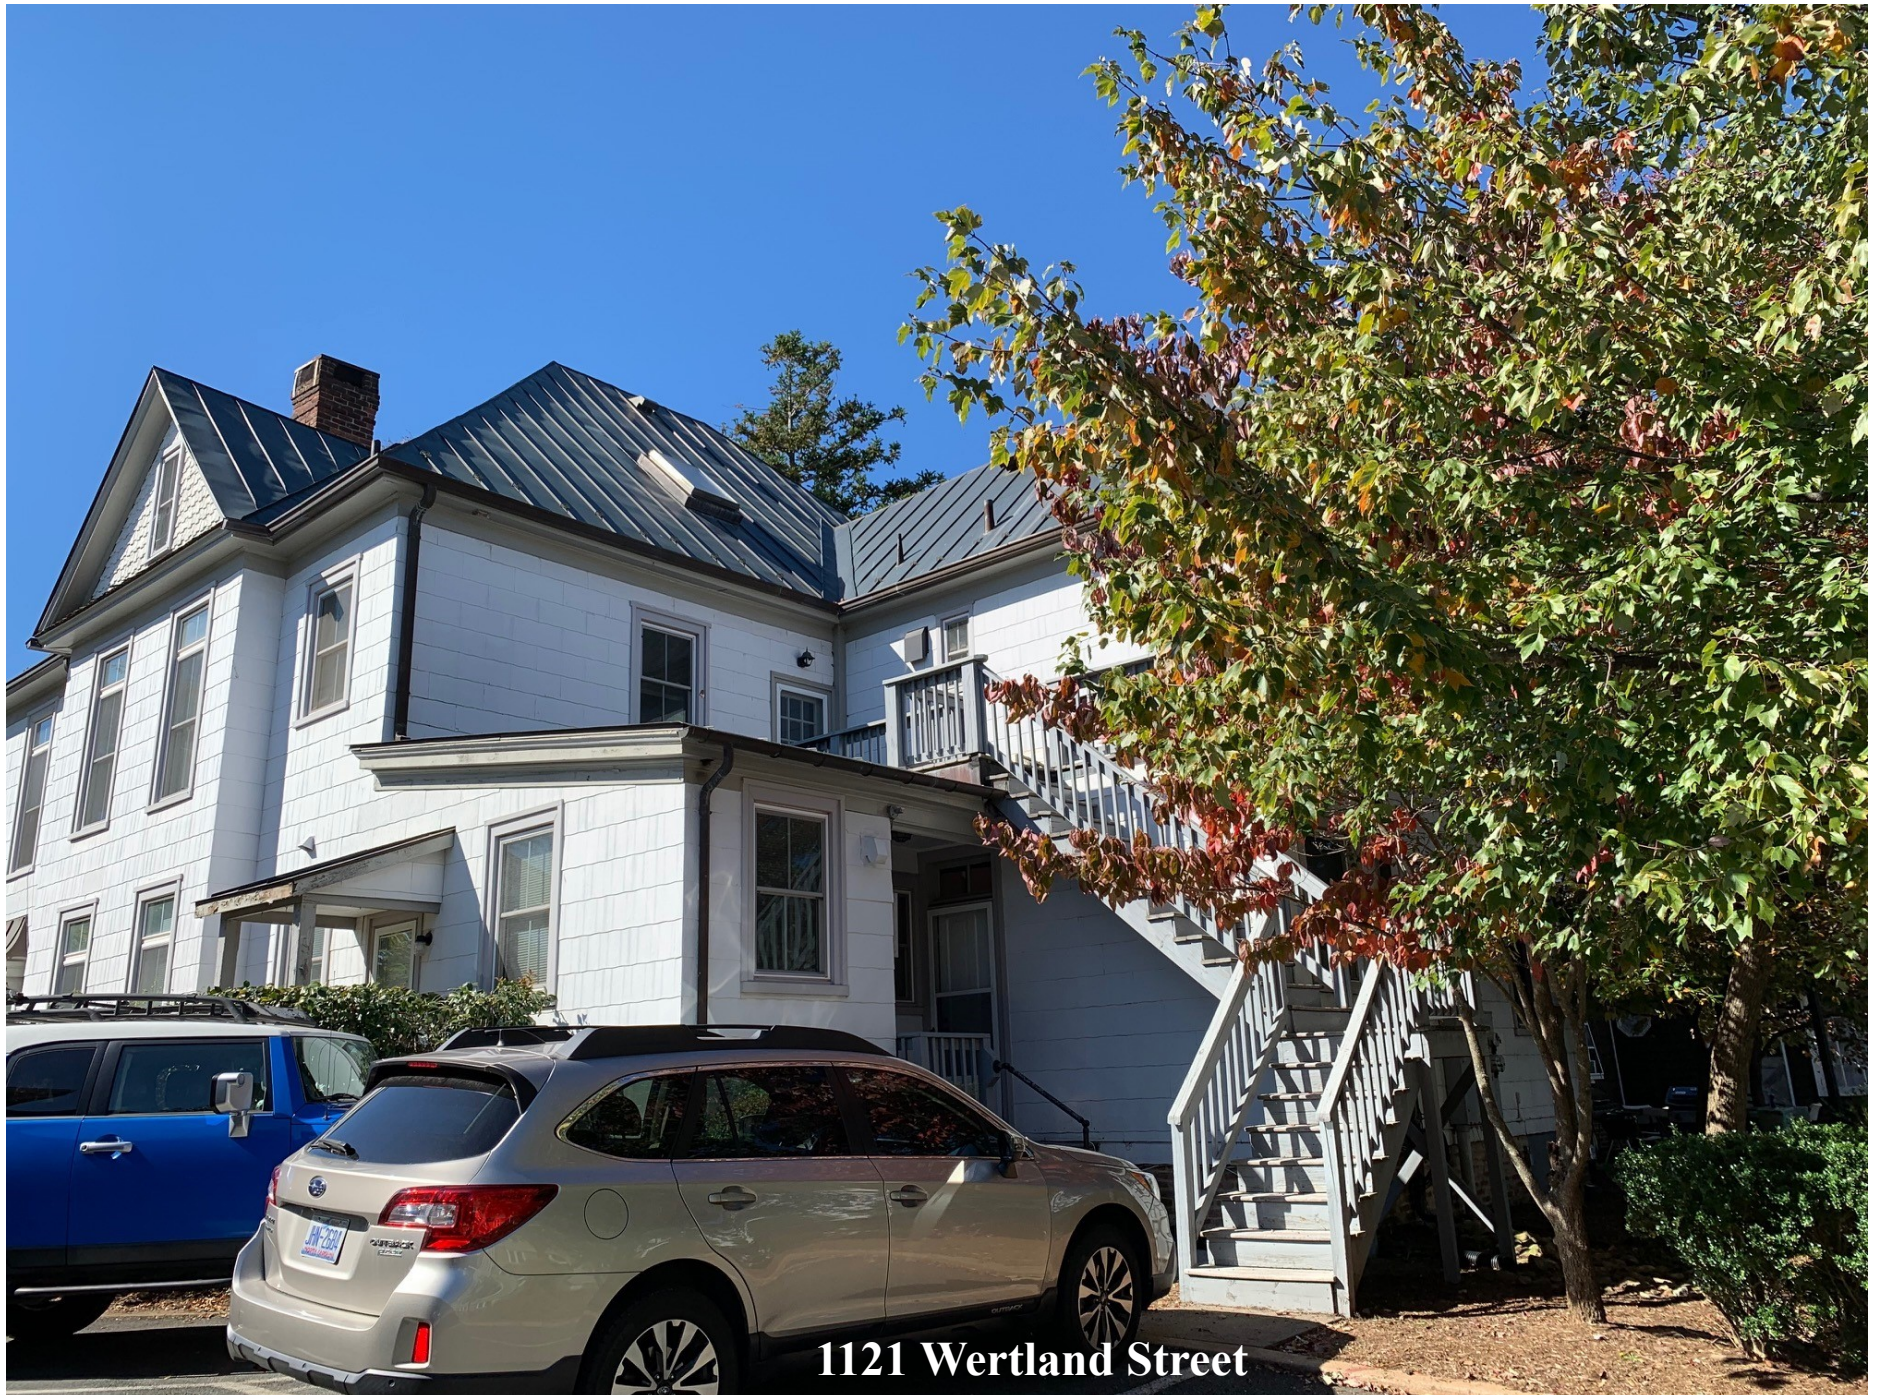
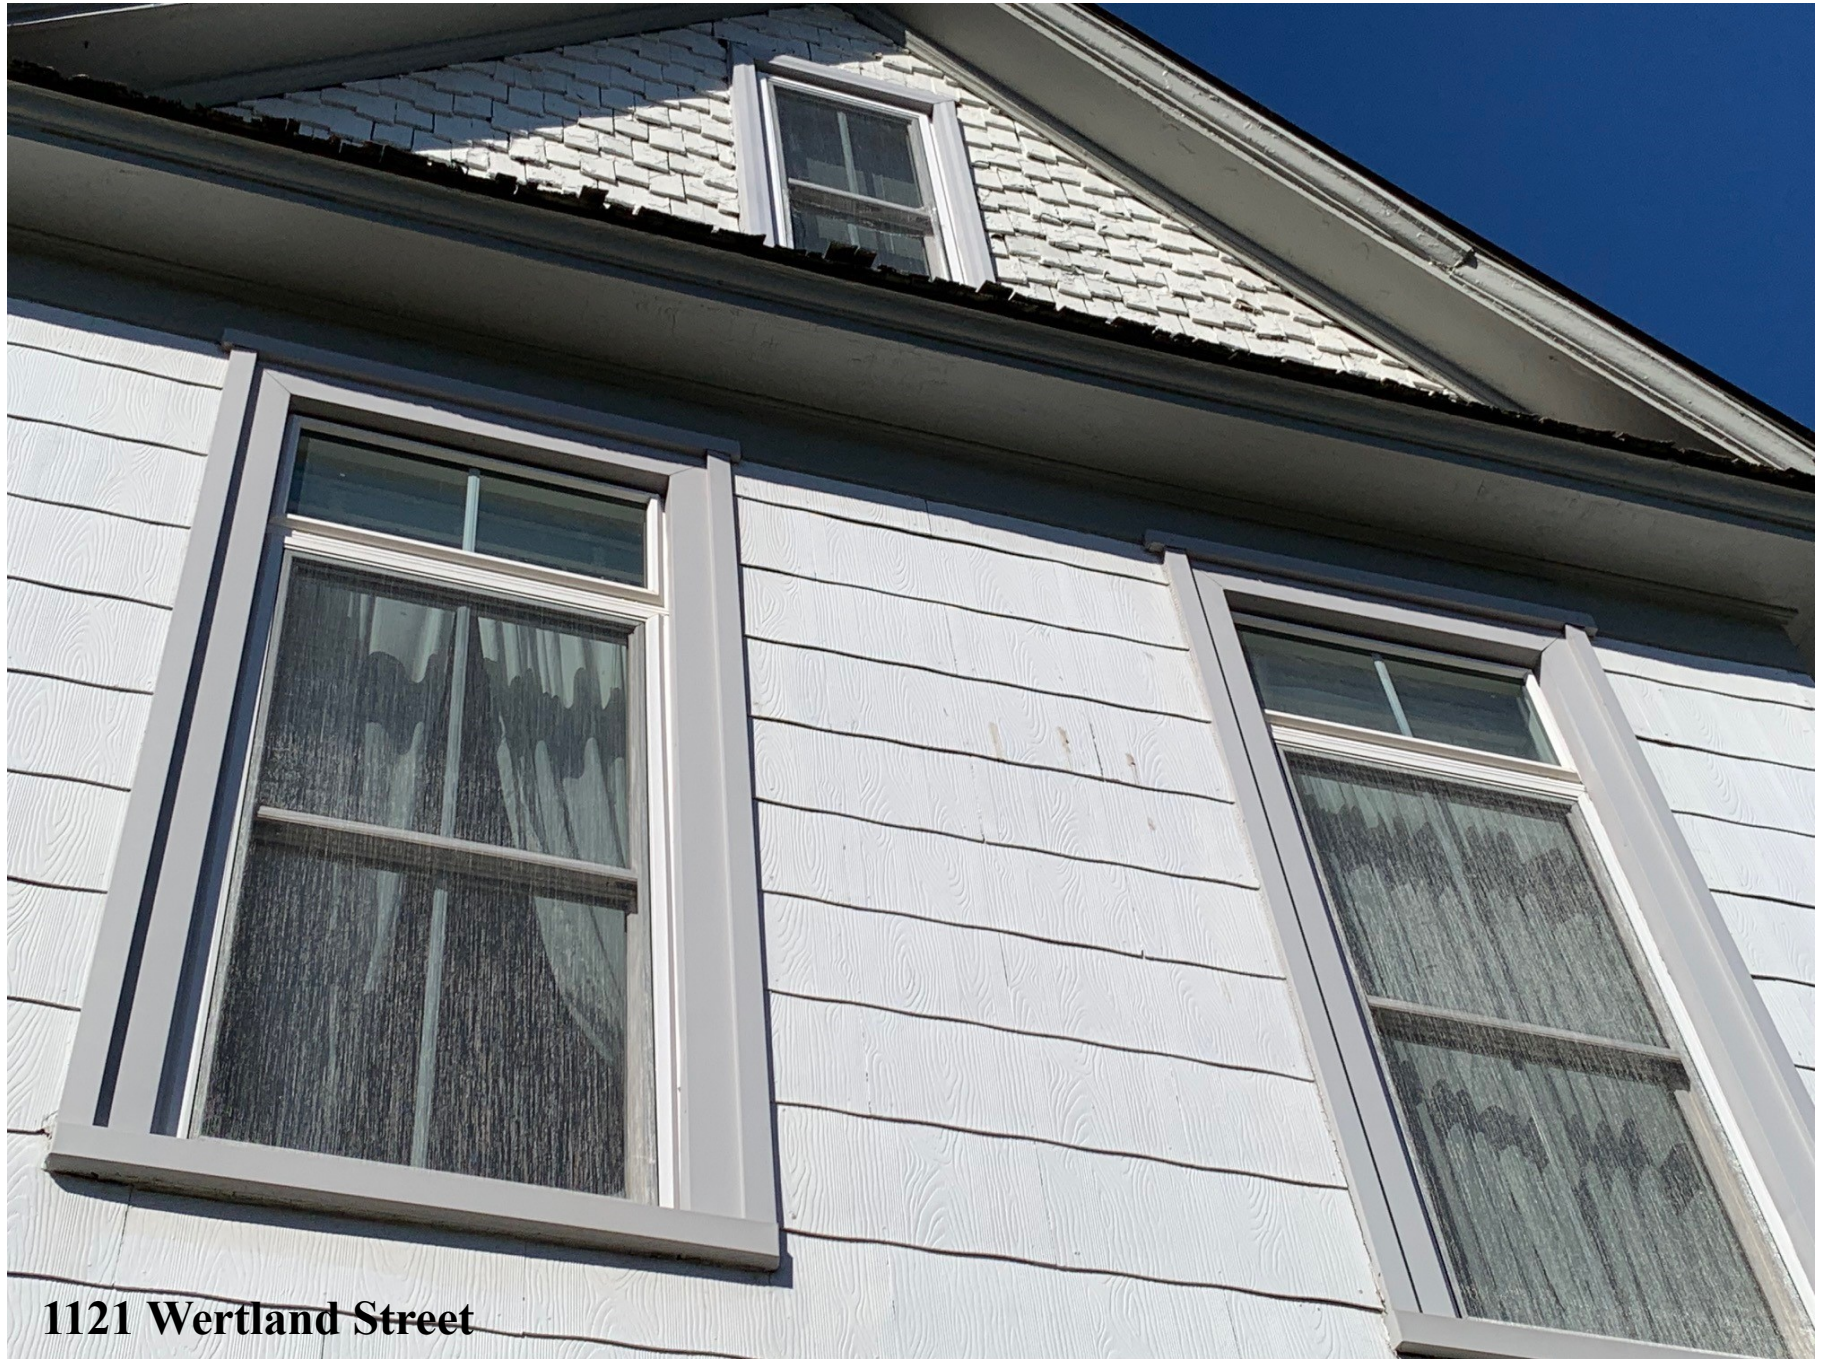
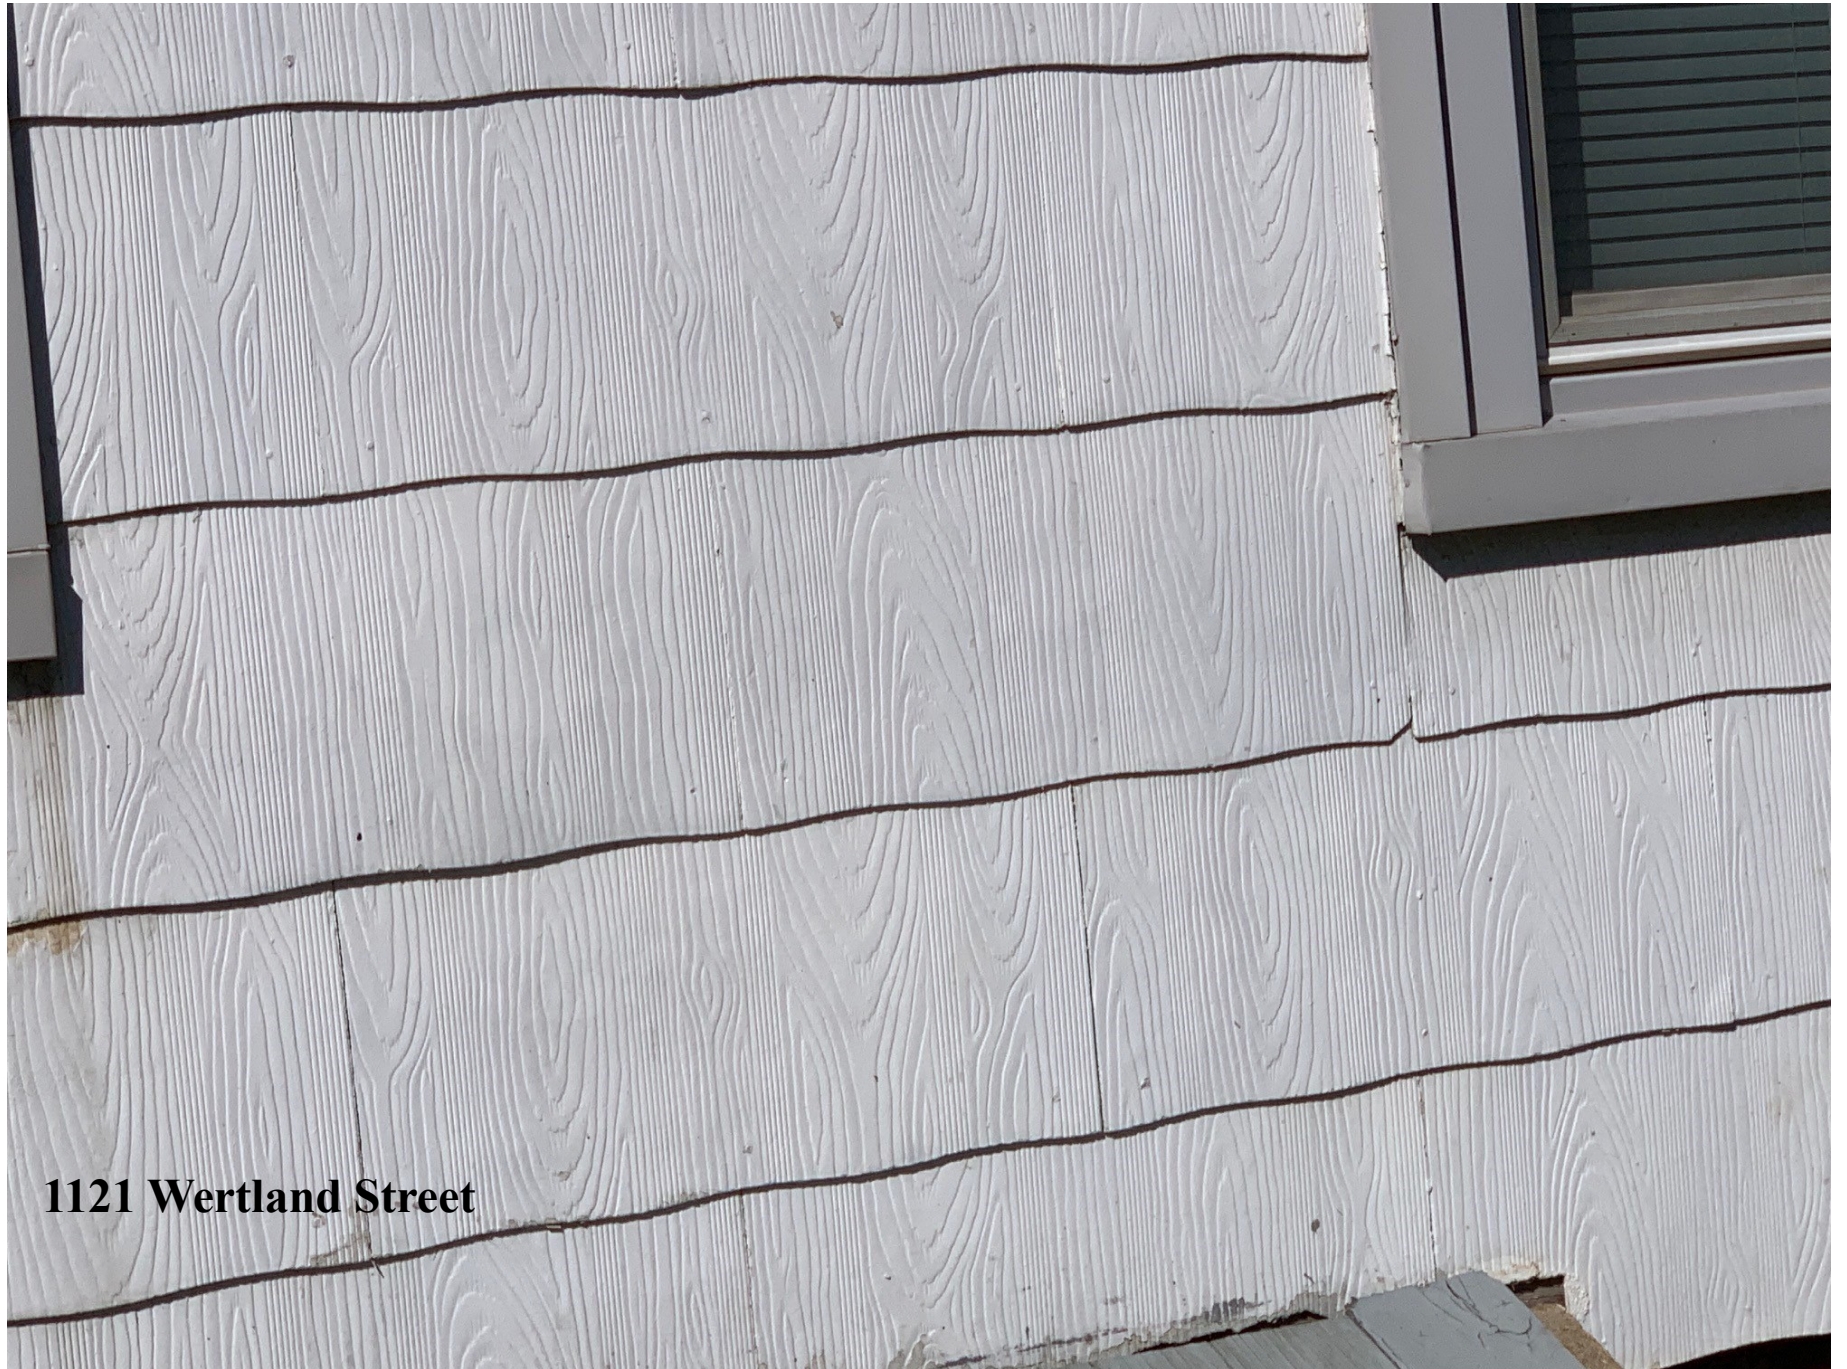
1121 Wertland Street

1121 Wertland Street: Remove the asbestos siding, then repair/replace the presumably wood siding underneath. Remove aluminum on windows, repair/replace trim and sills. Repair/replace any missing or damaged cedar shingles on gable ends. (Soffits and gable trim are not covered with metal.)
