PUBLIC APOLOGY AND STATEMENT

**A RESOLUTION
APPROVING A SETTLEMENT OF
CIRCUIT COURT CASE NO. CL-10-000360-00**

SUMMARY APPRAISAL REPORT

Of
219-221 West Main Street
Charlottesville, Virginia 22902
Our File: C11-05-009

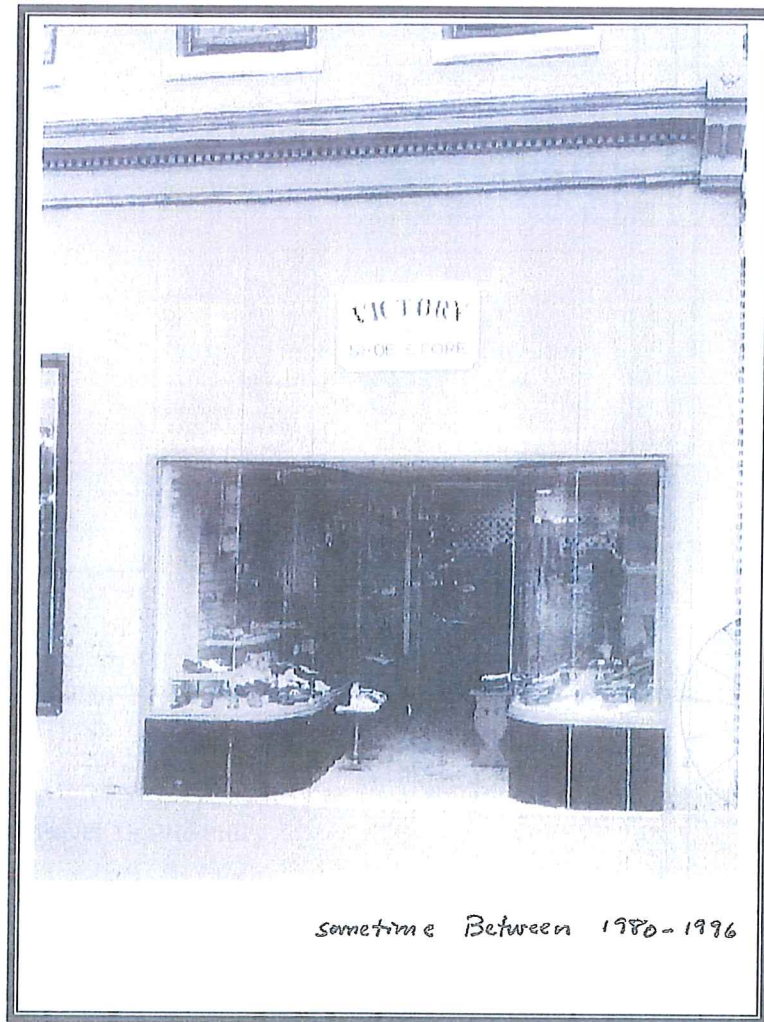
Pre-Construction Photo from Neighborhood Development Office-City of Charlottesville

Façade shows a storefront window design that curves from either end into a covered porch entry. These curved windows act as display areas for retail goods inside the store. Solid wainscot base under the glass shows of some sort of stone panels. No canopy shown in this photo.

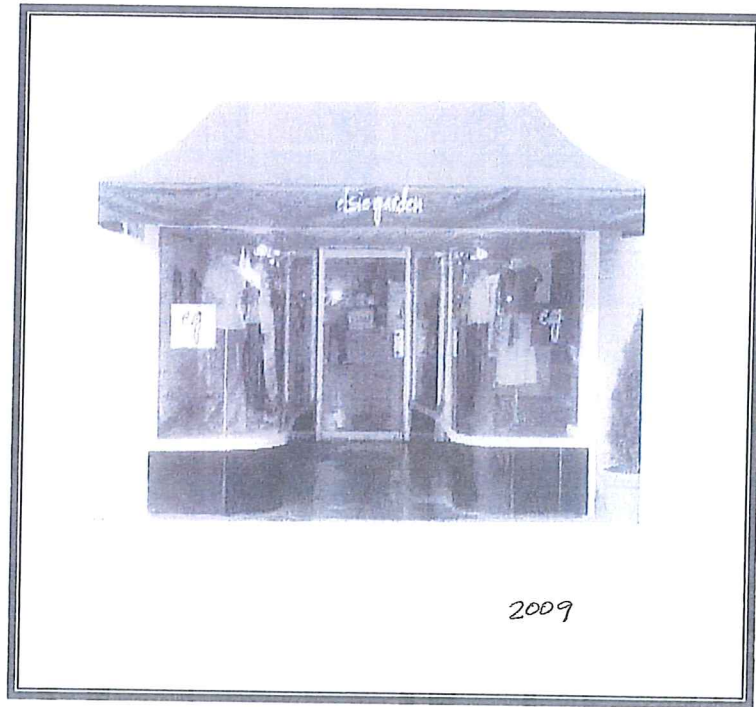
Pre-Construction Photo from Neighborhood Development Office-City of Charlottesville

Storefront shows same curved glass with stone base showing window displays for retail goods. Fabric canopy is fixed over façade entry.

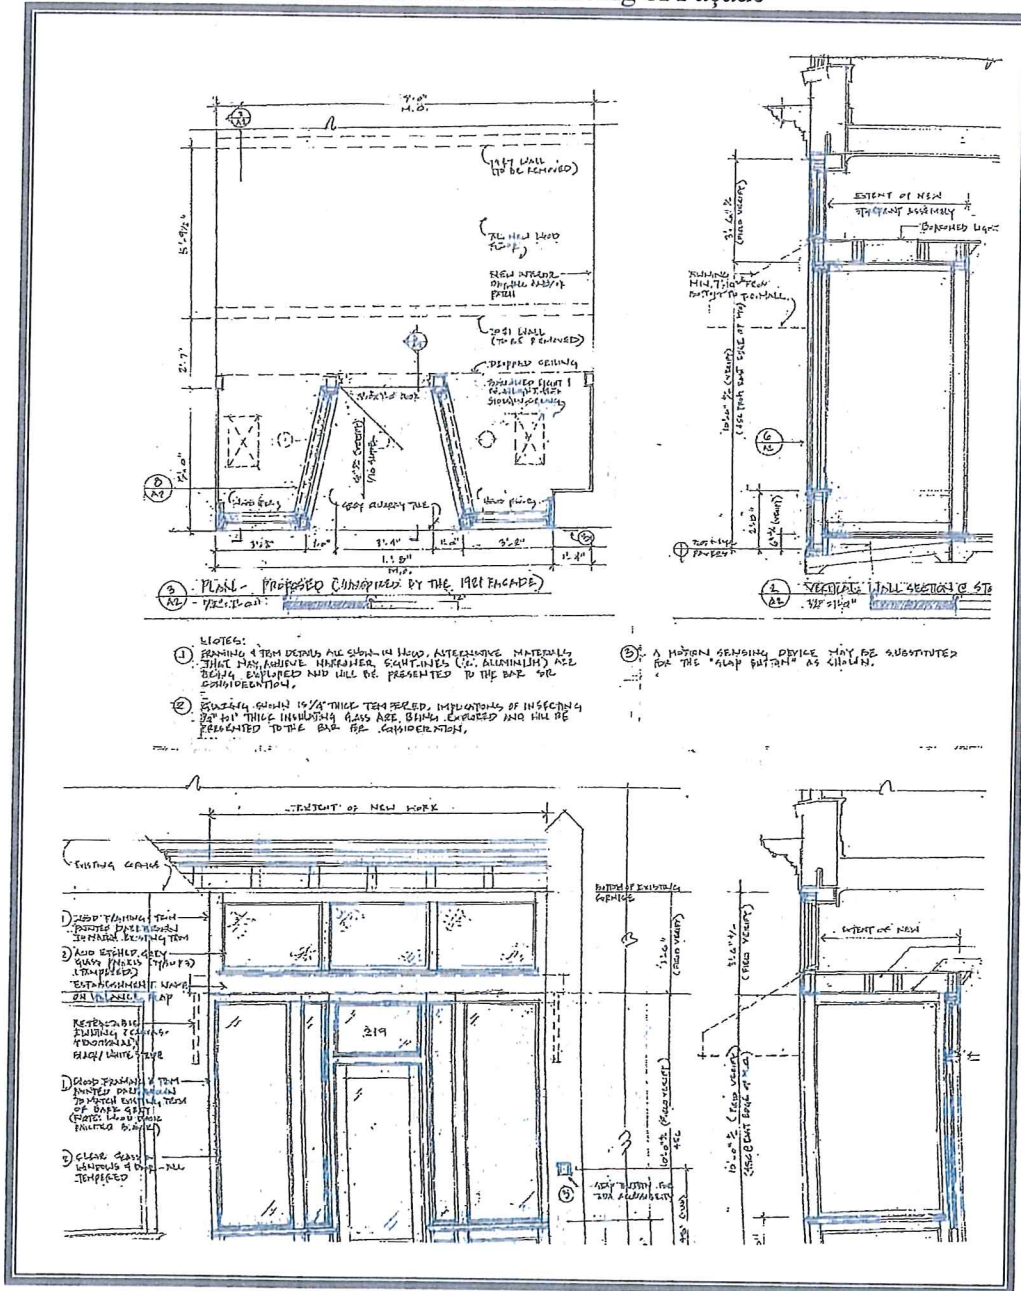
Post-Construction Drawing of Façade

New façade added overhead fixed transom windows. It maintained a storefront glass entry with a smaller covered porch area not as deep as the previous façade. The previous window displays were altered to add more floor space vs. built-up display platforms. This added approximately 37 square

feet of inside space totaling 150 square feet vs. 113 square feet from before. Covered porch area is now about 22 square feet.

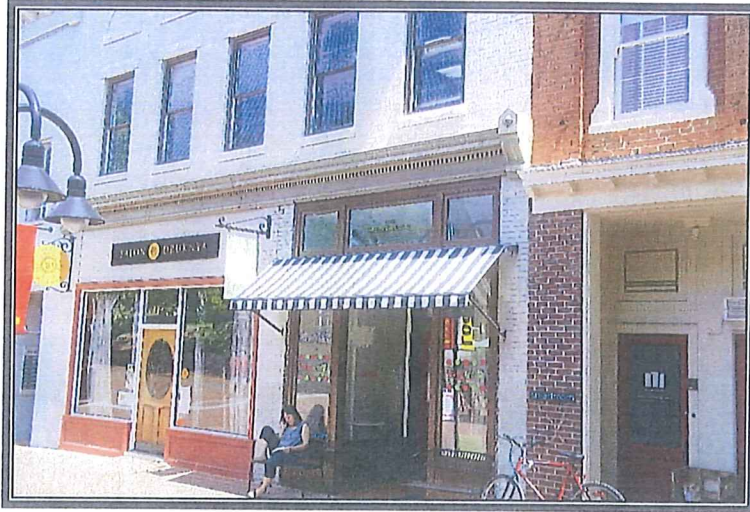
Post-Construction Photo from property viewing

Façade shows a storefront window design that is angled with wainscot base used from wood materials and wood framing. There is a fixed transom window above also framed in wood. Fabric canopy changed.

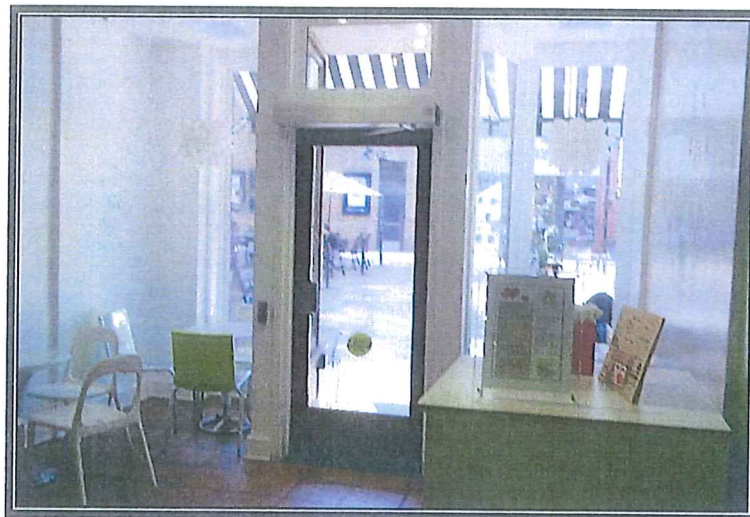
Post-Construction Photo from property viewing

Built-up display platforms were replaced with ceramic tile floors for added floor space. There is a fixed transom over the entry door that leads to the interior retail space. To do this, the subfloor was reworked and the reinforcing concrete was added. Actual costs were not obtained, however, the owner informed with the added concrete work, that the overall cost to perform the change was over \$100,000.
