**Certificate of Appropriateness Application**

BAR 15-08-02

1413 ½ University Ave.

## Chancellor Building Window Replacement

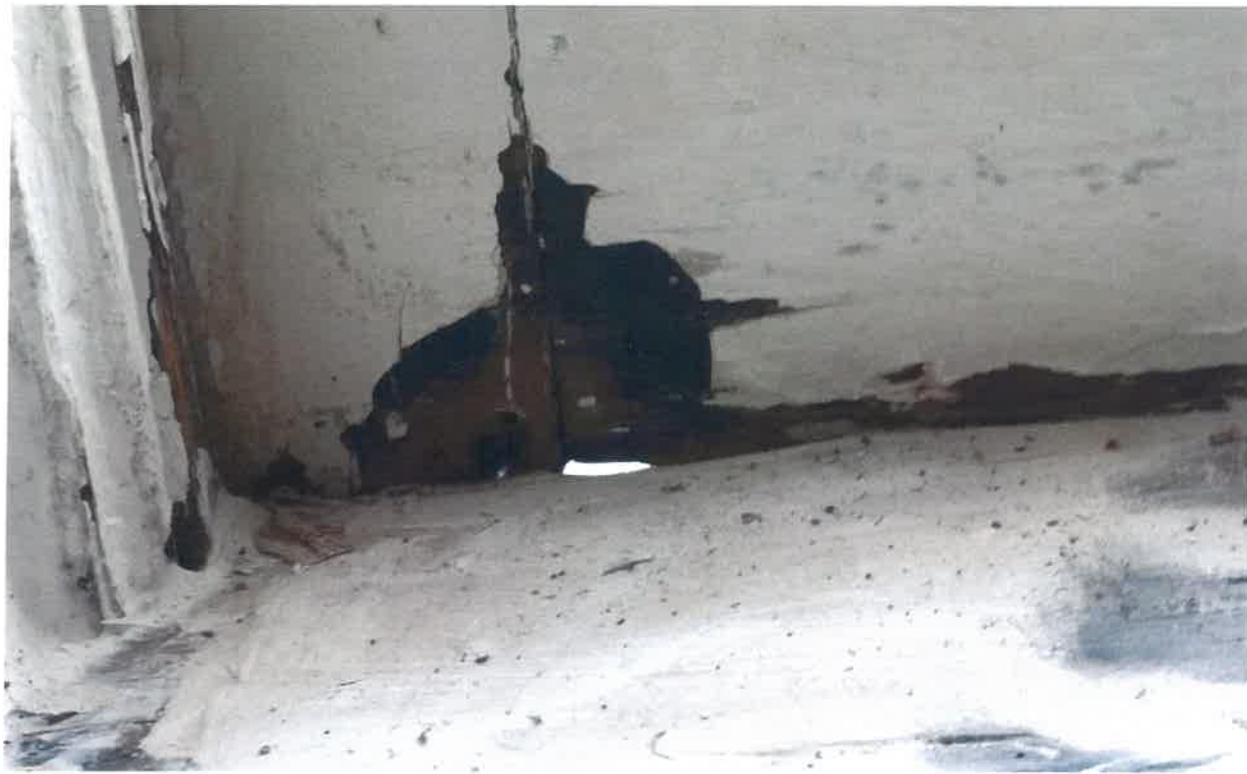
Poor condition of sash and stool.

I hope the pictures of the existing condition of the windows will provide sufficient argument for replacement – rottted sashes, broken sash cords, etc.... Of course, the owner is interested in energy-savings benefits as well.

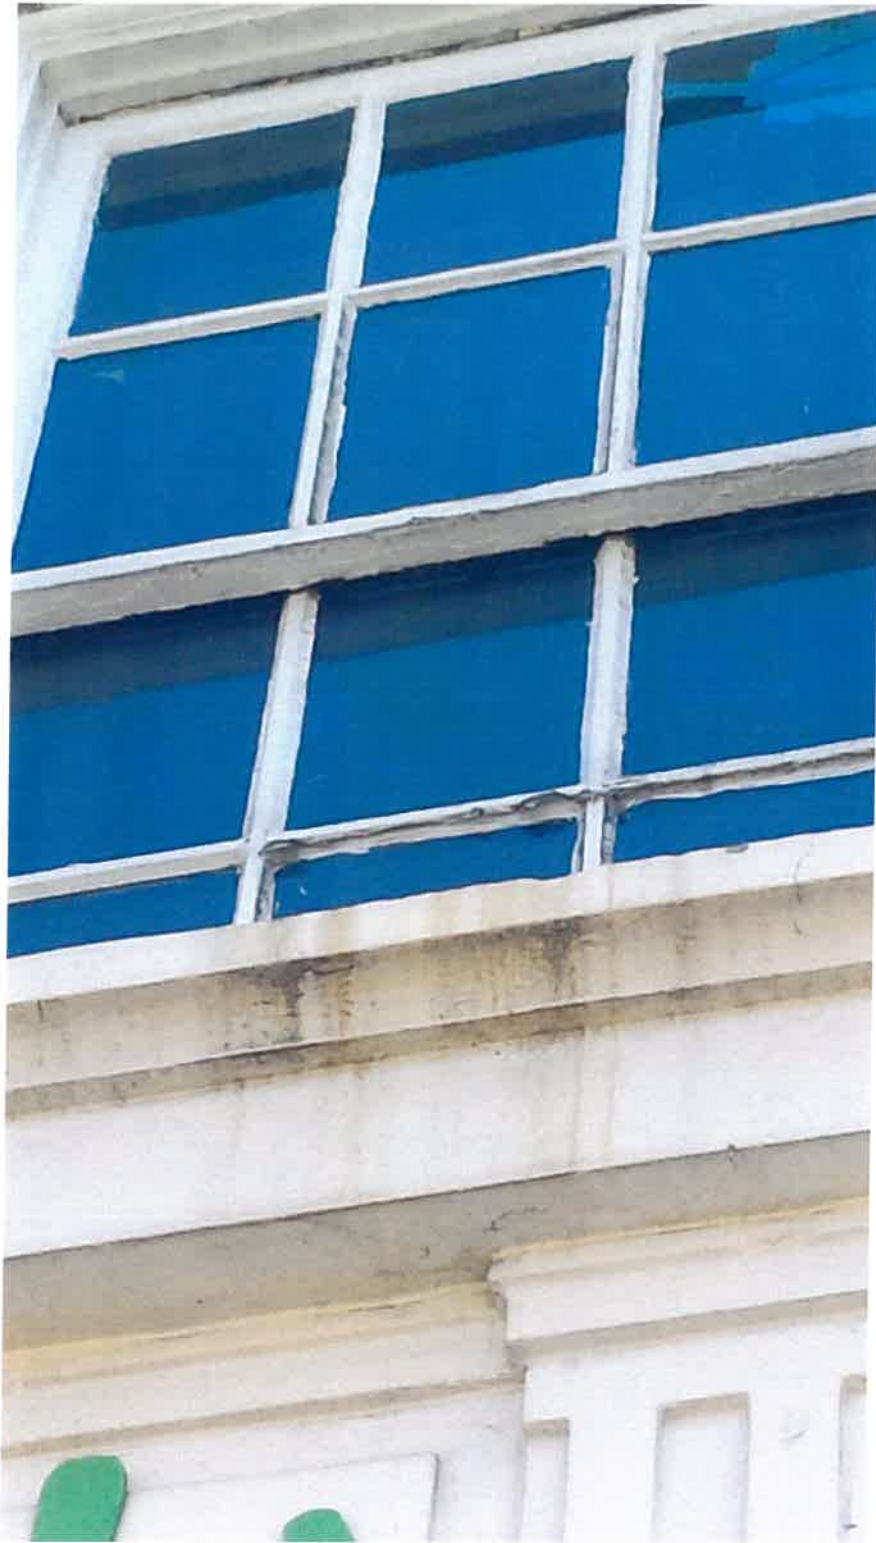
Disrepair of exterior glazing

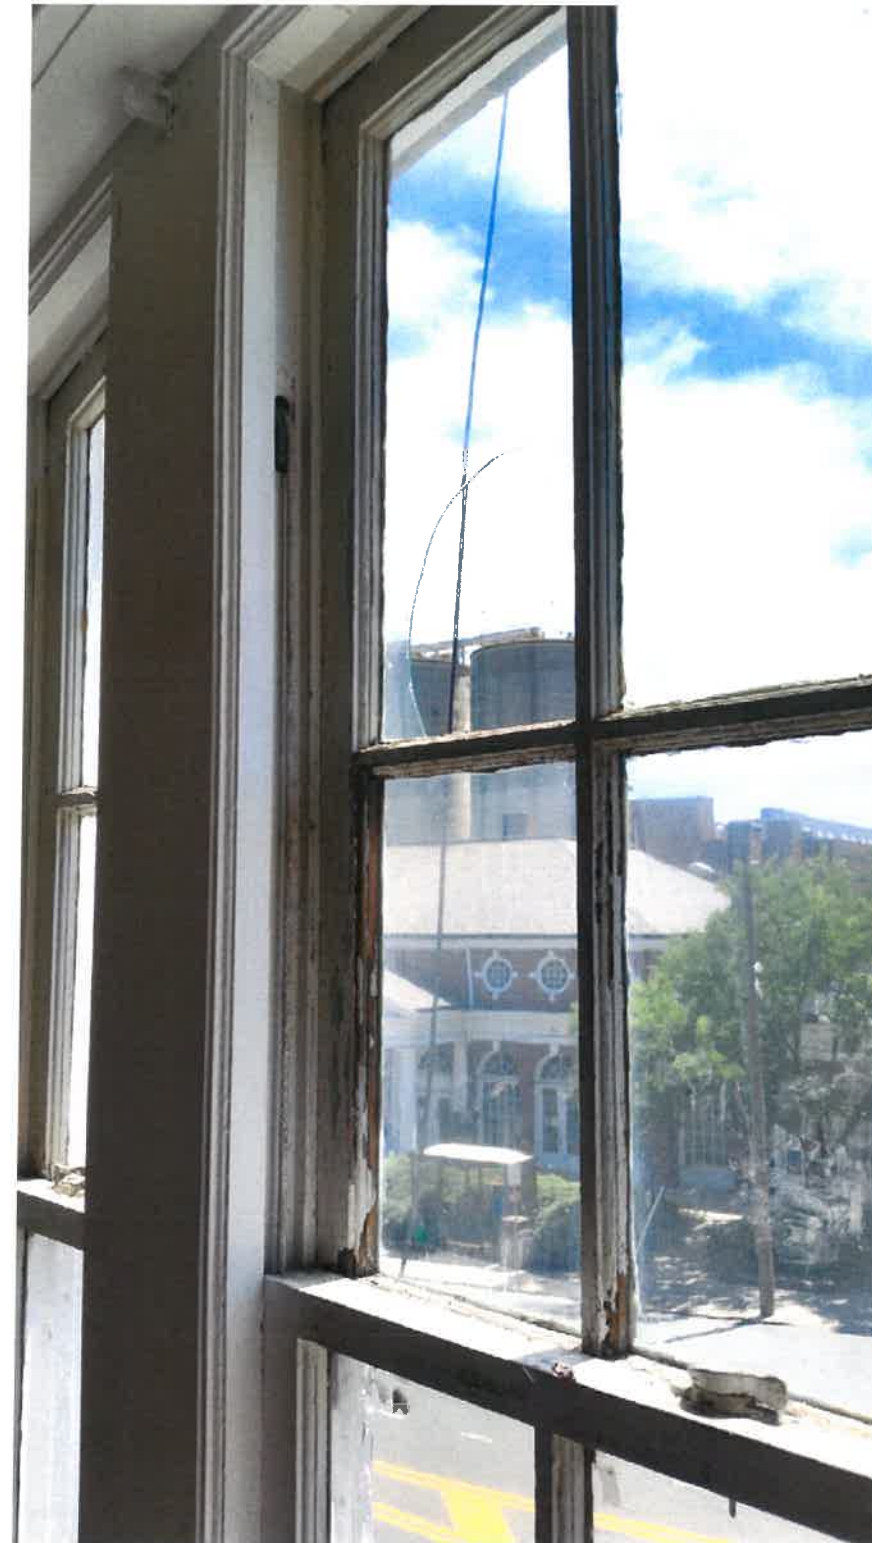
Sash cords are missing at most windows

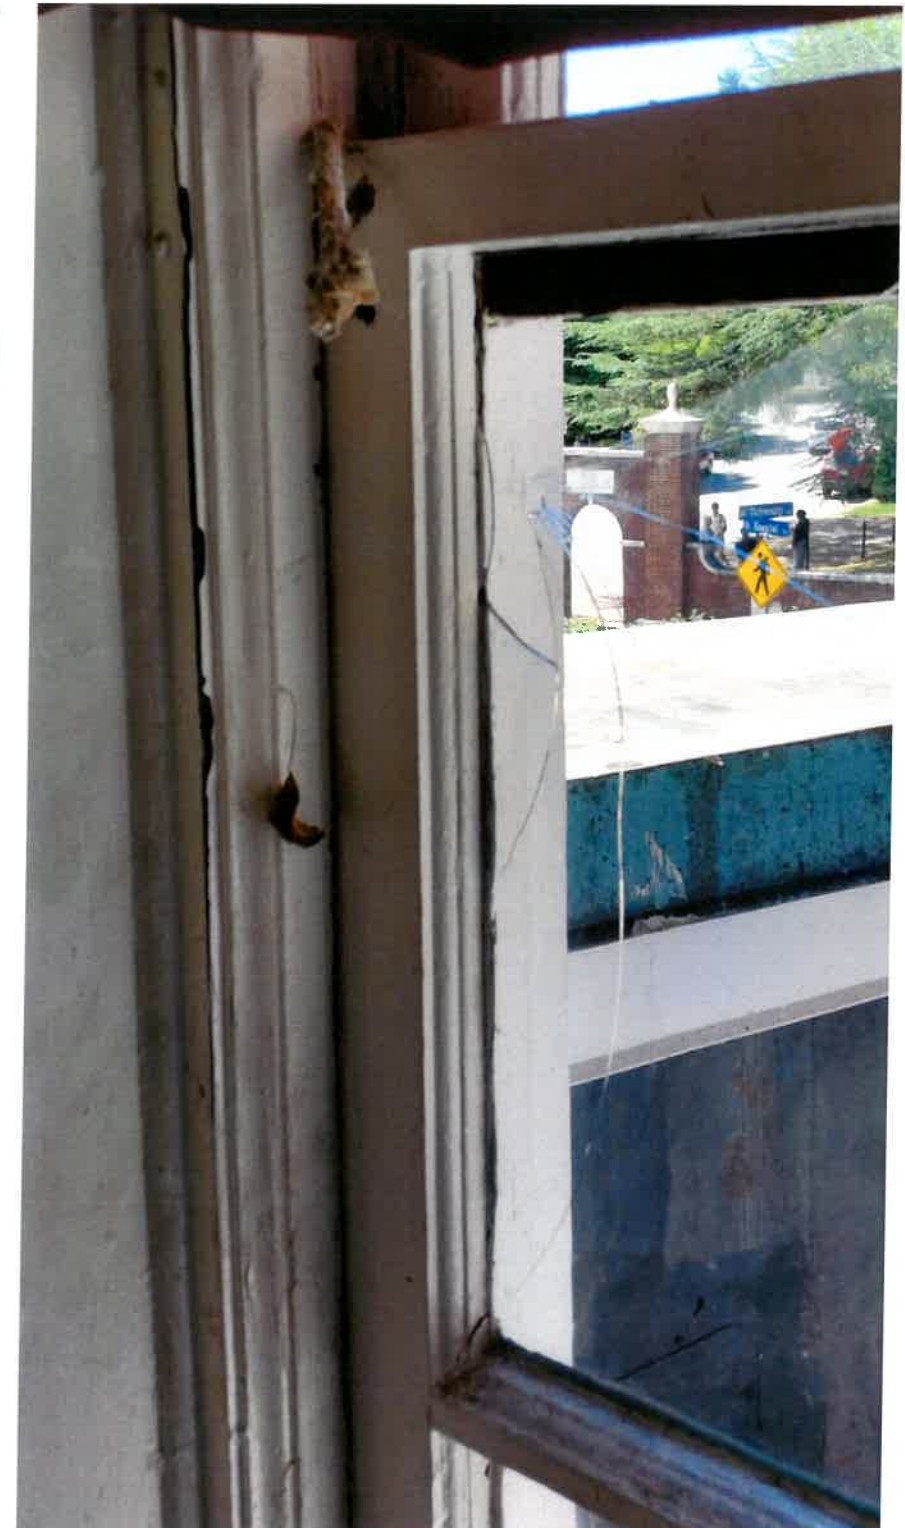
Many sashes are screwed together

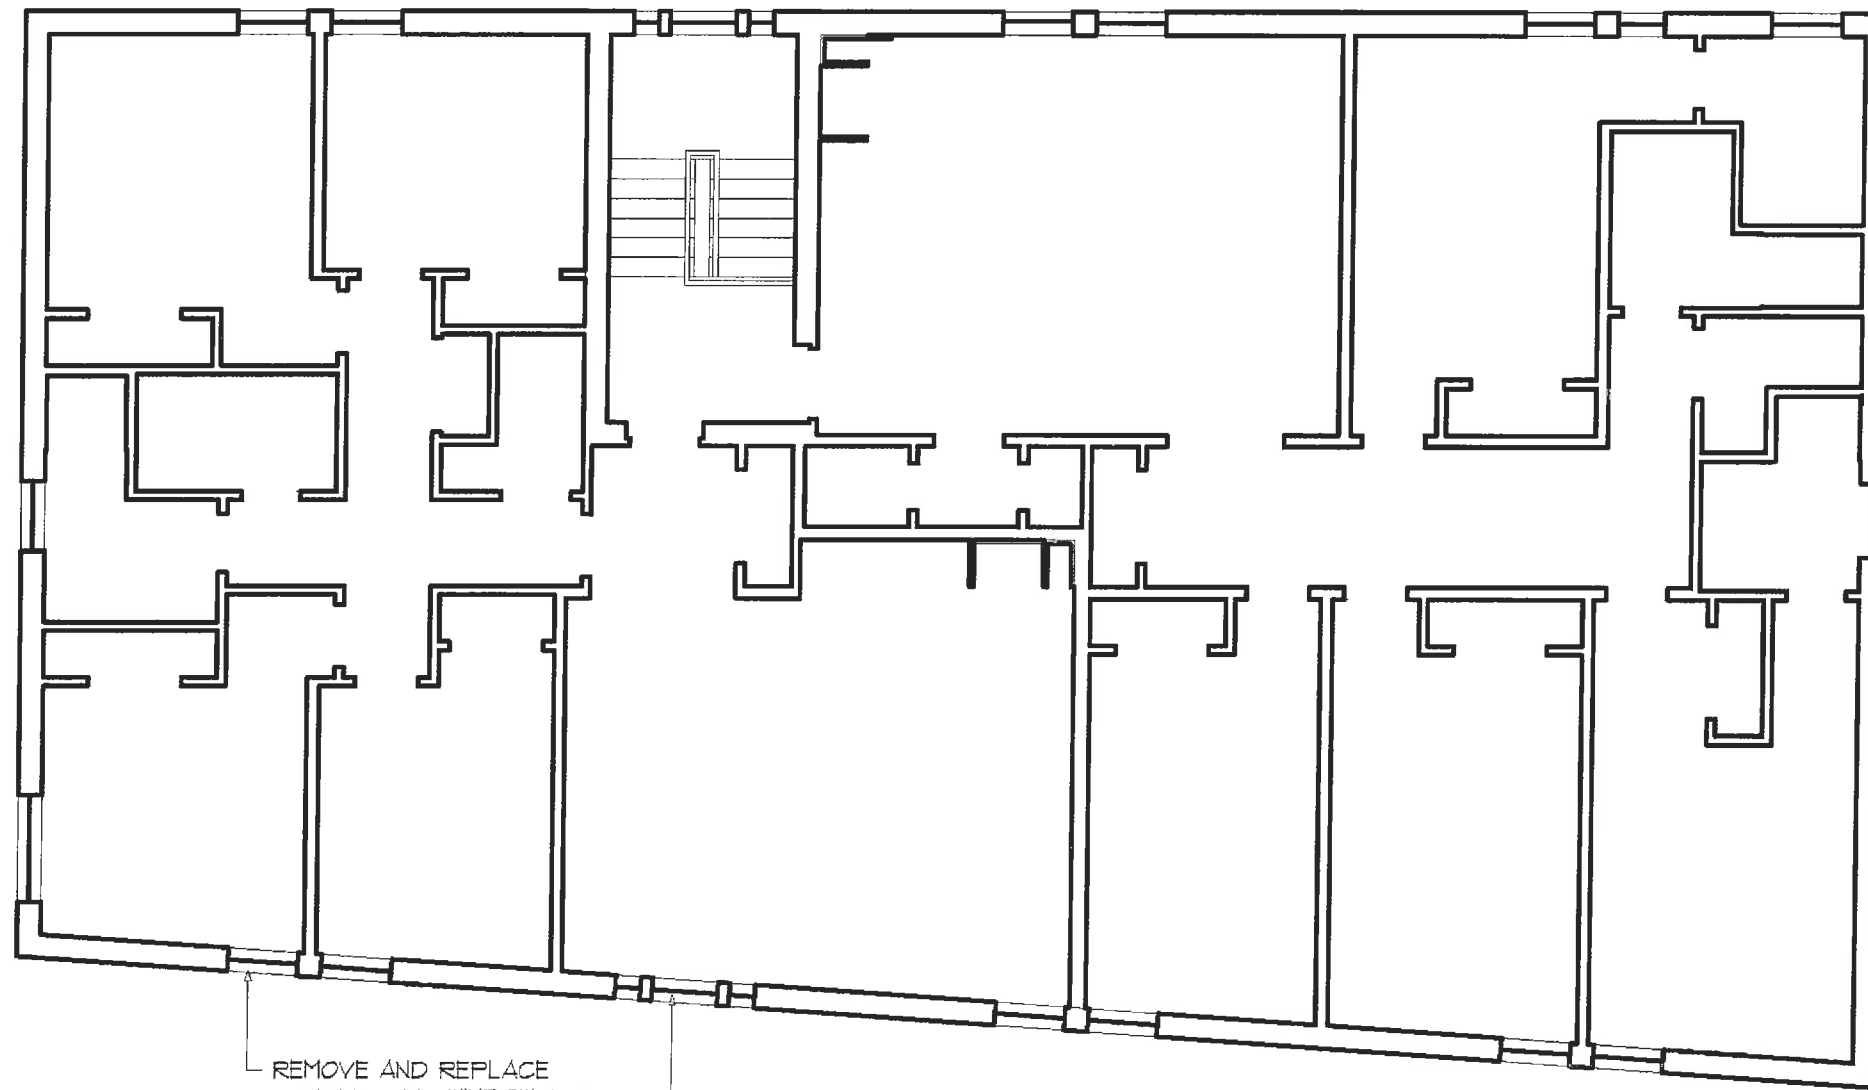
NEW FLOOR PLAN - SECOND STORY OF CHANCELLOR BUILDING

REMOVE AND REPLACE  
DOUBLE-HUNG WINDOW, TYP.

All of the second story windows will be replaced. The pictures include all of the windows, at least in part, in the submittal. (The building exterior is difficult to photograph due to the adjacent buildings). I provided a note on the second floor plan to remove and replace double-hung windows, typ. All of the second floor windows are double-hung windows.

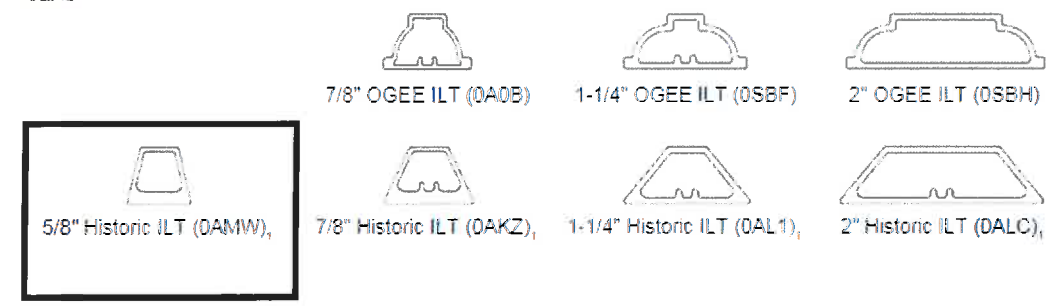
Proposed Pella Details for simulated putty-glazed mullions.

\* - Full elevations and section details will be generated from Pella field measurements.

Pella is noted as the supplier on the front sheet. Typical Pella details are provided on the last sheet. Clear glass is intended.
