VIRGINIA
HISTORIC LANDMARKS COMMISSION

SURVEY FORM

Historic name County/Town/City <u>Albermarle/Charlottesville</u> Street address or route number <u>16 Elliewood Ave.</u>	Common name
USGS Quad <u>Charlottesville West, Va</u> Original owner Original use Present owner Present owner address Present use <u>restaurant</u> Acreage	Date or period <u>1945</u> Architect/builder/craftsmen Source of name Source of date Stories <u>2 stories</u> Foundation and wall const'n Roof type <u>hip roof</u>

DEPARTMENT OF HISTORIC RESOURCE
RECONNAISSANCE SURVEY FORM

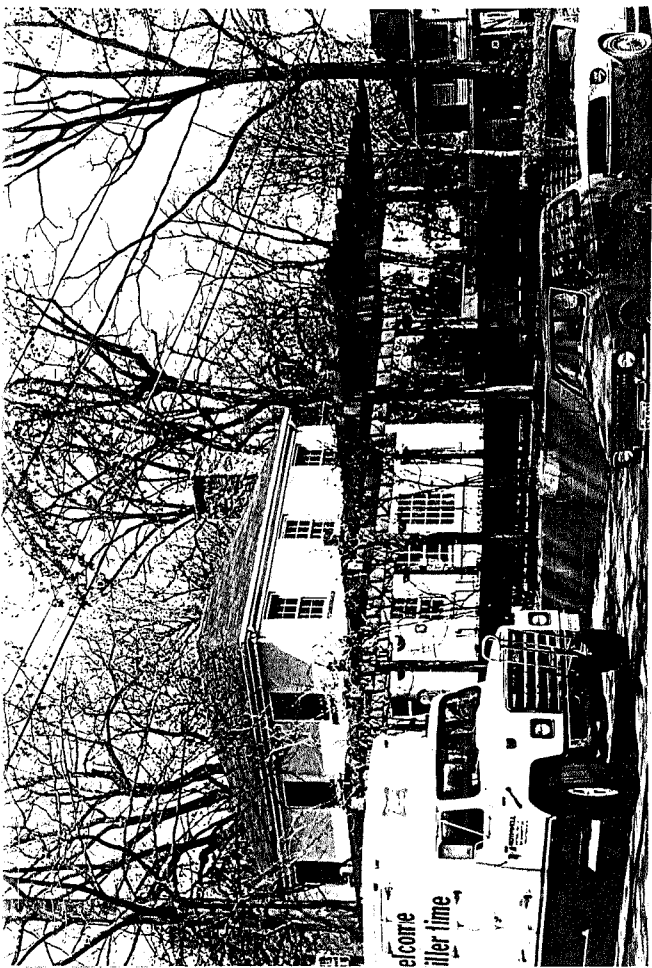
Location and description of entrance Entrance (modern) is on the south side.

Because of its basically Georgian form, this cinder-block house blends reasonably well with the older buildings on the street. Moreover, it stands well back from the street in a large shaded yard. The pergola was built in 1981 to serve outdoor diners.

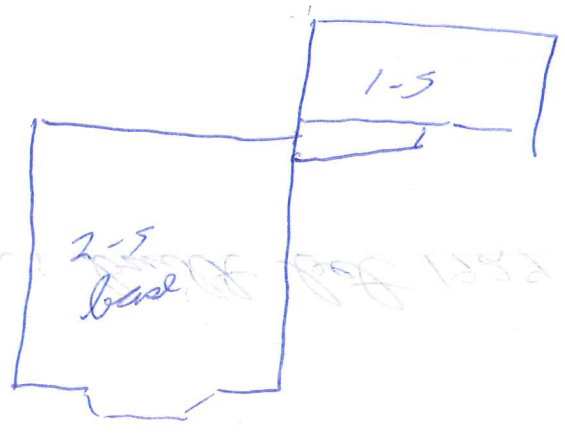
Bruce House

c. 1947

Sanborn: built bet 1929 & 1957

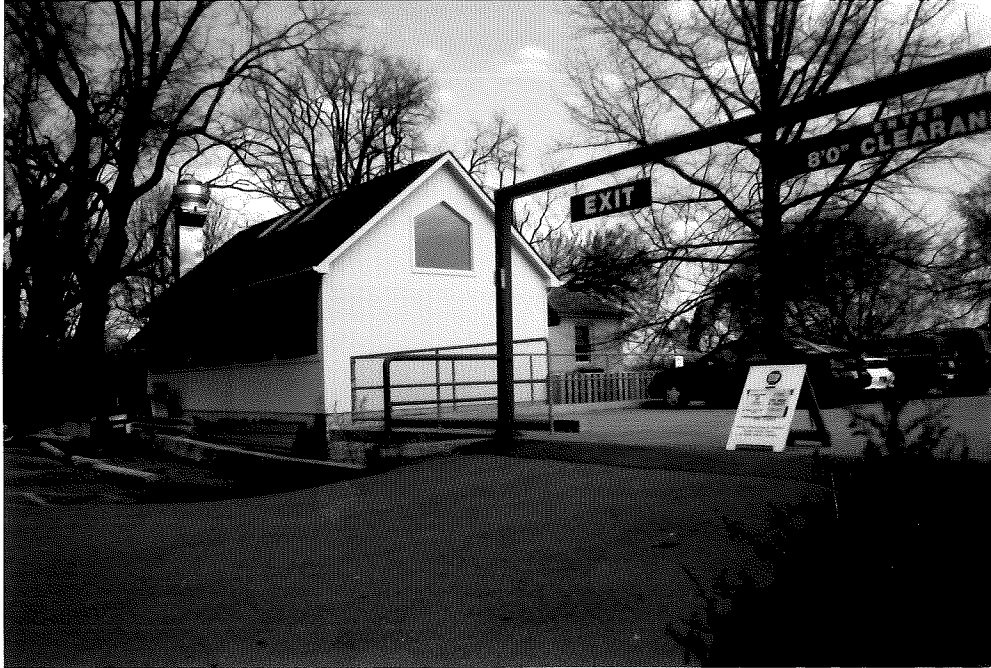
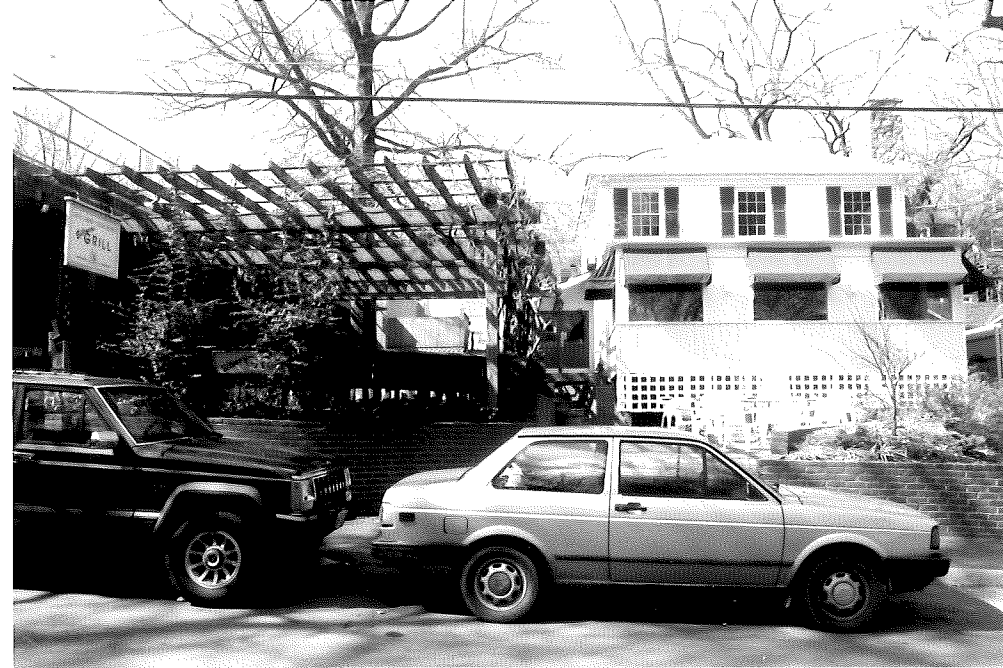
Name Biltmore Grill, 16 Elliewood Ave.

Four-square form with Colonial Revival features, building has three-bay front facade with full-width, enclosed front porch topped by hipped roof and fitted with plate glass windows shaded with canvas awnings. Inoperable blinds flank six-over-six, double-hung sash windows at the second floor. Large exterior side chimney of stone rises at the northeast side of the building.

Contents 3 exterior views
