# VIRGINIA HISTORIC LANDMARKS COMMISSION

## SURVEY FORM

Historic name County/Town/City <u>Albermarle / Charlottesville</u> Street address or route number <u>5 Elliewood Ave</u>	Common name  
USGS Quad <u>Charlottesville West, Va</u> Original owner Original use Present owner Present owner address  Present use <u>Commercial</u> Acreage	Date or period <u>1920</u> Architect/builder/craftsmen  Source of name Source of date Stories <u>1 story</u> Foundation and wall const'n  Roof type <u>flat roof</u>

DEPARTMENT OF HISTORIC RESOURCE  
RECONNAISSANCE SURVEY FORM

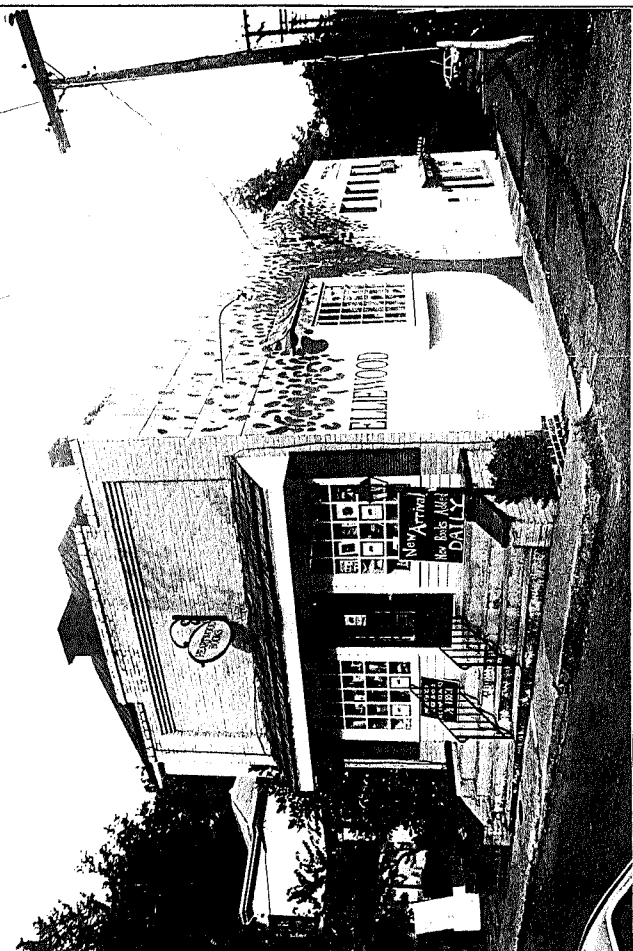
Location and description of entrance **Storefront has apparently been altered in recent years.**

This long, narrow building contains a shop at basement level as well (the India Gift Shop), as the land slopes and the basement can be entered at grade at the E end of the building.

The parapet front remains unaltered. The bay window on the S side is probably modern.

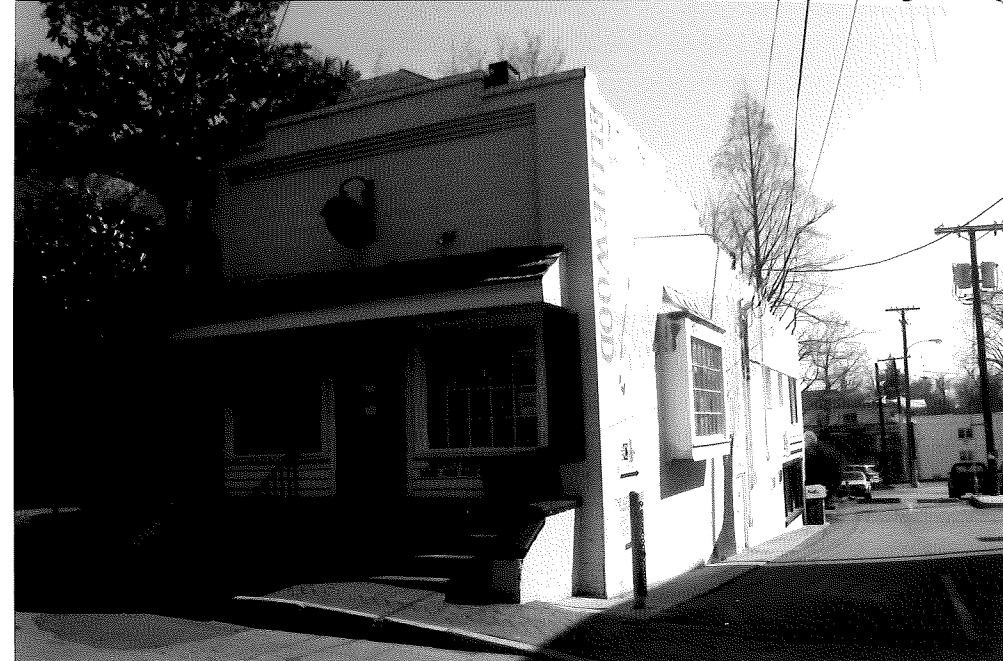
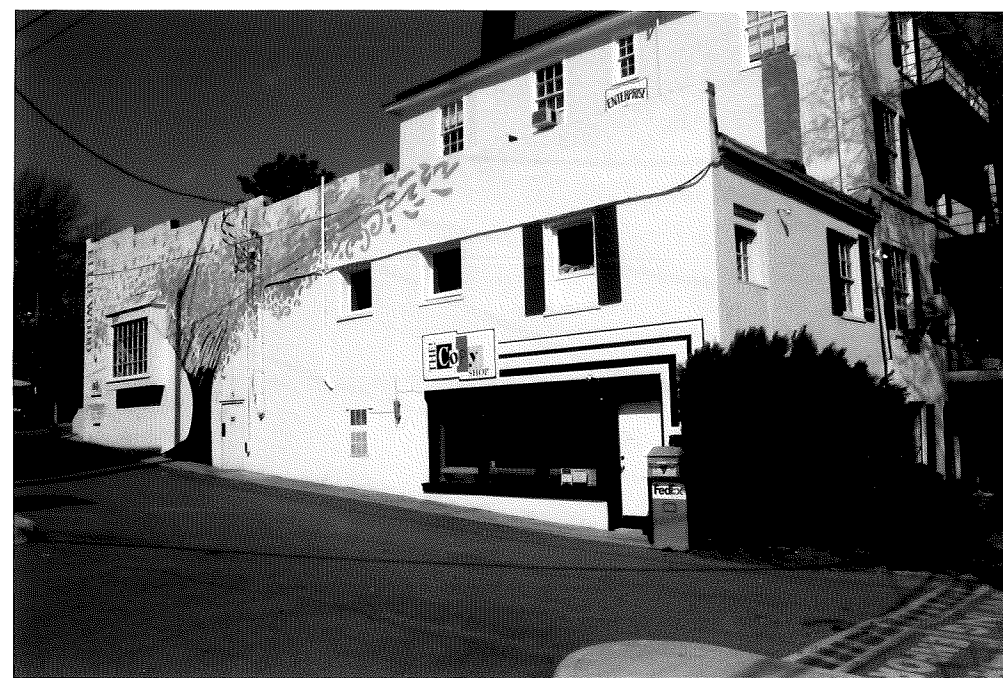
Contents 2 exterior views

Commercial building fronted by three-bay facade, with central entrance flanked by large, multi-light display windows fitted with inoperable blinds. Facade clad with weatherboard below windows; full-width stoop of brick and concrete sheltered by a wood-shingled pent roof; entrance has multi-light wooden door. Upper half of front facade is brick with stepped cornice and cap at top of wall, which has raised center section. Southwest side wall, covered with stucco and decorated with a painted mural of a tree, steps down; has shallow wooden bay window fitted with multi-light fenestration; and modern four-part store front (three plate glass windows and entrance) at rear of wall serve The Copy Shop in lower level of building. Three second-floor windows on side wall contain plate glass; windows in rear wall are double-hung six-over-six sash. A brick flue rises from the rear of the building.

This building may have originally been a stucco dwelling, built on the site between 1907 and 1913, enlarged and remodelled in the 1920s to serve commercial purposes (Sanborn 1907, 1913, 1920). Its modifications do not allow it to contribute to the historic district; however, the upper section of the front facade remains unaltered from the 1920s, and the multi-light shop windows are mid-twentieth-century Colonial Revival.
