RECONNAISSANCE LEVEL SURVEY REPORT

DEPARTMENT OF HISTORIC RESOURCE
RECONNAISSANCE SURVEY FORM

DHR Identification Number: 104-5072

Cook Row Rental House (103 Linden Street)

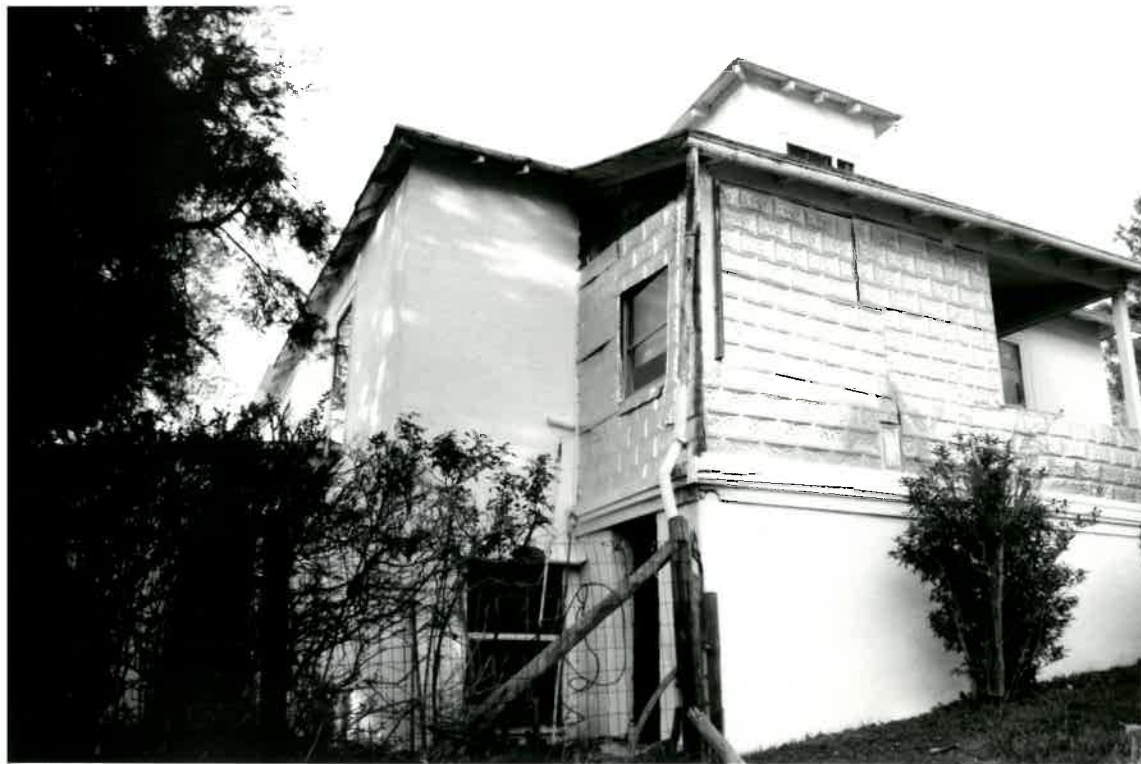
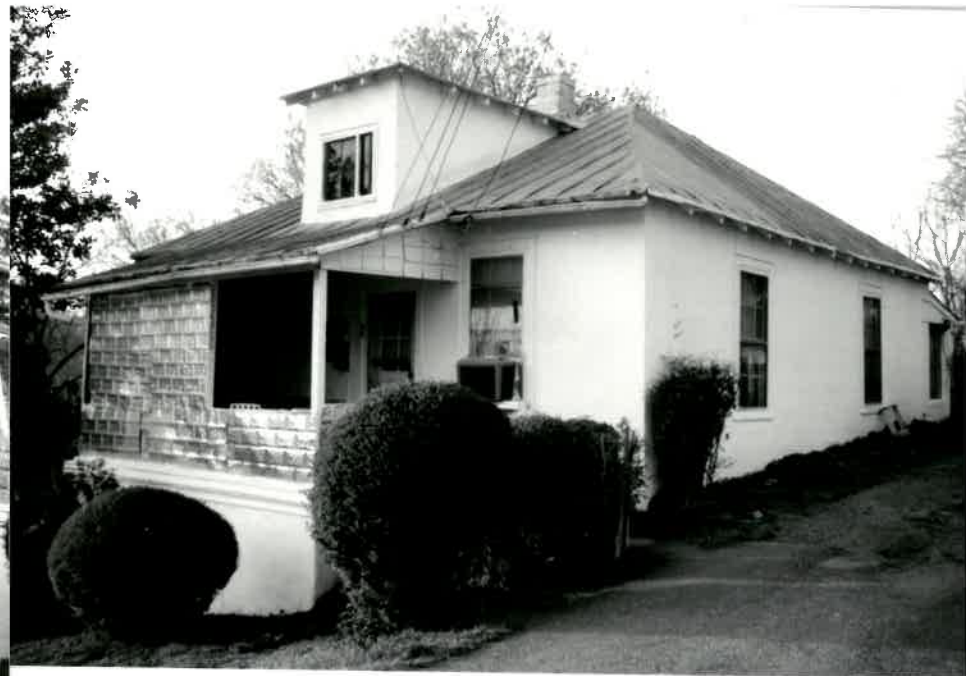
Negative no. 15673

Date 4.1997 File No. ⁵⁰⁷² 104-~~5072~~112
Name Cook ~~Addition~~ Rental House (103 Linden St.)
Town Row
City Charlottesville
County _____
Photographer Leslie A Giles
Contents 2 exteriors of house
