Street address 128 Madison Lane
Town/City Charlottesville
Historic name St. Peter's Hall Common name Phi Gamma Delta Fraternity House

1. Name of property: Phi Gamma Delta Fraternity House
Address of property: 128 Madison Lane
City Charlottesville County N/A State VA Zip Code 22903
Name of historic district: Rugby Road-University Corner Historic District

PHI GAMMA DELTA FRATERNITY HOUSE
128 Madison Lane

DEPARTMENT OF HISTORIC RESOURCE
RECONNAISSANCE SURVEY FORM

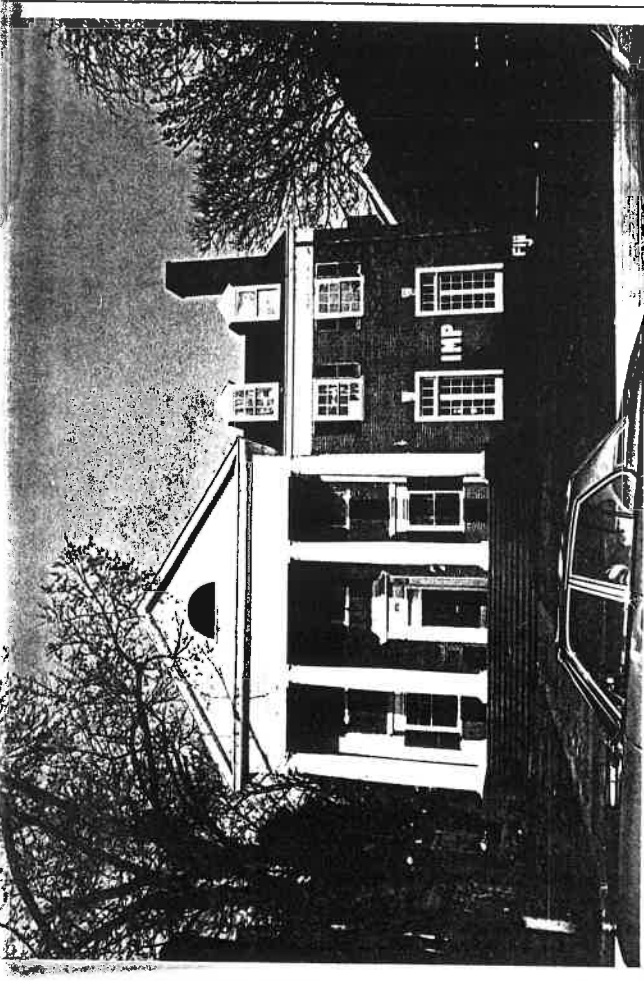
File No. 104-130
Negative no(s). 7230

One of the earliest of the UVA fraternity houses, this building was added to in the 1920s--hence the asymmetrical facade.

The S wing has brickwork of Flemish bond while the original unit has brickwork laid in 6-course American bond.

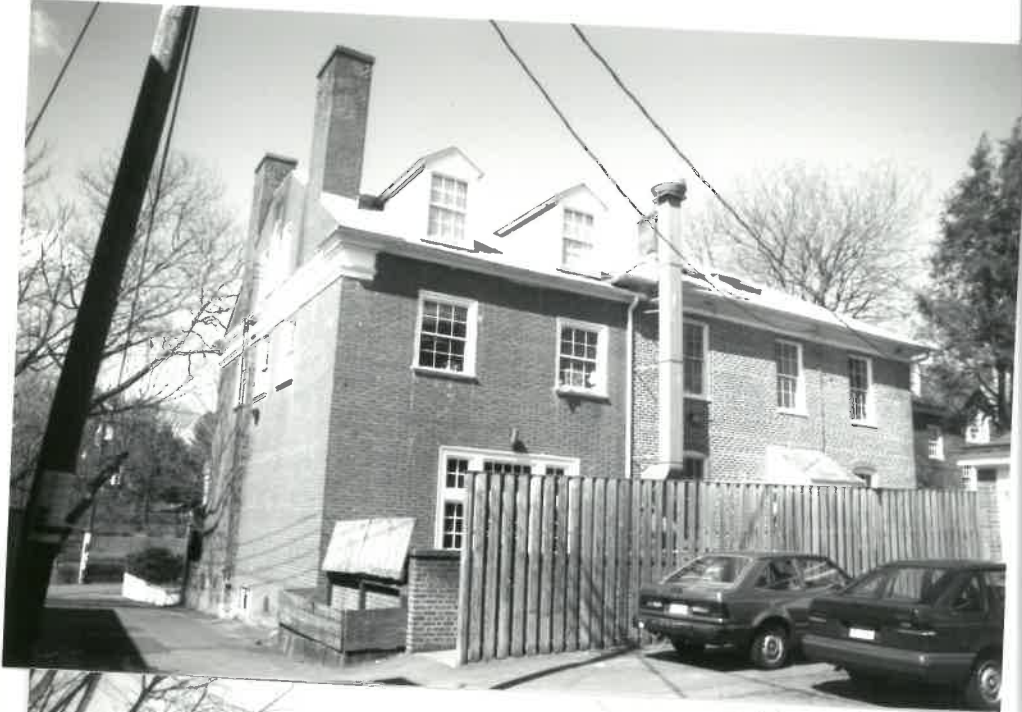
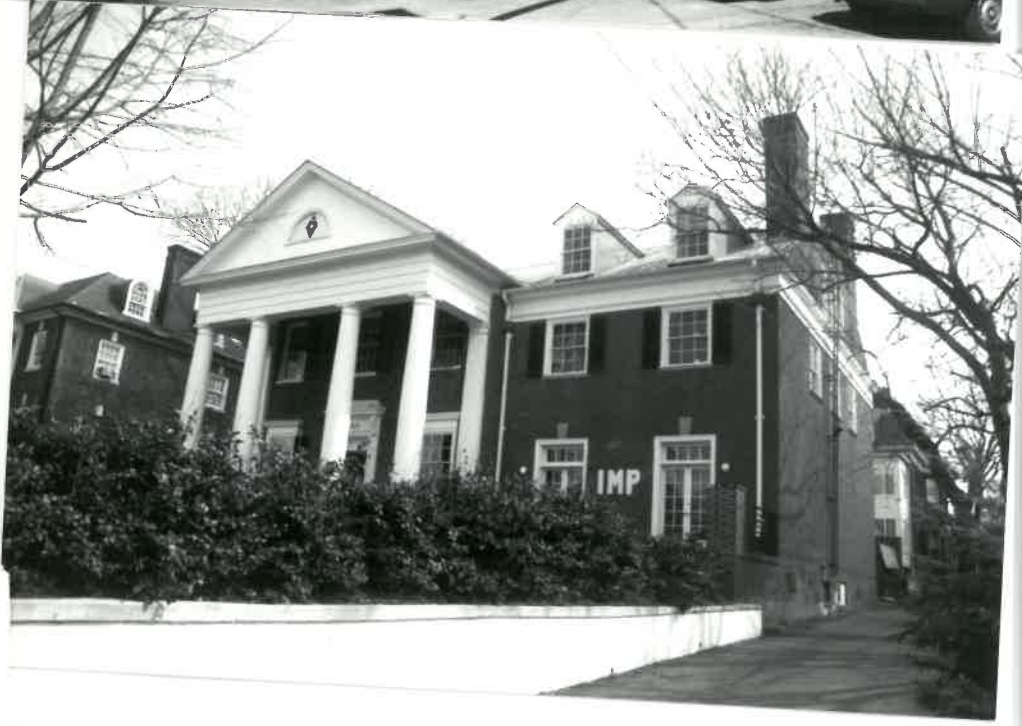
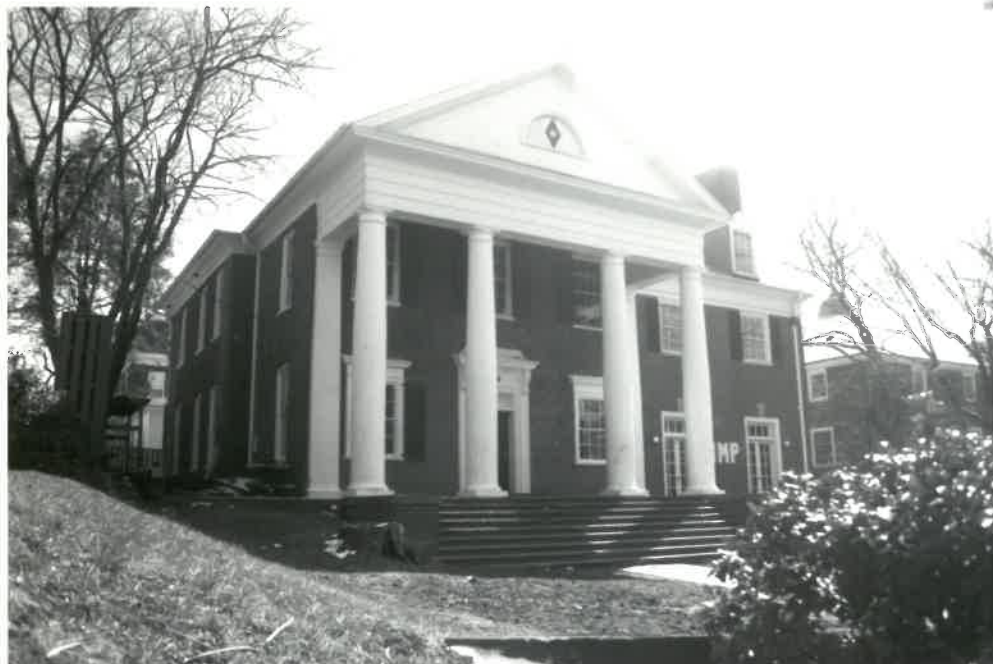
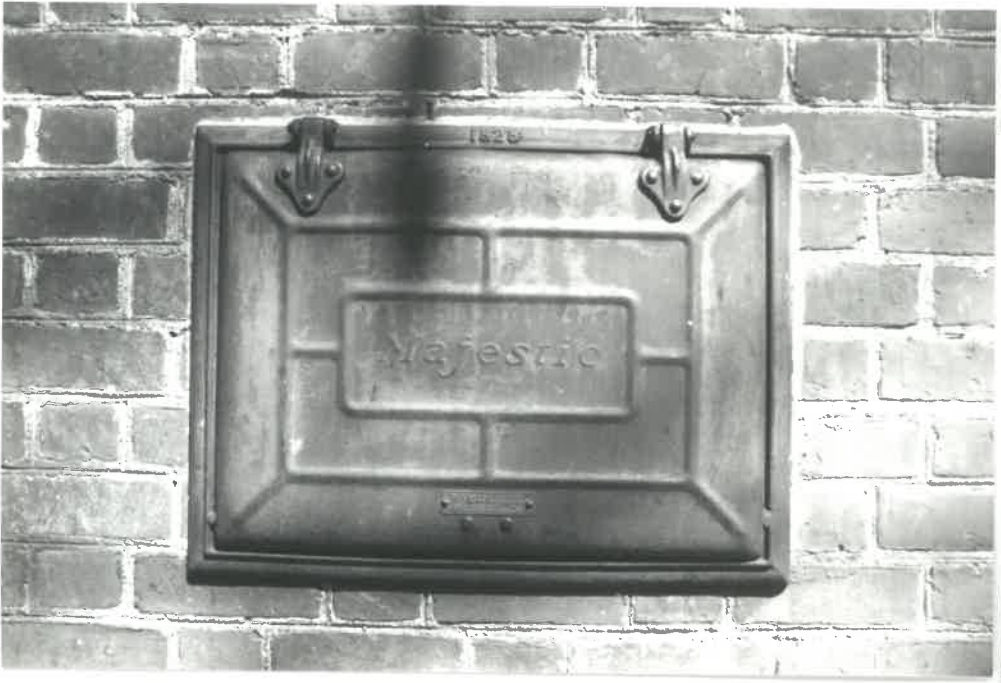
Date 3/9/96
 File No. 104-133-20
 Name St. Peter's Hall / Fig House
128 Madison Lane
 Town Charlottesville
 County _____
 Photographer S.C. Sprad
 Contents Exterior Views

Asymmetrical Classical Revival building with seven-bay front facade; full-height tetrastyle Roman Doric portico, with lunette in its pediment, fronts three bays on northeast end of facade, the original section. Two front and two rear gable-roofed dormers are in newer section, each containing six-over-six double-hung sash window. Original section has hipped roof, and walls in six-course American bond; the addition, in Flemish bond, has a gable roof with flat ridge, and an entablature at cornice level in the gable end. Entrance in center bay of original section has shallow hip-roofed hood on scrolled brackets, and transom over door. The first-floor windows of this section's front facade have simple entablatures; the first floor of the addition has two, two-leaved multi-light windows with multi-light transoms and keystones in the lintels. The entablature of the house and portico is dentillated.
