VIRGINIA HISTORIC LANDMARKS COMMISSION

SURVEY FORM

Street address **130 Madison Lane**
 Town/City **Charlottesville**
 Historic name **St. Elmo's Hall** Common name **Delta Phi Fraternity House**

1. Name of property: Saint Elmo Hall

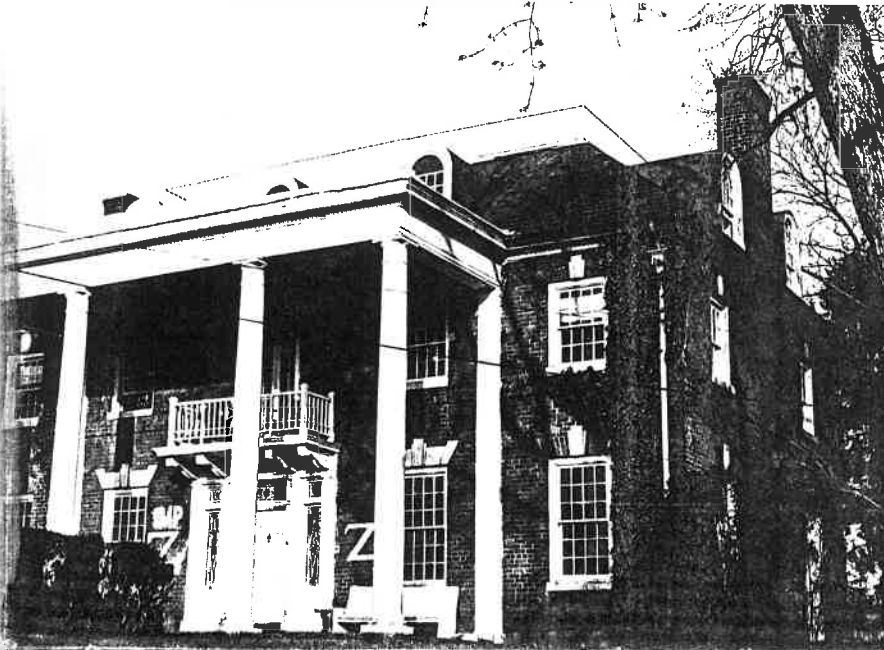
Date 4-83 File No. 104-130Name 130 Madison Lane

130: brick (7 course common bond) on low cement foundation; 2 1/2 stories; truncated hip roof with iron balastade and 3 semi-circular dormers; 5 bay; 2 story, 3 bay portico with 4 attenuated unfluted Tuscan columns and 2 reflective pilasters. Colonial Revival. c. 1915. gutter cornice with "wall of Troy" dentils, brick belt course. tripartite entrance in center bay with 4 attenuated, fluted engaged columns supporting balcony on consoles, etched glass transom and side-lights, balcony has 12 light double-door and iron railing. upper windows - 8 over 8 light sash with stone sills, end bays have jack arches with large stone keys, 1st floor windows - 12 over 12 light, end bays have buck jack arches with stone keys, middle bays have stone jack arches with large stone keys and end blocks. 2 interior end chimneys.

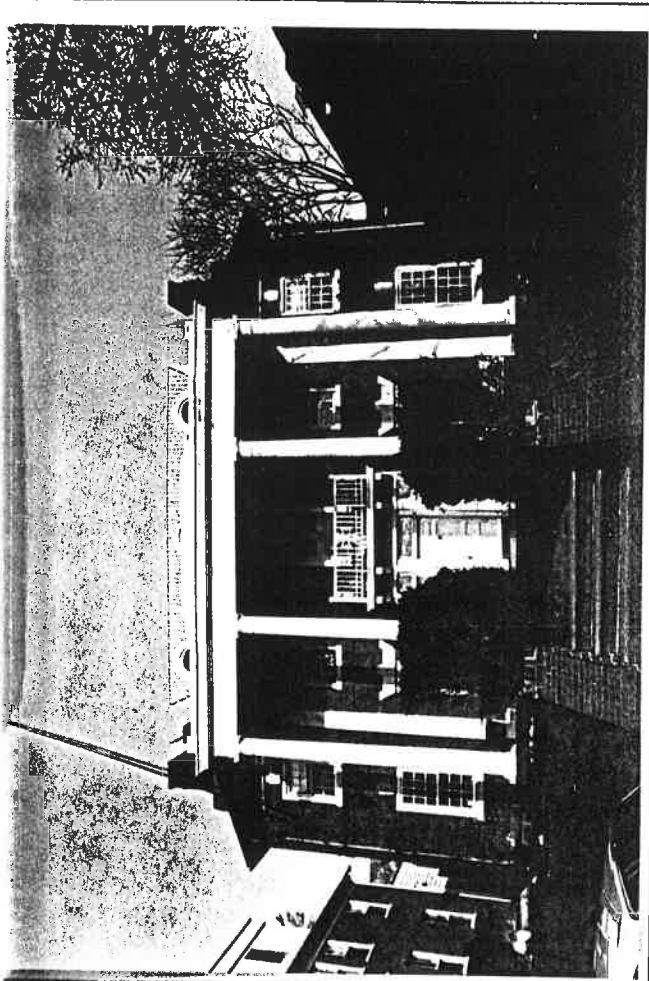
Porch	Stories	Bays	General description
<input checked="" type="checkbox"/> yes <input type="checkbox"/> no	<input type="checkbox"/> 1 <input type="checkbox"/> 3 <input checked="" type="checkbox"/> 2 <input type="checkbox"/> _____	<input type="checkbox"/> 1 (center) <input type="checkbox"/> 2 <input type="checkbox"/> 4 <input type="checkbox"/> 1 (side) <input checked="" type="checkbox"/> 3 <input type="checkbox"/> _____	<p>Monumental tetrastyle portico with upper deck.</p>

Location and description of entrance **Large Prominent central entrance with top- and side-lights.**

This house is distinctive because of its tall, flat-roofed portico and round-headed dormers. It remains virgually unaltered on the exterior except for the addition of modern iron railings.

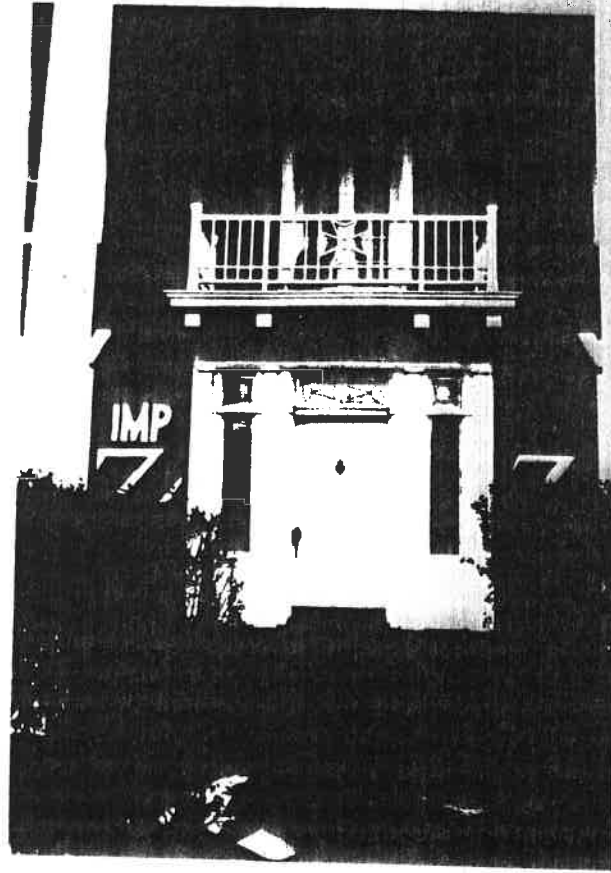
Photo #2

West entrance, looking east from Madison
Lane

The central entrance has leaded sidelights & transoms & there is a second storey balcony supported on consoles above it.

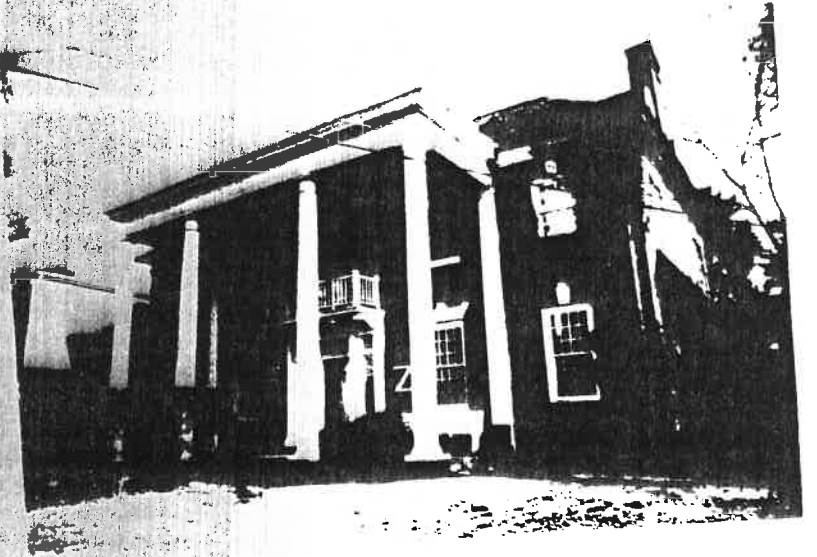
Photo #1

West facade, looking east from Madison
Lane

A 2-story, flat-roofed portico with slender Roman Doric columns covers three bays of the facade.

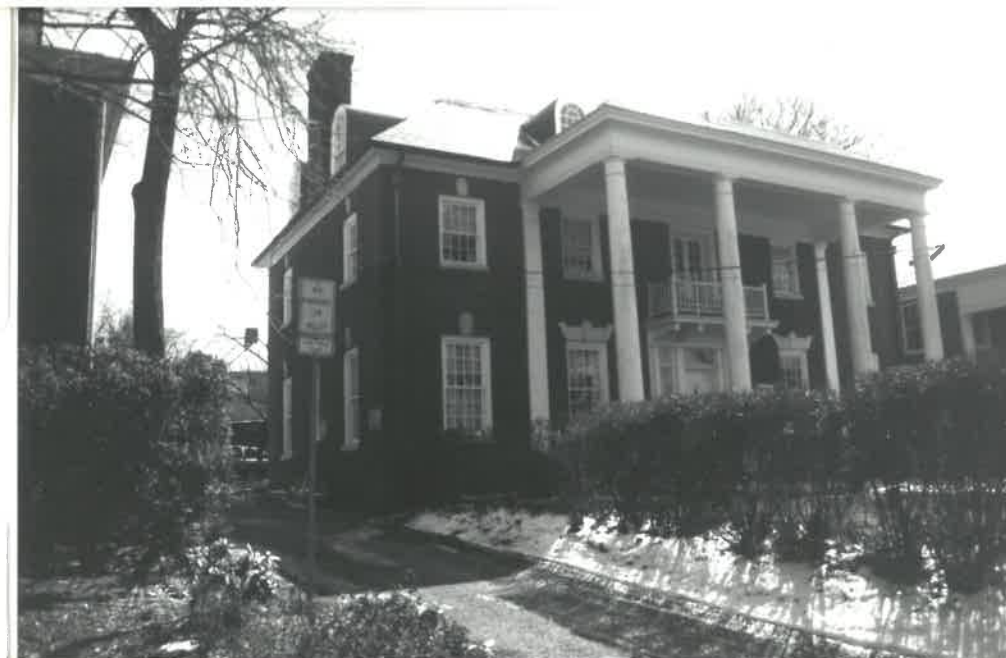
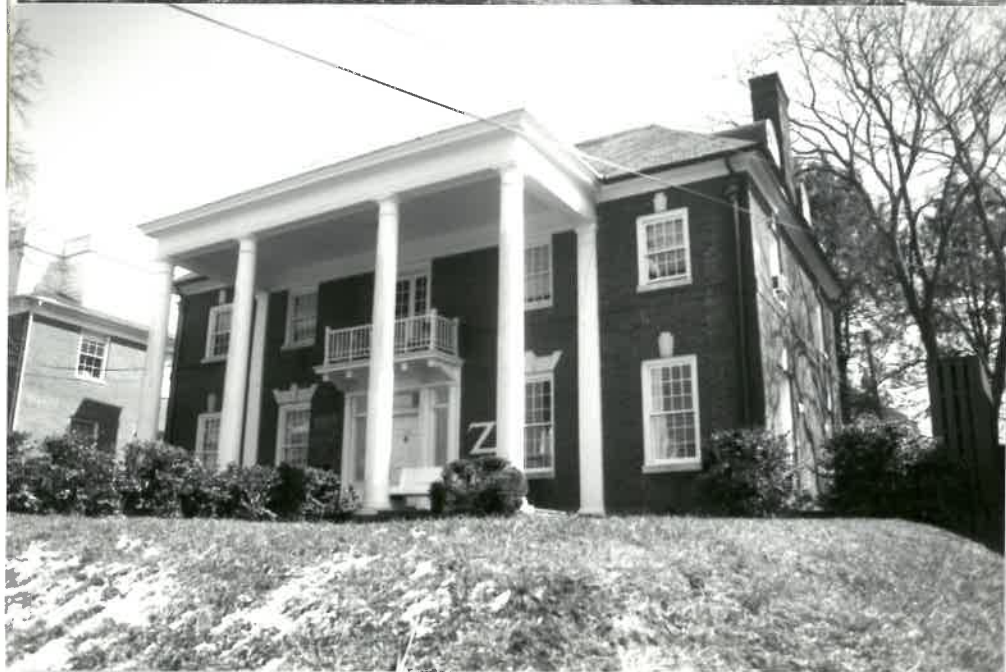
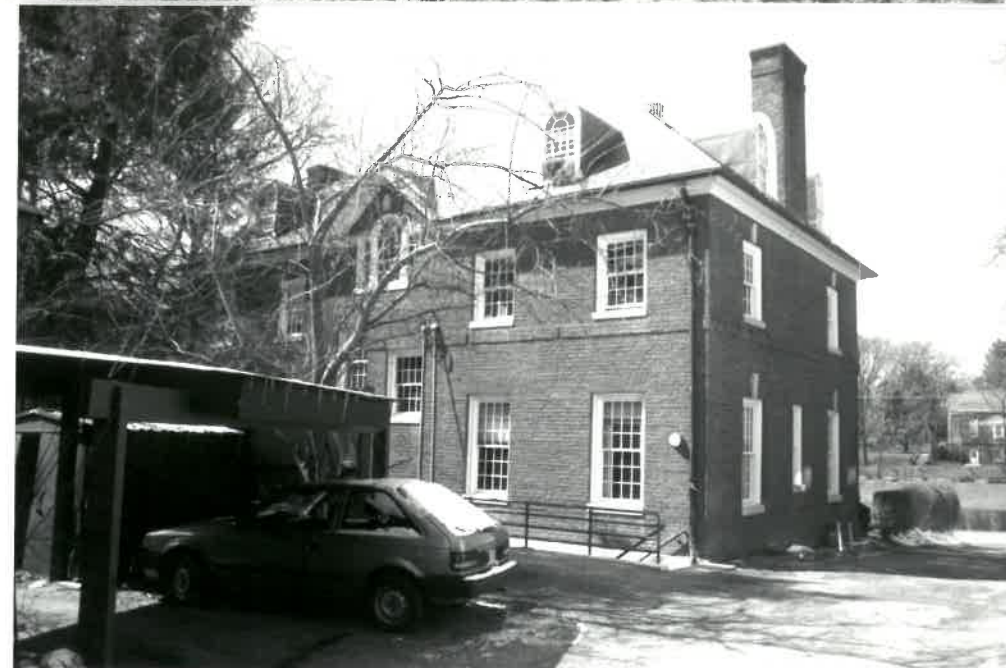
Date 3/9/96 File No. 104-133-19

Contents 3 exterior views
