VIRGINIA HISTORIC LANDMARKS COMMISSION

HISTORIC DISTRICT SURVEY FORM

Street address **135 Madison Lane**
 Town/City **Charlottesville**
 Historic name _____ Common name _____

Style/period **Modern Vernacular** Date **Ca. 1960s** Architect/builder _____

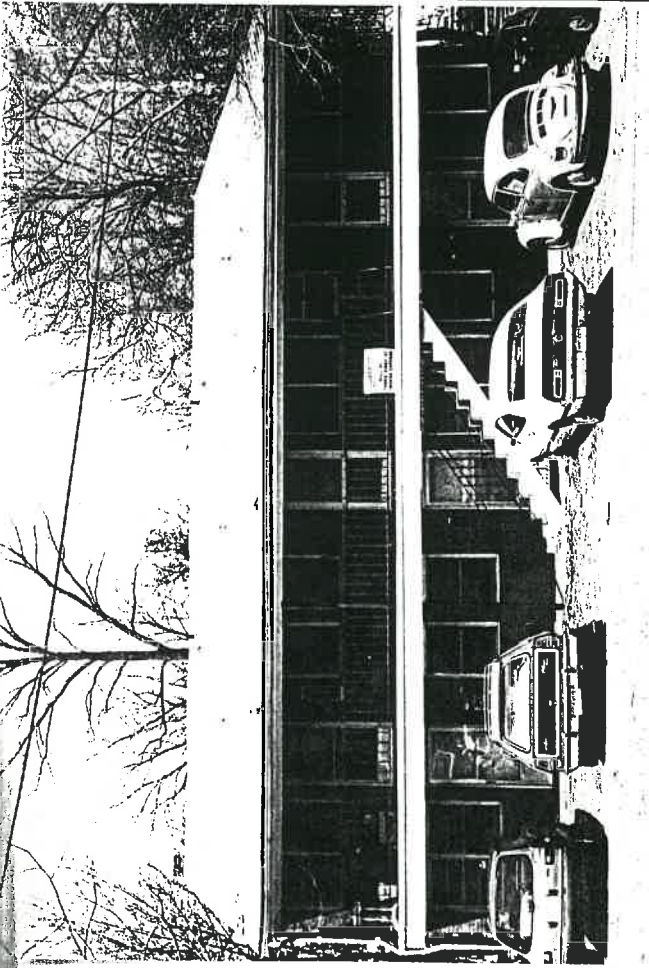
File No. 104-130
Negative no(s). 7234

| Porch | Stories | Bays | General description |
|--|---|---|--|
| | | | Full-length double-tier porch inset under main roof. Provides access to upper apt's. |

Location and description of entrance **Six separate front entrances, all alike**

This motel-like apartment building is located at the north end of Madison Lane, away from the main row of fraternity houses and Madison Bowl.

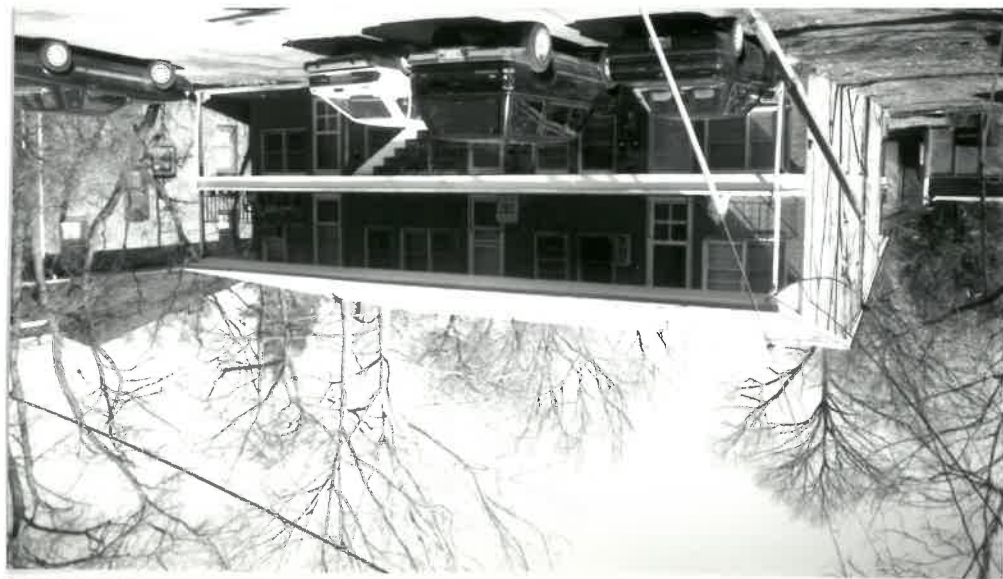
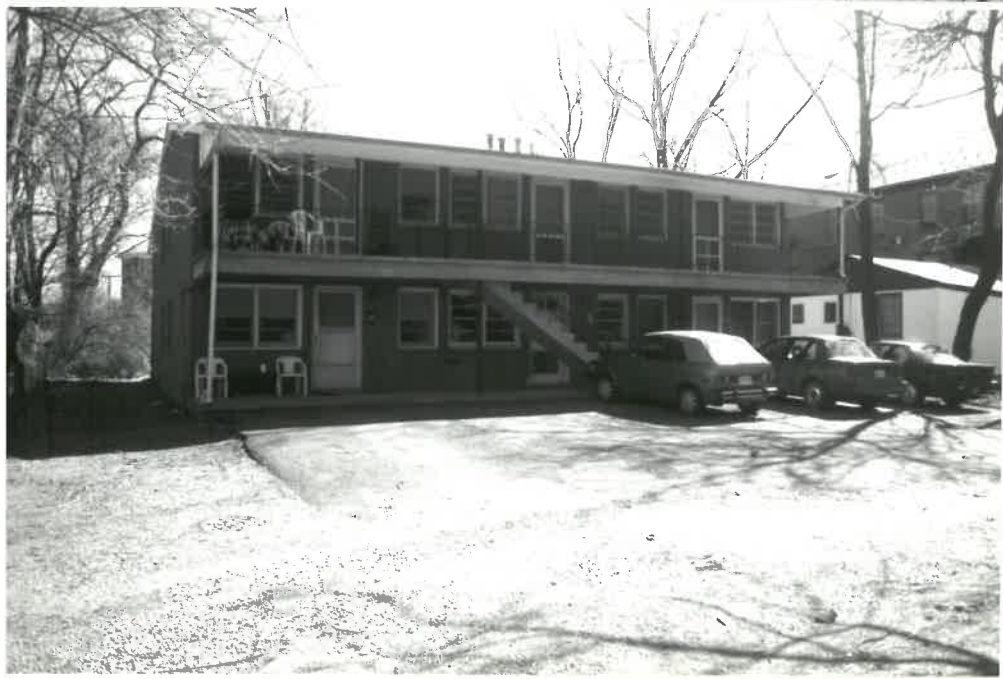
Contents 2 exterior views

Two-story, rectangular block apartment building, of brick (probably veneer) with two-story two-level porch across front and rear; gable ends, with low gable roof with no extension on end walls, and simple boxed cornice on front and rear. Three units accessed from each level on both porches; wood frame windows, single and paired, with two-over-two double-hung sash with horizontal mullions. Porches have metal railings on second level.
