VIRGINIA
HISTORIC LANDMARKS COMMISSION
SURVEY FORM

Historic name	Common name
County/Town/City Albemarle, Charlottesville	
Street address or route number 167 Madison St.	
USGS Quad Charlottesville West, Va.	Date or period c. 1930
Original owner	Architect/builder/craftsmen
Original use dwelling (duplex)	
Present owner	Source of name
Present owner address	Source of date
	Stories
Present use apartments	Foundation and wall const'n
Acreage	
	Roof type
State condition of structure and environs fair	
State potential threats to structure	
Note any archaeological interest	
Should be investigated for possible register potential? yes ___ no X	
Architectural description (Note significant features of plan, structural system and interior and exterior decoration, taking care to point out aspects not visible or clear from photographs. Explain nature and period of all alterations and additions. List any outbuildings and their approximate ages, cemeteries, etc.)

DEPARTMENT OF HISTORIC RESOURCE
RECONNAISSANCE SURVEY FORM

PROPERTY NAMES	EXPLANATION
167 Madison Lane	Address-Current

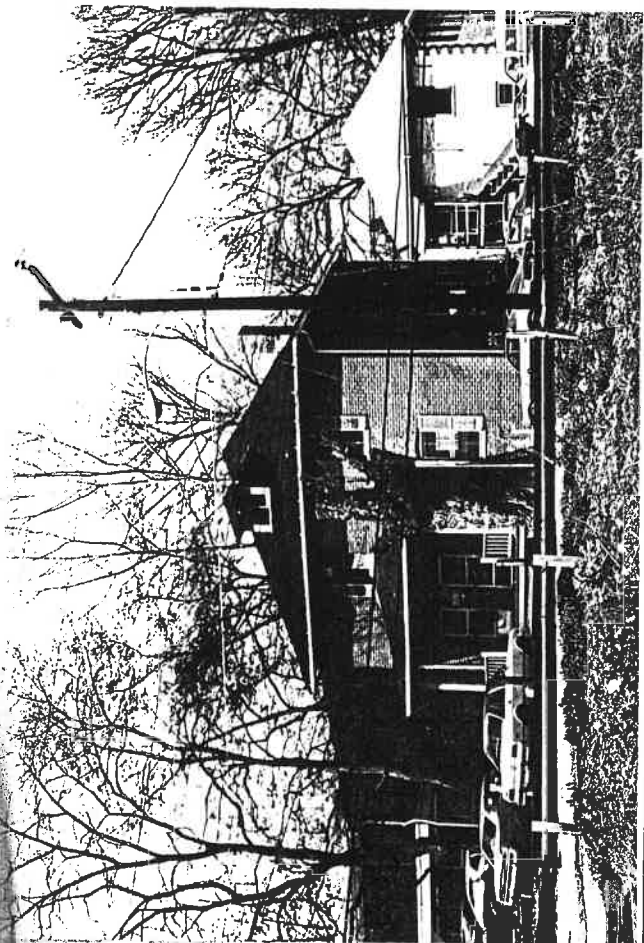
Two entry doors are located to the left side of the main facade; both are plain.

This house is located at the north end of Madison Lane at its intersection with Chancellor Street.

This house is less well detailed than others of its period further south on Madison Lane.

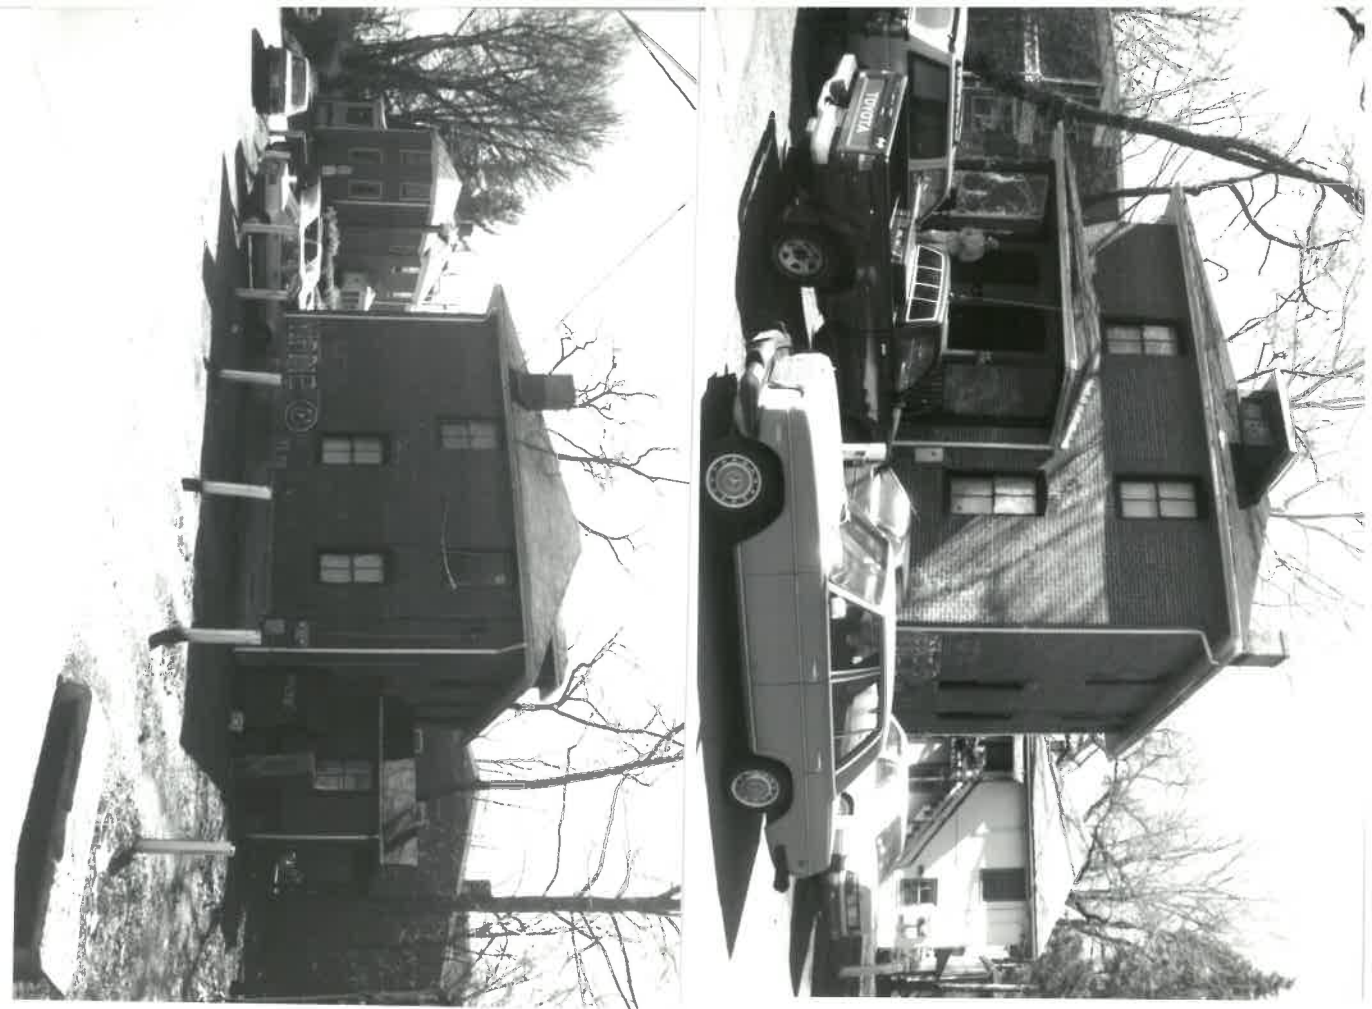
Name 167 Madison Lane

Contents 2 exterior views
