IDENTIFICATION

Historic Name: Brooks Museum
 Date/Period: 1876
 Style: Victorian
 Height to Cornice:
 Height in Stories: 3 with high basement
 Present Zoning:
 Land Area (sq.ft.):
 Assessed Value (land + imp.):

Architectural   And Historic
Survey #140

Brooks Museum

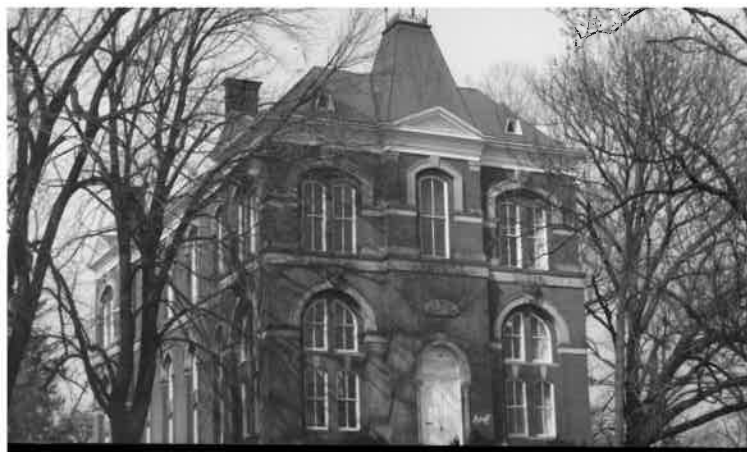
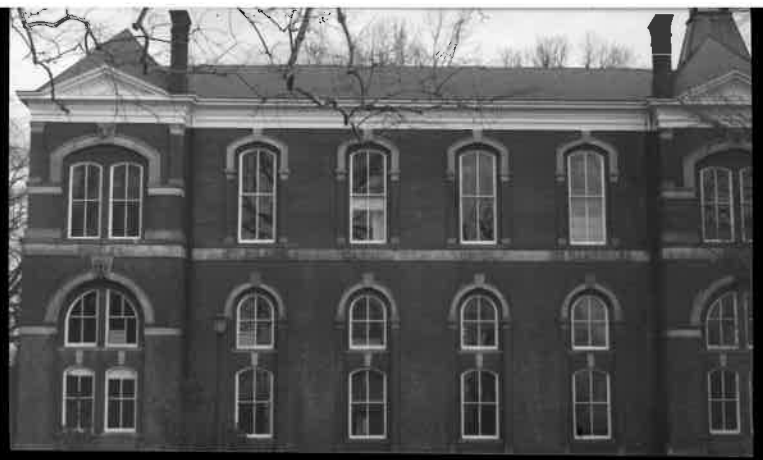
The basement of this building is faced with granite; the upper floors are of brick laid in 5-course American bond. Windows on the first and second floors are framed within two-story arches; those on the first and third floors have segmental heads, while those on the second floor are round-headed; all have two-over-two lights. External ornament is of granite in the form of keystones, window enframements, stringcourses, pilaster caps, and--most delightfully--animal heads gazing earthward above a band carved with the names of great scientists. The north and south facades have a six-bay arrangement with projecting end pavilions; each pavilion is topped with a pediment of decidedly un-classical proportions with a wooden cornice and projecting brick "modillions." The east end and west end have three bays each. The entrance bay in the east end is approached by a dramatic flight of stairs; the double doors are flanked by polished granite columns with caps of vaguely Romanesque derivation. The mansard roof of the eastern "tower" is capped with iron cresting. Strangely-shaped dormers appear on the east and west sides of the roof. In all, the vigorous forms of this building offer a delightful contrast to the prevalent Classicism.
