SURVEY FORM

Historic name	Common name
County/Town/City Charlottesville, Va.	
Street address or route number 1023 Wertland St.	
USGS Quad Charlottesville, East, Va	Date or period c. 1875
Original owner	Architect/builder/craftsmen
Original use	
Present owner	Source of name
Present owner address	Source of date
	Stories
Present use residence	Foundation and wall const'n
Acreage	
	Roof type

RECONNAISSANCE LEVEL SURVEY REPORT

PROPERTY NAMES	EXPLANATION
House (1023 Wertland St.)	Historic/Location

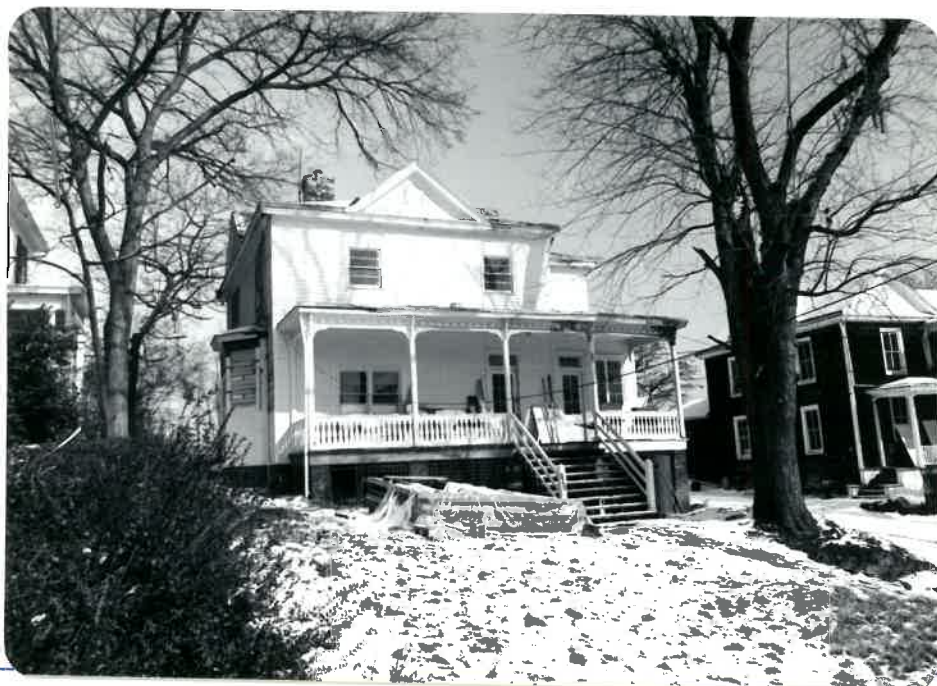
1023: clapboarding . 2 story. standing seam metal, 2 hipped roof with small front gable. 3 bays. 3 bay 1 story porch. Vernacular. c. 1875. bay window on west side, cut out work on porch with brackets. central bay entrance. 2 over 2 double on 1st story and single 2 over 2 on 2nd story, door with transom light, eastern bay door with transom light. 2 interior chimneys. originally L-shaped porch but arm has been enclosed and new windows have been added, 1 story rear addition.

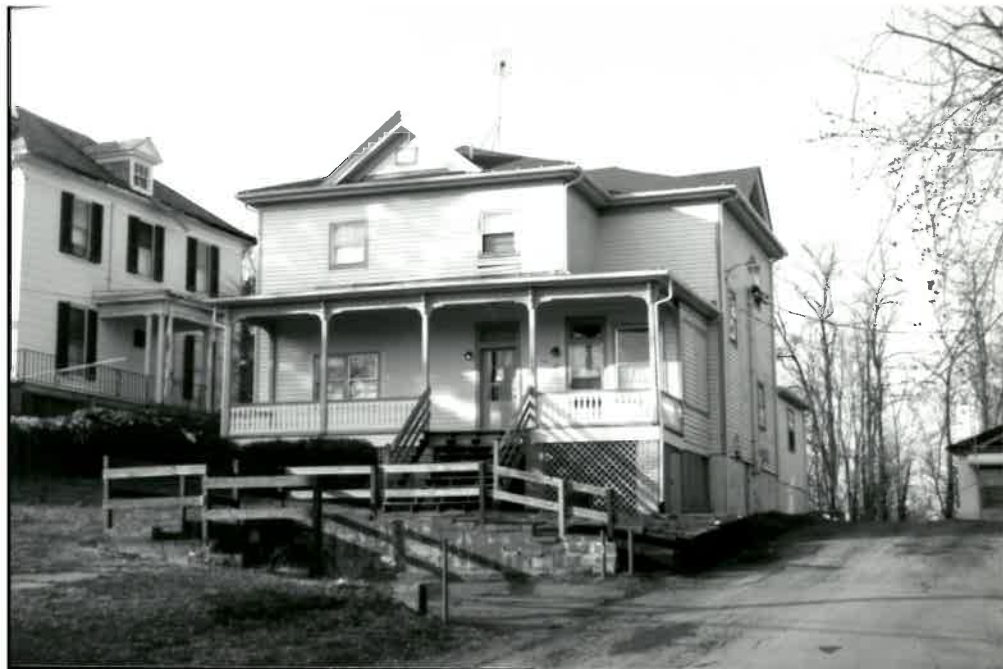
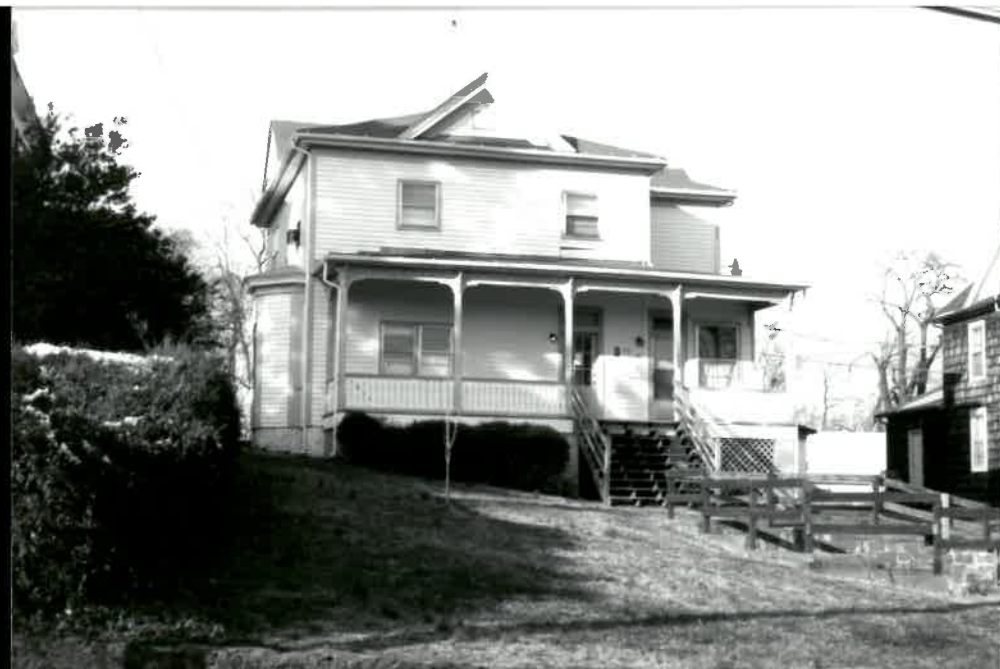
Date 3.19.96 File No. 104-136-5

House has double front entries with transoms (indicating they are both early), a porch with chamfered square wood posts and sawn balustrade, brackets, and frieze, a one-story bay window on the west side, and small gables on the front and sides.

Some alterations have been made to windows, especially on the front second story. To the rear is a one-story frame addition with a concrete-block foundation and T1-11 siding.

Contents ² ext. views
