VIRGINIA HISTORIC LANDMARKS COMMISSION

SURVEY FORM

Historic name	Common name
County/Town/City Charlottesville, Va.	
Street address or route number 1109 Wertland St.	
USGS Quad Charlottesville, East, Va	Date or period c. 1900
Original owner	Architect/builder/craftsmen
Original use	
Present owner	Source of name
Present owner address	Source of date
	Stories
Present use residence	Foundation and wall const'n
Acreage	
	Roof type

1109 WERTLAND STREET

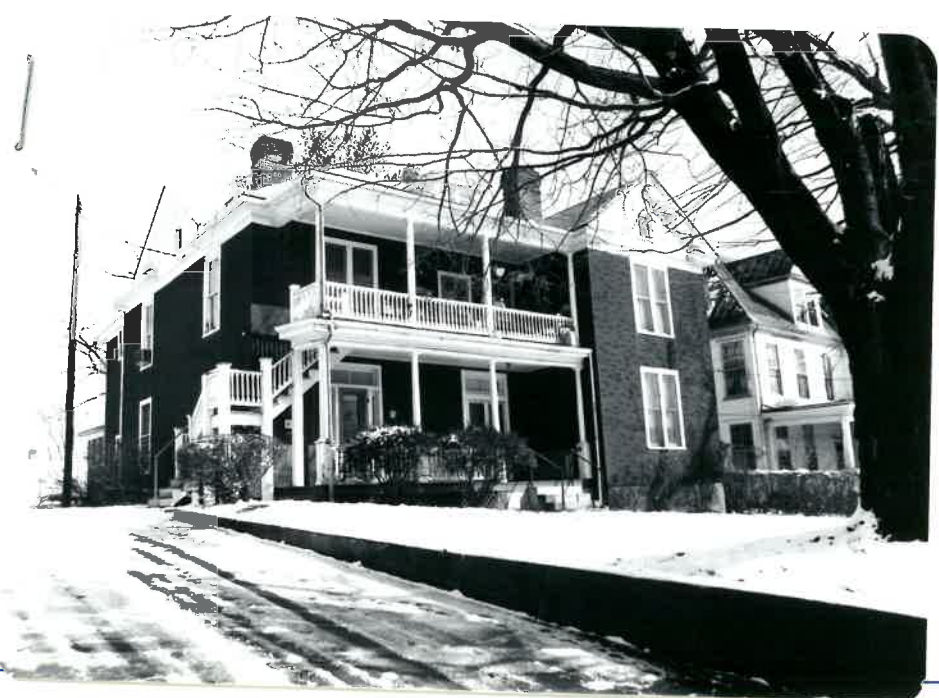
1109: tar paper (imitation red brick). 2½ story. hipped roof with intersecting gable with asphalt shingles and 1 pedimented dormer. 2 story 2 bay (west). ~~wood shingle~~ ^{COLONY} shingle. c. 1900. fish scale wooden shingles in front gable. central bay 2 door entrance and western bay doorway. west bay: door with side and transom lights on 1st story, 2 side by side 1/1 DHS on 2nd story; central bay: 1st story has double door with transom and 2nd story has 2 doors; est bay: side by side 1/1 DHS on both floors; 1 4-pane fixed window in gable; dormer: 2 3/1. 2 interior chimneys. stairway to 2nd story porch added, also 1 story and 2 story rear additions.

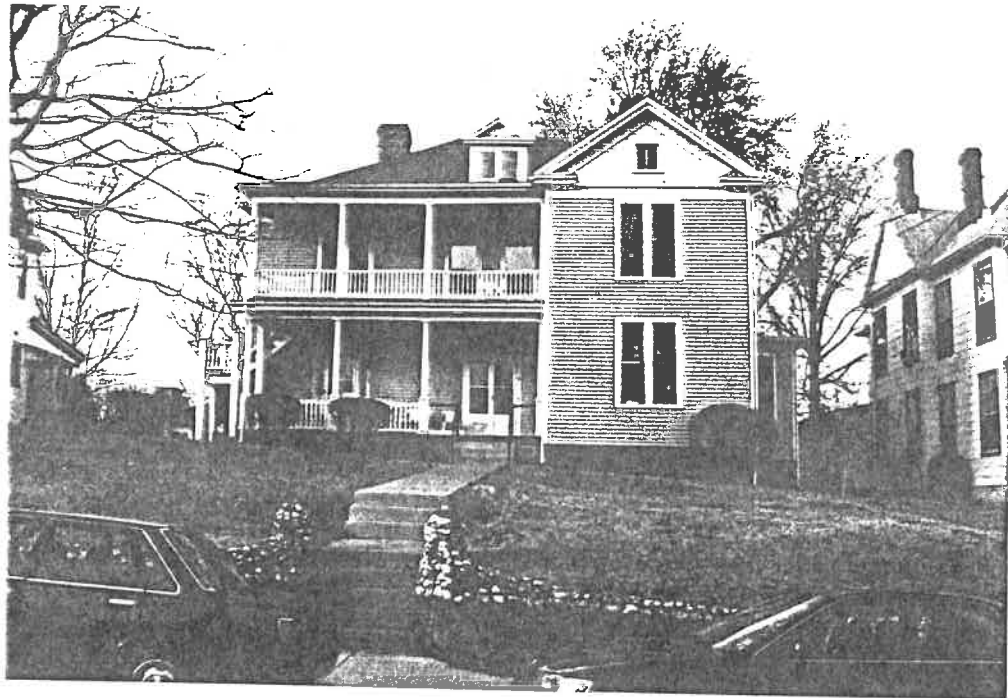
The basic massing of this Victorian house is similar to that of those on either side of it, but the proportions are different. Very likely all three were built about the same time, perhaps by the same builder. This is a two-story, three-bay, double-pile house with a projecting bay at the eastern end of the facade. An original two-story addition, with a one-story addition behind it, covers the rear elevation, and there is also a small one-story wing on the eastern side. The walls, probably originally weatherboarded, were covered with imitation brick tar paper siding in the mid-1900's, and that has now been replaced or covered with vinyl siding imitating the original weatherboarding. The asphalt-shingled hipped roof has gables over the projecting bay on the facade and centered on both side elevations. It has a boxed cornice with returns. One pedimented gable dormer is centered on the facade. There are two interior chimneys. The tall windows are single-paned, double-sash. Those in the projecting side bay are paired. A two-story verandah with slender columns and a Victorian turned balustrade covers two bays of the facade. An exterior stair projects to the west of the verandah. At the first story level, there are double entrance doors with a transom in the central bay and a single door with transom and sidelights in the western bay. At the second story level, there is a single door without a transom in the central bay. A quartzite retaining wall runs along the sidewalk.

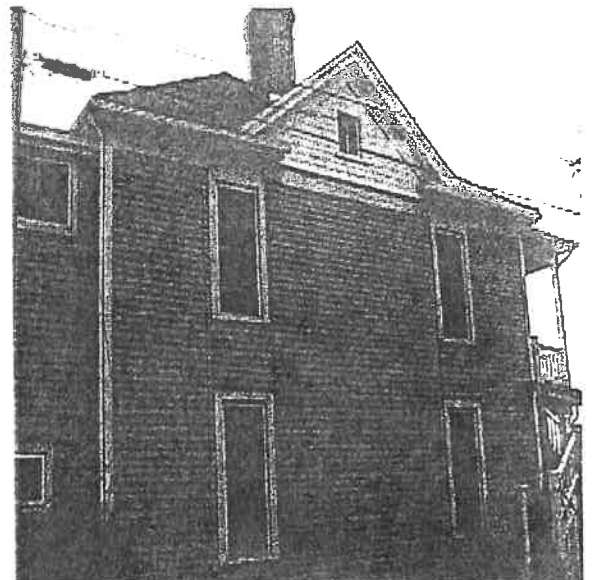
This house is a contributing resource in the Wertland Street Historic District, listed on the National Register of Historic Places. For several years, it was the home of a future Virginia governor and a future u. S. Ambassador to Australia.

behind it, covers the rear elevation, and there is also a small one-story wing on the eastern side. The walls, probably originally weatherboarded, were covered with imitation-brick tar paper siding in the mid-1900's, and that has now been replaced or covered with vinyl siding imitating the original weatherboarding. The asphalt-shingled hipped roof has gables over the projecting bay on the facade and centered on both side elevations. It has a boxed cornice with returns. One pedimented gabled dormer is centered on the facade. ~~There are~~ There are two interior chimneys. The tall windows are ~~double~~ single-paned, double-sash. Those in the projecting side bay are paired. A two-story verandah with slender columns and a Victorian turned balustrade covers two bays of the facade. An exterior stair projects to the west of the verandah. At the first story level, there are double entrance doors with a transom in the central bay and a single door with transom and sidelights in the western bay. At the second story level, there is a single door without a transom in the central bay. A quartzite retaining wall runs along the sidewalk.

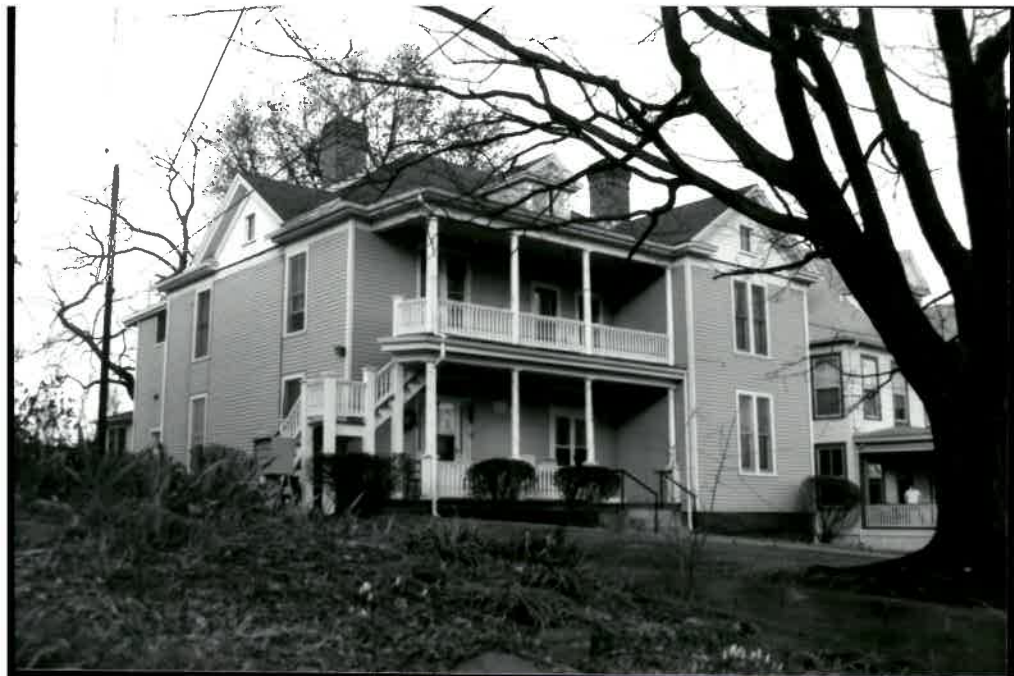
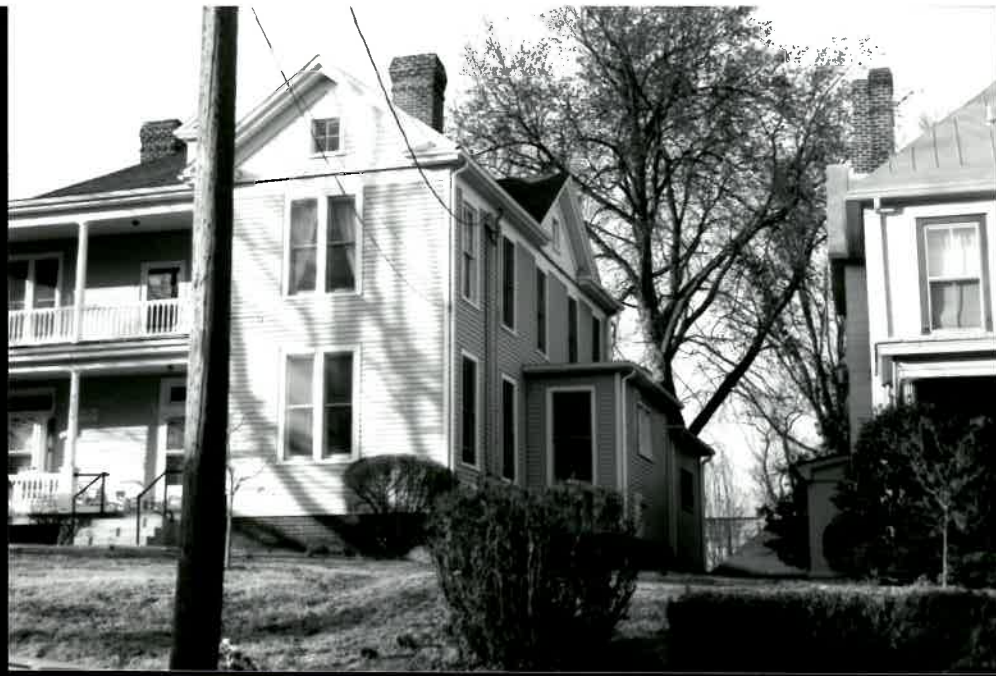
Name House (1109 Westland St.)

Contents 3 ext. views
