**CITY OF CHARLOTTESVILLE  
BOARD OF ARCHITECTURAL REVIEW  
STAFF REPORT  
October 17, 2017**

BAR 17-10-04

222 East Main Street

Window Replacement

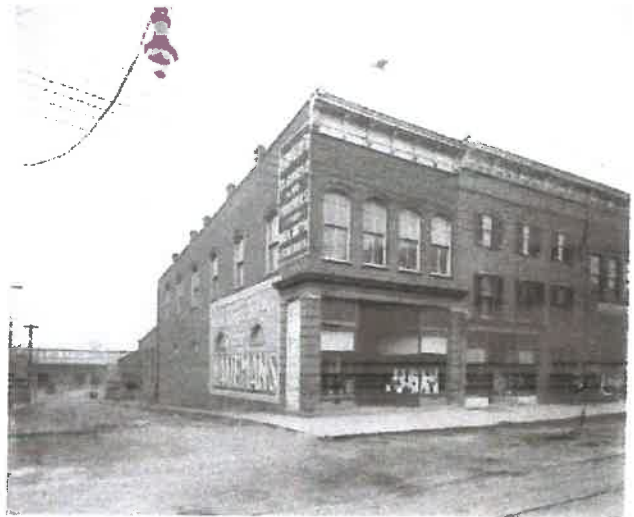
Moses Kaufman and sons built the Kaufman Building in 1883 as a dry goods store and residence. The two-story red brick building had a simple Classical Revival façade. In 1915, Louise Zimmerman, a milliner, lived on the second floor. At some point during the mid-20th century the Kaufmans remodeled the façade — updating it in the Renaissance Revival style, reducing the number of upper story windows from four to three, enlarging the central window and adding an open pediment above it.

*Kaufman Clothing, 1915*  
Image from Hulsinger Collection, University of Virginia

The building was constructed in 1883 as Kaufman's clothing store. The enclosed 1915 photograph (attachment A-1) shows its original design. In 1920 the Kaufman family renovated the building's front facade, producing the building's current aspect (shown in context as attachment A-2).

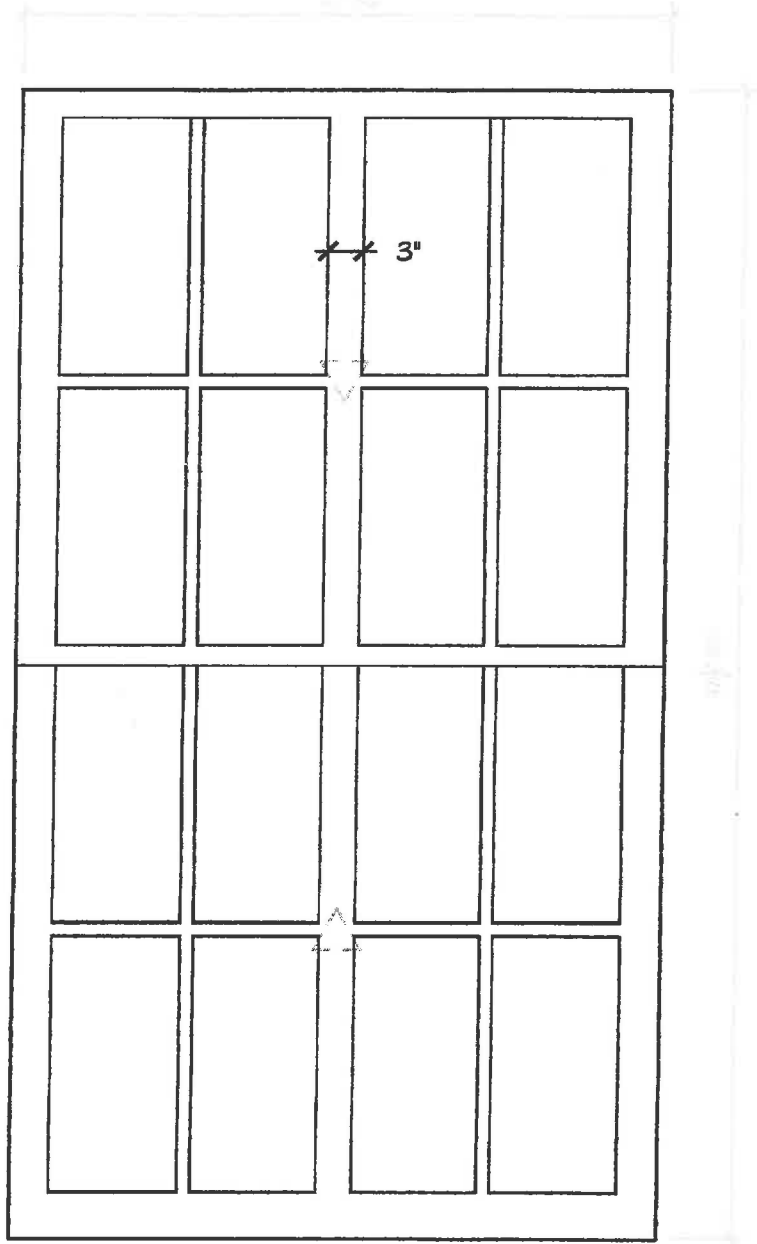
Alternate Option for CMDHTP-With 3" Center SDL & 1 1/8" SDL

Gaston and Wyatt presented me with four options (see: attachment C). They differ in two ways. As Gaston and Wyatt's Larry Topping advised me:

"As you are probably aware, Marvin has two types of replacement windows that will work. One is clad on the exterior and wood on the interior (like the windows that were replaced) and the other is wood inside and out. We always prefer clad windows when possible but they are not always appropriate. Due too the wide bar in the center, your window creates a unique situation. Your bar is approximately 3 inches. Marvin has a standard bar that is 2 13/32" (almost 2 1/2) From the street, it is very unlikely that anyone would notice the difference, but there is one. Marvin will do a custom 3" center bar but it adds significantly to the price. They also have at the same 2 13/32" standard bar in their wood exterior window, but the 3" because it is wood, is much cheaper than the clad one..."

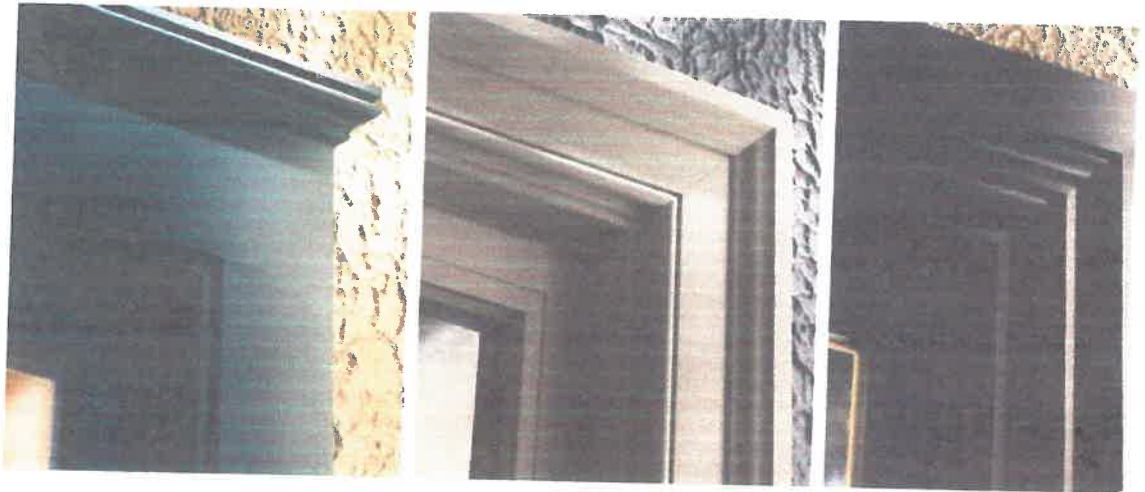
### ALUMINUM CLAD WOOD FOR A LOW MAINTENANCE EXTERIOR

All aluminum cladding is not created equal. Our extremely durable extruded aluminum substrate is significantly stronger than form aluminum. Marvin clad meets the toughest AAMA 2605-05 70% PVDF standard for a finish with superior resistance to fading and chalking.

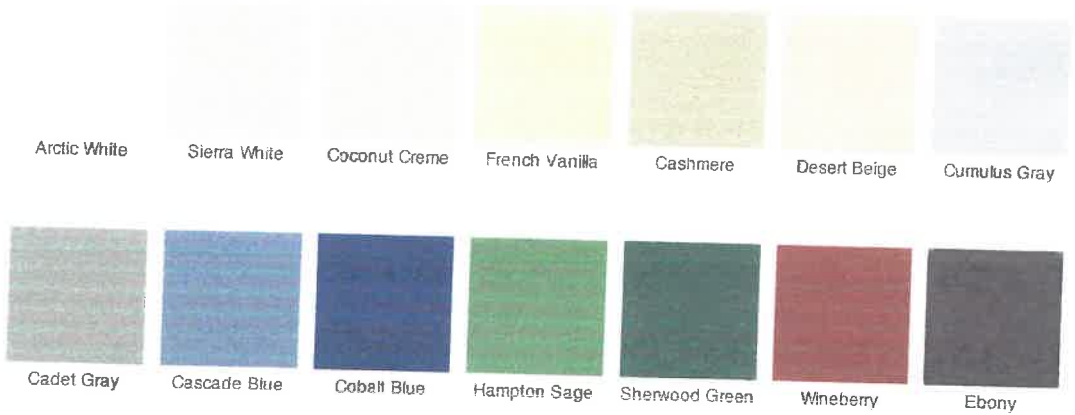
#### Select Clad Colors

- All standard, select and custom colors meet AAMA 2605-05
- Clad colors shown are approximate. Please visit a [Marvin dealer](#) near you to see color samples
