BAR 21-01-05 116 West Jefferson Street Tax Parcel 330183000 Jefferson Street Properties, LLC, Owner Gordon Johnson, Peter Johnson Builders, Applicant Porch reconstruction

CITY OF CHARLOTTESVILLE BOARD OF ARCHITECTURAL REVIEW STAFF REPORT February 17, 2021

BAR 21-01-06 116 West Jefferson Street, TMP 330183000 North Downtown ADC District Owner: Jefferson Street Properties, LLC Applicant: Gordon Johnson, Peter Johnson Builders Project: Front porch reconstruction, alterations at rear elevation

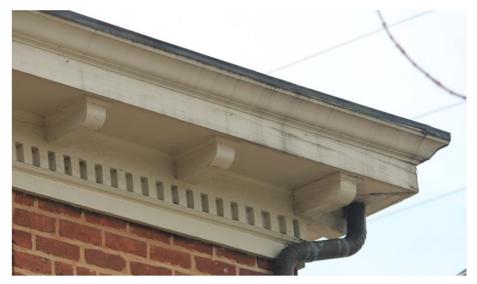
Existing cornice at 116 West Jefferson Street. New porch cornice to match.

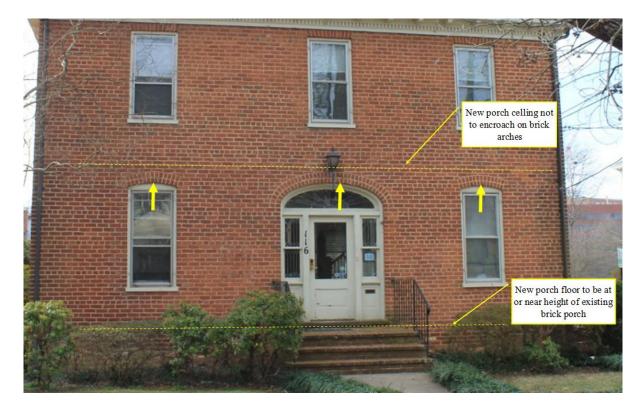
Cornice at 116 West Jefferson St

116 West Jefferson Street (Existing)

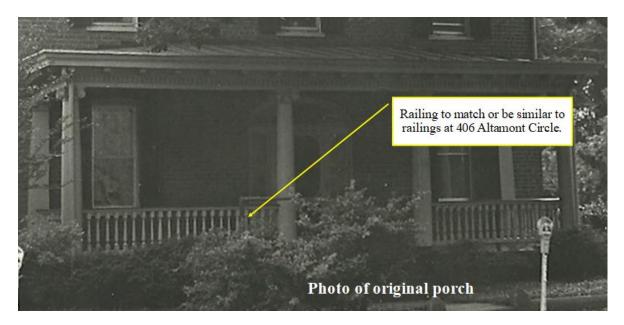
Original porch at 116 West Jefferson Street

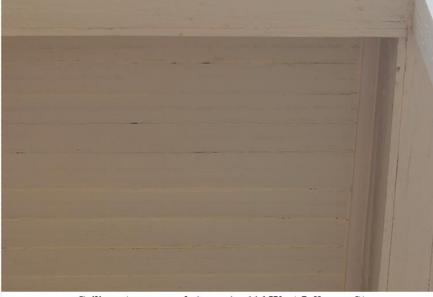
116 West Jefferson Street (existing) - note ceiling board and trim

- <u>Ceiling</u>: Beaded-board with simple cove or crown at entablature, similar to existing celling at rear, upper porch. Porch ceiling will be above—and encroach onto--the brick arches above the entry and two windows. Painted. Color: TBD. *

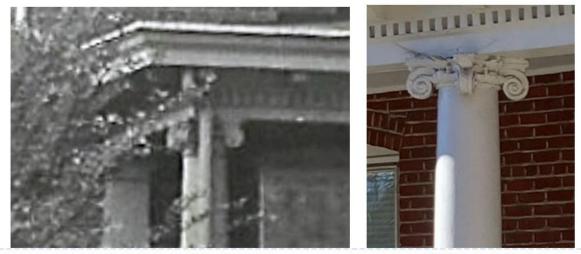
Column capitol

- <u>Columns</u>: (Similar to the columns at 406 Altamont Circle.) *
 - Capital: Photos indicate Angular (Scamozzi) Ionic.
 - Shaft: Smooth. Round columns at the front. Square, engaged columns at the walls.

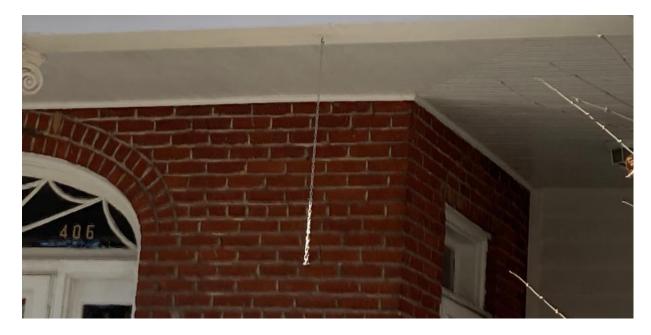
406 Altamont Circle – note ceiling board and trim
