Board of Architectural Review (BAR) **Certificate of Appropriateness**

Roger Birle from DGP Architects requested administrative approval for a tax credit project at 408 Park Street, including replacing the roof, replacing a door on the front second floor, replacing four pairs of windows on the south side, and adding new shutters. In addition, planned repairs included: window well, railings, front walk, and brick repointing. There was consensus that administrative approval would be appropriate.

STATE HISTORIC REHABILITATION TAX CREDIT PROGRAM HISTORIC PRESERVATION CERTIFICATION APPLICATION PART 2 - DESCRIPTION OF REHABILITATION

HISTORIC PRESERVATION CERTIFICATION APPLICATION PART 2 - PHOTOGRAPHS

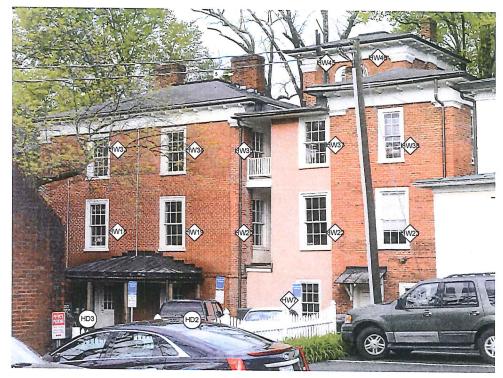
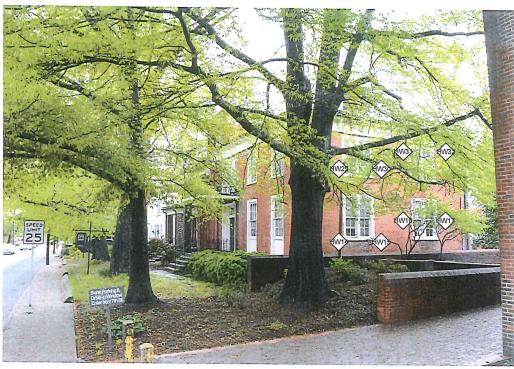
408 PARK STREET
EAST & SOUTH ELEVATIONS
NOT TO SCALE

SCHEMATIC EAST ELEVATION

SCHEMATIC SOUTH ELEVATION

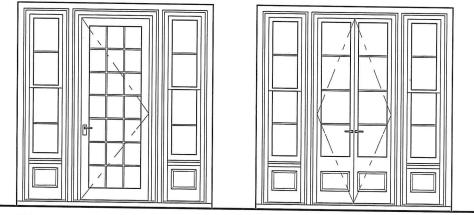
408 PARK STREET BALCONY DOOR

EXISTING

PROPOSED (HISTORIC)

Number 10. Architectural feature Exterior Porch Door Approximate date of feature Unknown, not original Describe existing feature and its condition: Frame and sidelights are original, but center door has been replaced mid-20 th Century. Thickened mullions are not original, but allow for existing standard door size.	Describe work and impact on existing feature: Replace door with pair of single glazed French doors that fit in original door opening. Muntins to align with original sidelights. Custom door to be of mahogany for paint with brass interlocking threshold. Exterior mahogany storm/screen panels to be single light.
Photo no. 10-A to 10-C Drawing no.	
Number 11. Architectural feature Second Floor Interior Guardrail Approximate date of feature Unknown, not original Describe existing feature and its condition: Second Floor stair balustrade turns into guardrail that has been extended with painted plywood panels. The original pickets have been removed, but the original handrail is still in place.	Describe work and impact on existing feature: Second Floor guard rail will match existing stair balustrade in design and material.

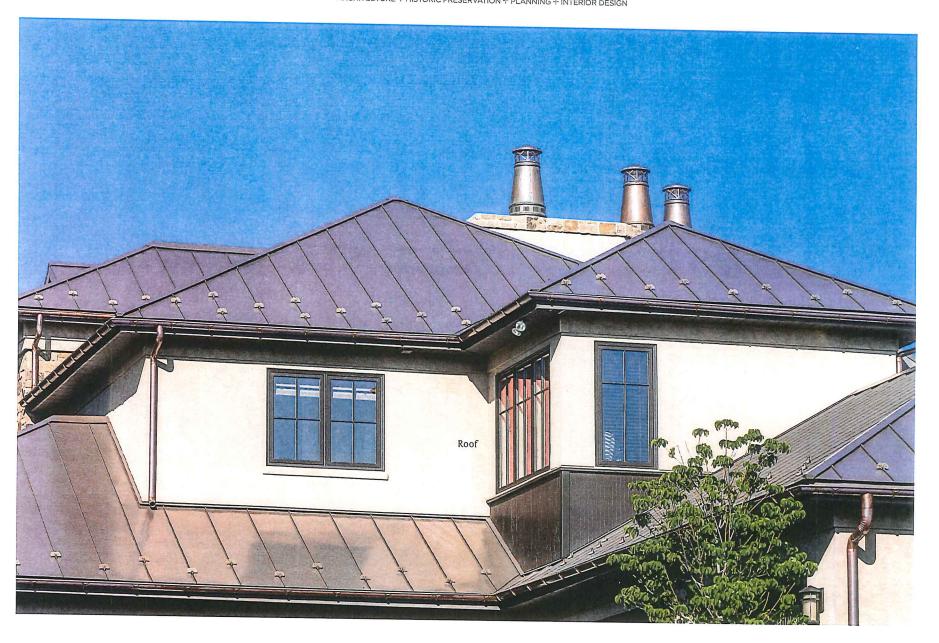
408 PARK STREET

ROOF

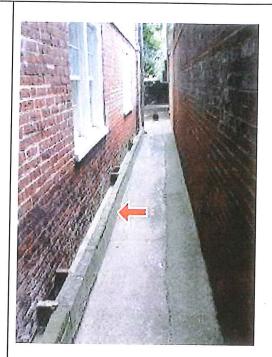
IMAGE 02-D

Number 2. Architectural featureExterior Window Well "Moat" Approximate date of featureUnknown Describe existing feature and its condition: Existing concrete moat around West and South walls of building holds water against brick walls. Masonry vents that are not original have CMU or brick curbs that have failed. Water is settling below existing Basement floor system. Photo no. 02-A to 02-E Drawing no.	Describe work and impact on existing feature: Existing, not original, slab will be removed allowing foundation wall to be waterproofed below grade. New slab to be poured with greater pitch than existing. Basement floor system will be replaced and not require venting, thus no exterior curbed vents will be needed in moat.	
Number 3. Architectural feature Roof/gutters and downspouts Approximate date of feature c. 1985 Describe existing feature and its condition: Combination of composite asphalt shingles, standing seam metal, and EPDM rubber roofing is at end of its lifecycle. Copper gutters and downspouts are leaking and no longer properly attached. Photo no. 03-A to 03-D Drawing no.	Describe work and impact on existing feature: New roof and flashing to be hand-crimped standing seam steel in prefinished charcoal color. New gutters and downspouts to match existing to be copper. New EPDM at flat roof areas to be black in color.

Number 2. Architectural Feature: Exterior Window Well "Moat"

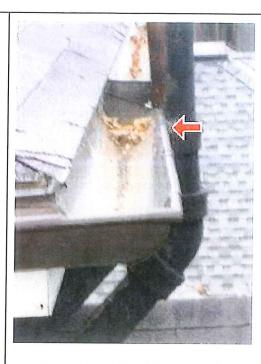
IMAGE 03-C

Number 3. Architectural Feature: Roof, Gutters and Downspouts

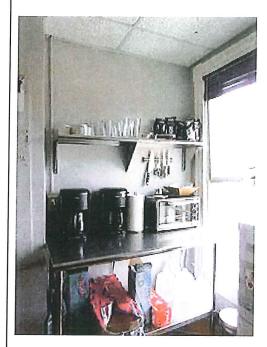
IMAGE 08-B

Number 8. Architectural Feature: Kitchenettes

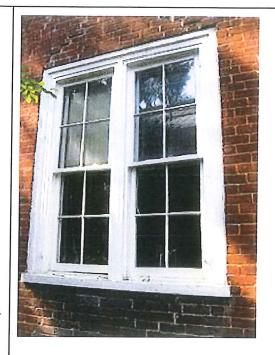
IMAGE 09-D

Property Address 408 Park St., Charlottesville, VA 22902	DHR Project Number:
Number 9. Architectural feature Windows Approximate date of feature 1854-1861, c. 1985 Describe existing feature and its condition: Original windows are in various conditions. All are double hung single glazed. Windows on South façade have substantial rot with racked sashes. All original windows have interior double track storm units with plastic frames that are damaged. Several units have broken sash cords. Photo no. 09-A to 09-F Drawing no.	Describe work and impact on existing feature: On South façade four units to have sash replaced with insulated glass with clear low-e glass. Muntin profiles and configurations to match existing. Original windows to be restored according to NPS Preservation Brief #9 to allow for one operating unit per room. Storm windows to be replaced with low-profile enamel-coated steel units with one-over-one configuration.

Number 9. Architectural Feature: Windows

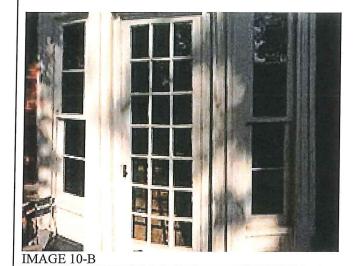
IMAGE 10-C

Number 10. Architectural Feature: Exterior Porch Door

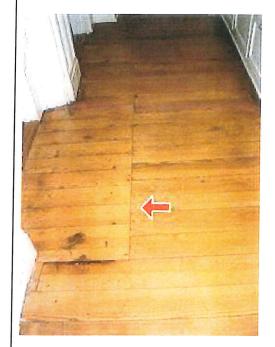
IMAGE 12-A

Photo no. 11-A to 11-E Drawing no.	
Number 12. Architectural feature Original Wood Interior Flooring Approximate date of feature 1854-1861 Describe existing feature and its condition: Existing floor on main levels is various widths of heart pine.	Describe work and impact on existing feature: Existing flooring to be cleaned and buffed, with no sanding required.
Photo no <u>12-A to 12-C_</u> Drawing no

Number 12. Architectural Feature: Original Wood Interior Flooring

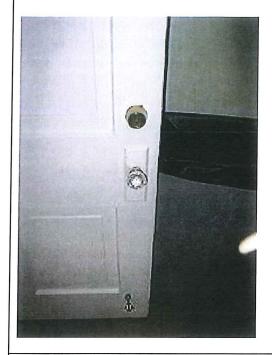
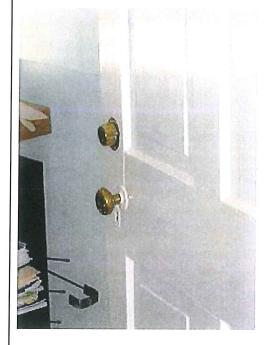
Number 14. Architectural Feature: Door Hardware

Number 13. Architectural feature Interior Plaster Approximate date of feature 1854-1861, c. 1995 Describe existing feature and its condition: Interior wall finishes are combination of original lime plaster, gypsum, and wall board. Hemosote panels were added at the end of the 20 th Century.	Describe work and impact on existing feature: Hemosote panels will be removed. Original plaster to be repaired using lime plaster. Gypsum and wall board to be repaired using gypsum wall compound. Original plaster has been tested and there is no asbestos present.
Photo no. 13-A to 13-D Drawing no.	
Number 14. Architectural feature Door Hardware Approximate date of feature c. 1995 Describe existing feature and its condition: Existing door hardware is a mix of mid-20 th Century replacements that do not match. No original hardware is present.	Describe work and impact on existing feature: All door hardware to be replaced with solid brass cylindrical passage sets.

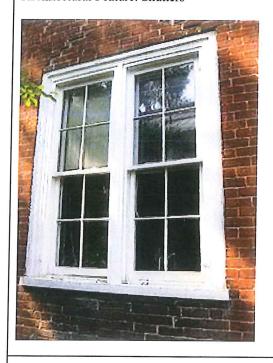
IMAGE 19-A

Number 19. Architectural Feature: Shutters

Describe existing feature and its condition: interlocking threshold. Existing "moat" condition has led to rot at sill and jamb of West Basement access door. Photo no. <u>18-A to 18-C</u> Drawing no. _____ Number 19. Describe work and impact on existing feature: Architectural feature Shutters New shutters and operable hardware will be added to work with Approximate date of feature Not extant existing pintels as feasible. Shutters to be of mahogany with Describe existing feature and its condition: copper cap on edges. Though hardware (or mortise for such) is present at all windows, no shutters are existing. Photo no. 19-A Drawing no. Number 20. Describe work and impact on existing feature: Architectural feature Insulation in Attic Because existing hipped roofs are unvented, units and ducts are Approximate date of feature c. 1985 in attic apace, and for increased energy efficiency we will replace Describe existing feature and its condition: existing insulation with spray foam insulation at rafter bays. Existing insulation is blown cellulose between ceiling joists. Thickness and condition of existing insulation is inadequate. Photo no. 20-A to 20-B Drawing no.

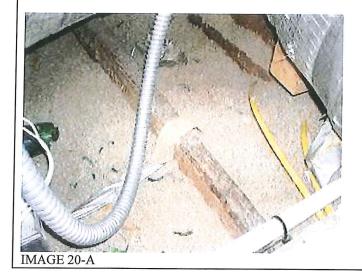
IMAGE 20-B

Number 20. Architectural Feature: Insulation in Attic

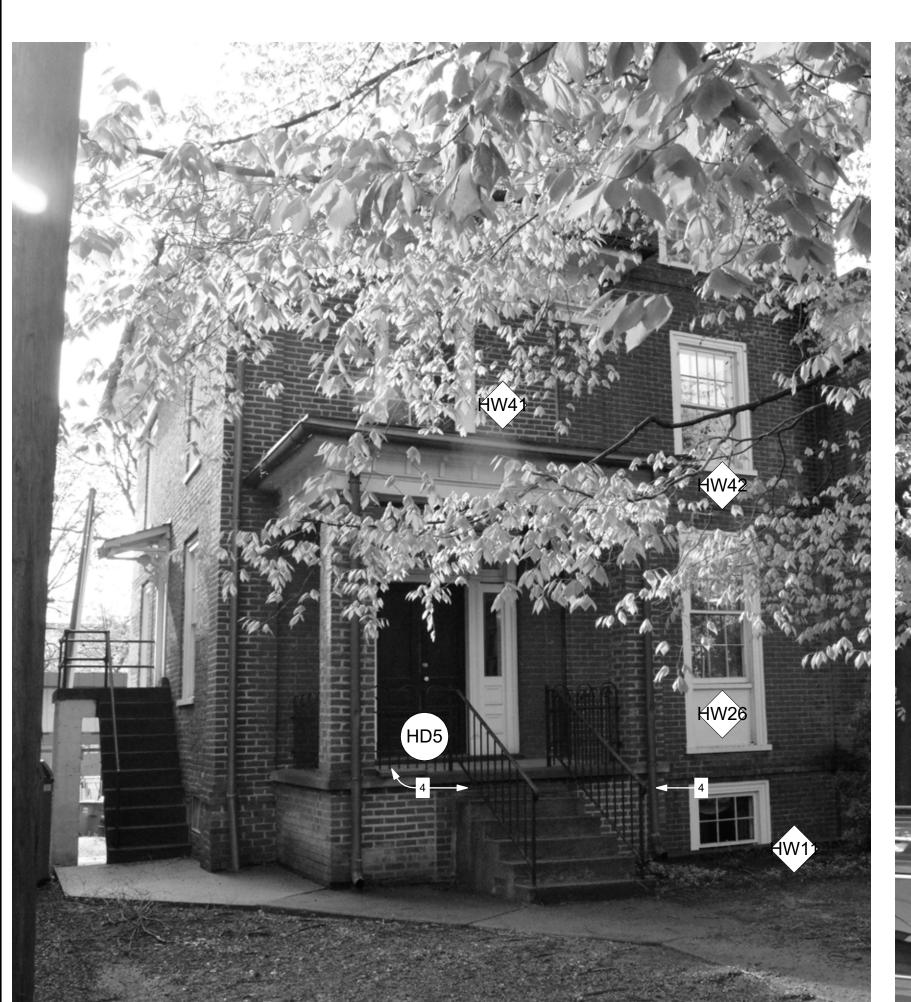
SCHEMATIC WEST ELEVATION SCALE: 1/4'' = 1'-0''

- REMOVE AND DISCARD THROUGH-WALL UNIT, REPAIR WITH BRICK TO MATCH EXISTING
- → 2 REMOVE CURB AND SEAL EXISTING VENTS
- 3 CLEAN AND REPAIR BRICK AS SPECIFIED
- 4 PROVIDE NEW METAL RAILINGS
- 5 AREA OF BRICK RESTORATION
