GOODWIN HOUSE

VDHR Reconnaissance Survey Form

VIRGINIA DEPARTMENT OF HISTORIC RESOURCES
PROPERTY SURVEY FORM
RECONNAISSANCE LEVEL

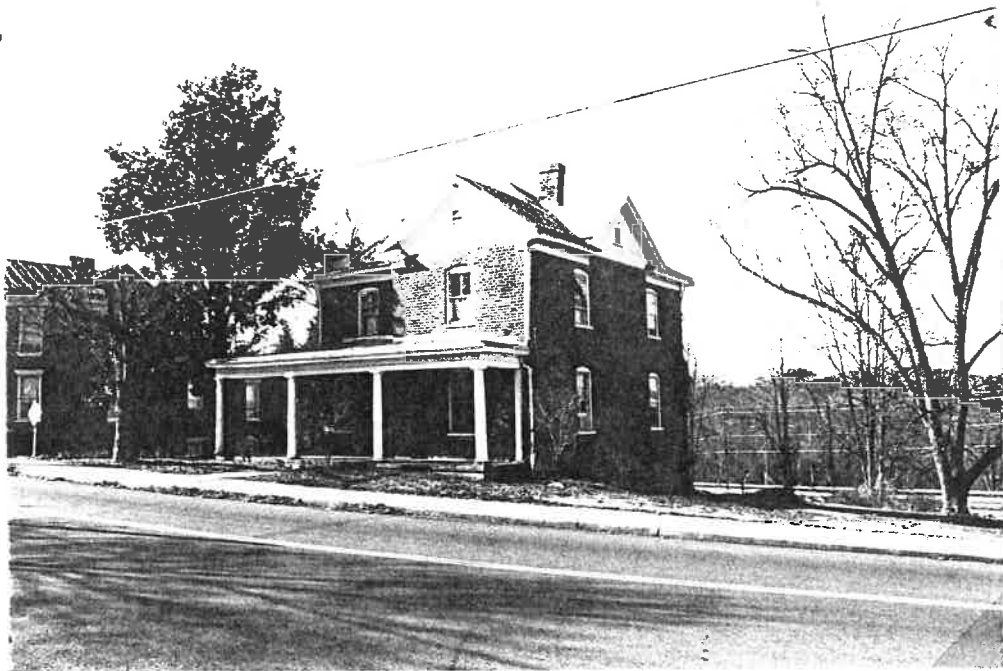
This 2-story, 3-bay, brick house, laid in seven-course common bond, is a vernacular rendition of the transitional phase between the Queen Anne and Colonial Revival styles. It has an irregular form reflecting the Queen Anne style, with a complex hipped roof clad with standing-seam metal, and simple decorative elements. There are two interior chimneys of brick. The house's central block has projecting gabled bays on the northeast end of the front facade and the northwest or rear of the southwest side. The northeast and rear walls have center gables. The gables in the projecting bays and the center gables are clad with diamond-patterned shingles, and have small rectangular louvered ventilation openings in them. The house has a boxed cornice with returns and a frieze board. The windows are two-over-two double-hung wood sash, and have shallow segmental arches. The two entrances, one in the front facade and the other in the projecting bay of the southwest side, have single-light transoms. There is a one-story, six-bay, Colonial Revival-style wraparound porch on the front and part of the southwest side, with Doric columns supporting a hipped roof. The porch's original floor has been replaced by one of concrete. The house's foundation is raised at the rear, and there is a shallow, one-story, hip-roofed frame section with a small porch in its southwest half at the rear of the house. Sited on a sloping corner lot between Ridge Street and Fifth Street to the southeast and northwest, and between Barksdale Street to the southwest and the connector between Ridge and Fifth Streets to the northeast, the house has a visually important position. The property has a shallow front yard, and a deep side yard to the northeast.
