VIRGINIA HISTORIC LANDMARKS COMMISSION

HISTORIC DISTRICT SURVEY FORM

Street address 155 Rugby Road
Town/City Charlottesville

Historic name Bayly Museum Common name

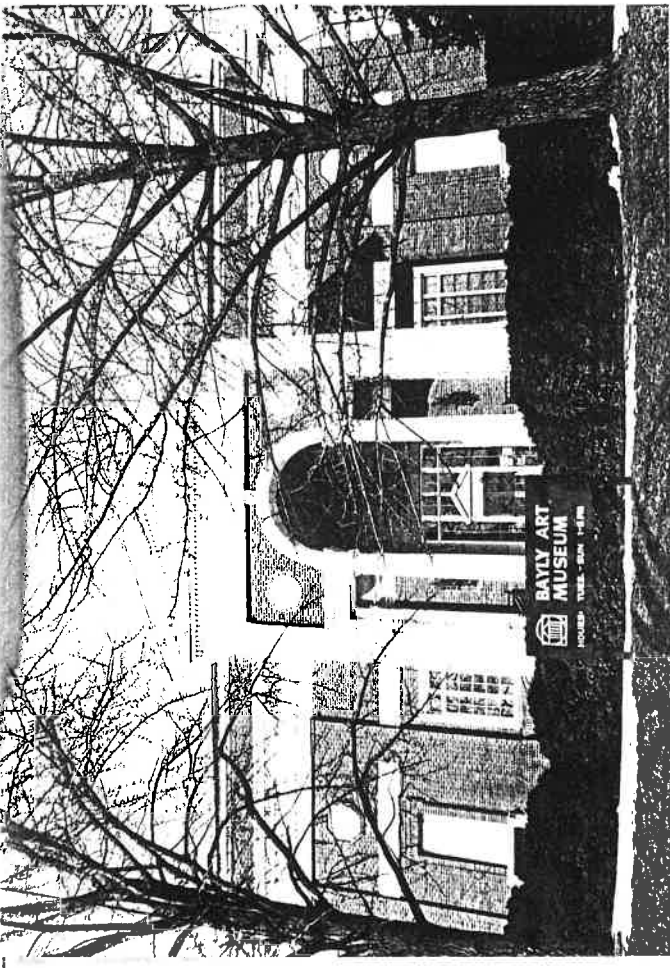
Location and description of entrance **pedimented entry set in a large glassed bay.**

This handsome example of Neo Classical public architecture occupies a terraced lot along Rugby Road just north of Fayerweather Hall. The building remains virtually unaltered on the exterior. At the rear is a large, windowless wing that may be a later addition.
