And Historic Survey

STREET ADDRESS:1511 University AvenueMAP & PARCEL:9-78CENSUS TRACT AND BLOCK:PRESENT ZONING:B-3ORIGINAL OWNER:J. H. Irving & Harry H. RobinsonORIGINAL USE:Men's Clothing Store?PRESENT USE:RestaurantPRESENT OWNER:College Land TrustADDRESS:c/o David H. Pettit, Trustee409 Park StreetCharlottesville, Virginia22901

HISTORIC NAME: DATE / PERIOD: c. 1930 STYLE: HEIGHT (to cornice) OR STORIES: 1 storey DIMENSIONS AND LAND AREA: 33,995 sq. ft. CONDITION: Good SURVEYOR: Bibb DATE OF SURVEY: Summery 1986 SOURCES: City Records Holsinger Photographs Sanborn Map Co., - 1896, 1920, 1929-57

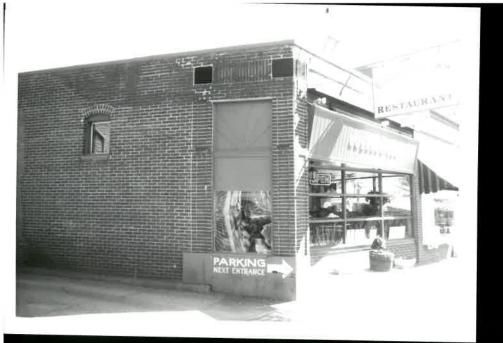
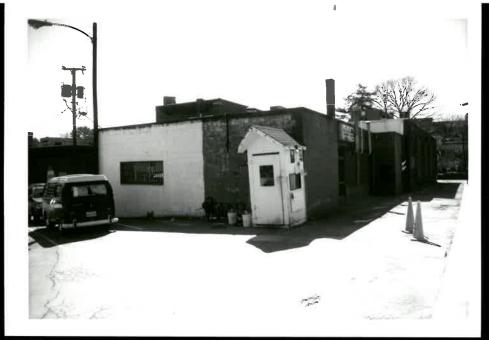
Date 3/10/96	File No. <u>104-133-56</u>				
Name College Jnn, 18	11 University Ave.				
Town Charlottesville					
County					
Photographer Site Sine Site					
Contents 2 enterior	IEWS

One section of an Art Deco storefront has survived the modernization of this one-storey building. Wall construction is of brick laid in stretcher bond throughout the building. A 1946 photograph shows what appears to be carrera glass storefront with a semi-octagonal arched central entrance loggia. This has been replaced with a wide, shallow loggia angled so as to accentuate the trapezoidal shape of the building. The entrance is now at the western end of the storefront beside a large multi-light display window. A paneled sign above the storefront covers or replaces the carrera glass panel and arch. The storefront is still framed by a decorative band of brick: header-stretcherheader, with corner blocks of black carrera glass. This is repeated in the first bay of the west side elevation where a display window has a tall transom panel of black carrera glass in a stylized fan motif. The paparet is plain. Four high, small, square, segmental-arched windows along the side elevation have been closed. Most of the rear elevation is covered by a cinderblock addition.
