VIRGINIA HISTORIC LANDMARKS COMMISSION

SURVEY FORM

County/Town/City Charlottesville, Va. Street address or route number 1021 Wertland

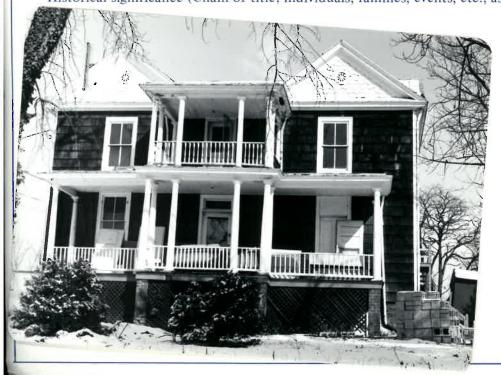
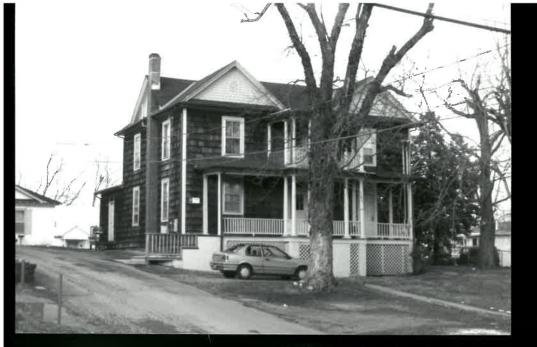
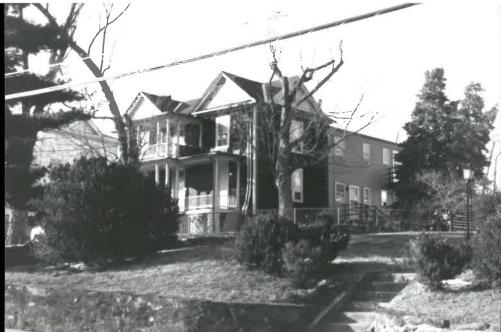
Date 3./996 File No. 104-136-4
Name House (1021 Westland St.)
Town
County Charlo Hesrille
Photographer Den Pezzoni
Contents Sext, views

> 1021: wood shingle. 2 story. standing seam metal, gable roof with 2 intersecting gables (1 per end). 3 bay. 3 bay 1 story 1st floor porch and 1 story 1 bay (central) 2nd floor porch. Col. Revival Georgian/ shingle style. c.1900. staggered pattern shingles in pediment, tuscan columns and turned ballustrade on porch. central bay entrance. 2/2, door with transom light. 1 exterior west chimney. front stairs removed to west side of porch, 2 story rear addition.
