STREET ADDRESS: 1254 Wertland Street
MAP & PARCEL 10-23
VDHR FILE NUMBER: 104-0136-0021
CITY FILE NUMBER:
PRESENT ZONING: B-3
ORIGINAL OWNER:
ORIGINAL USE: Residence
PRESENT USE: Residential Rental Property
PRESENT OWNER: Wertland, LLC
ADDRESS: P. O. Box 3344
Charlottesville, VA 22903

1254 WERTLAND STREET

RECONNAISSANCE LEVEL SURVEY REPORT

DEPARTMENT OF HISTORIC RESOURCE
RECONNAISSANCE SURVEY FORM

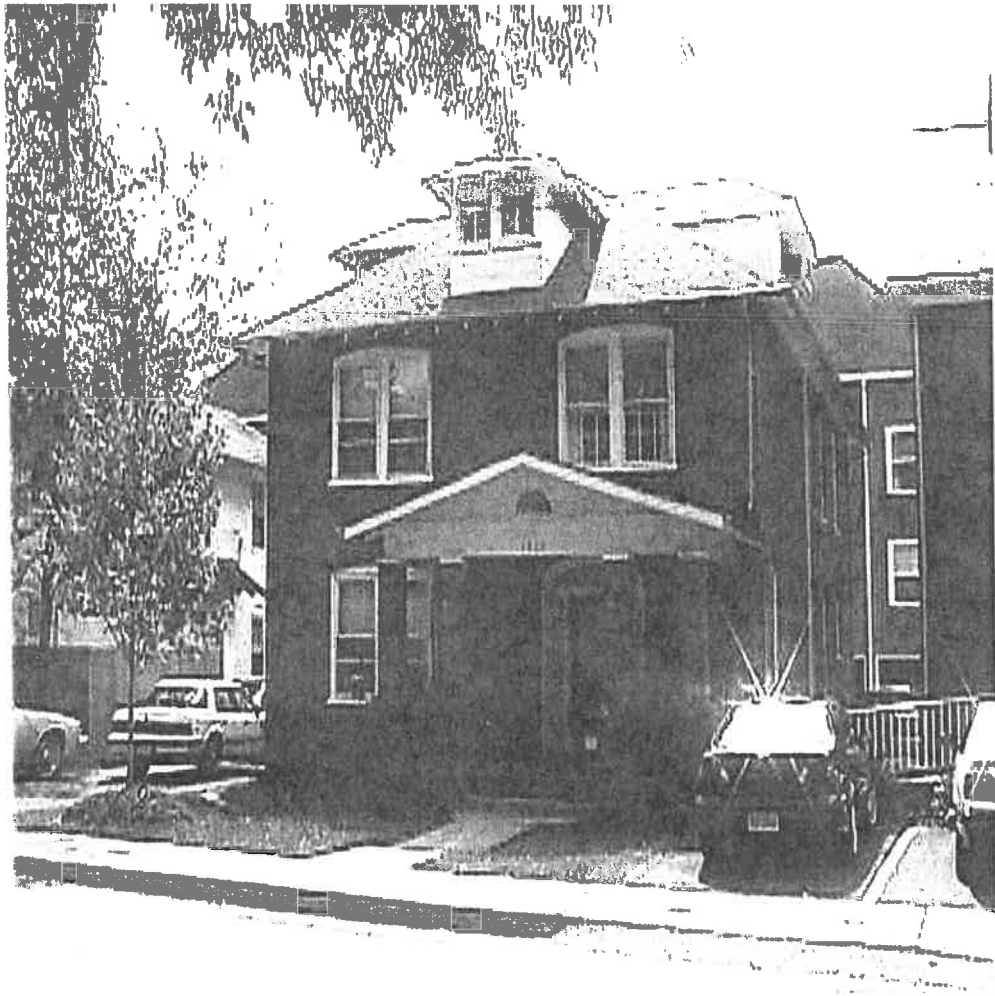
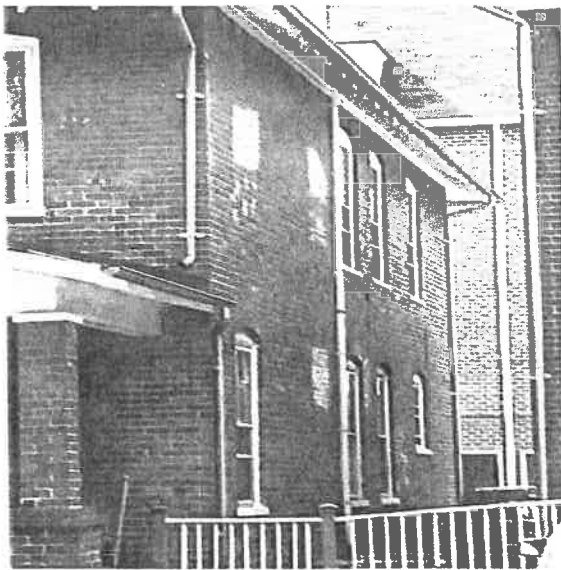
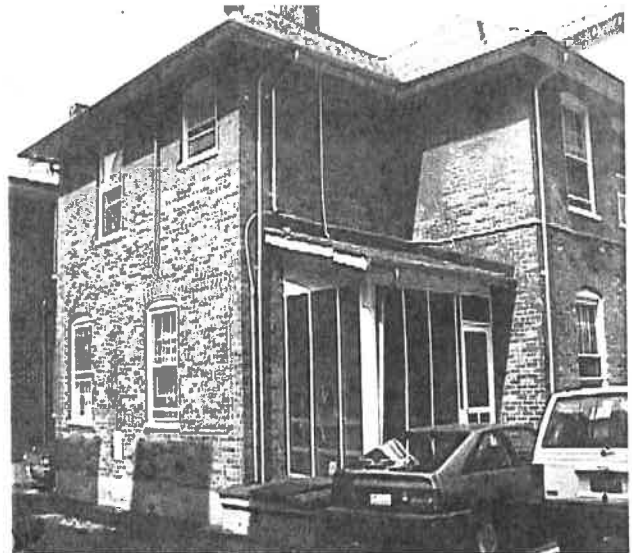
This 2½ story, two-bay, brick (stretcher bond) American four-square has an asphalt-shingled hipped roof with exposed rafter ends. There is a single large, hipped-roofed dormer on the facade and each side elevation. There is one central chimney. Windows are segmentally arched, double-sash, 6-over-6 light. Those on the facade are arranged in pairs. An original one-story entrance porch covers the western bay of the facade. Brick piers set on brick pedestals support a shallow gabled roof. The entrance door has sidelights and a semi-elliptical fanlight.

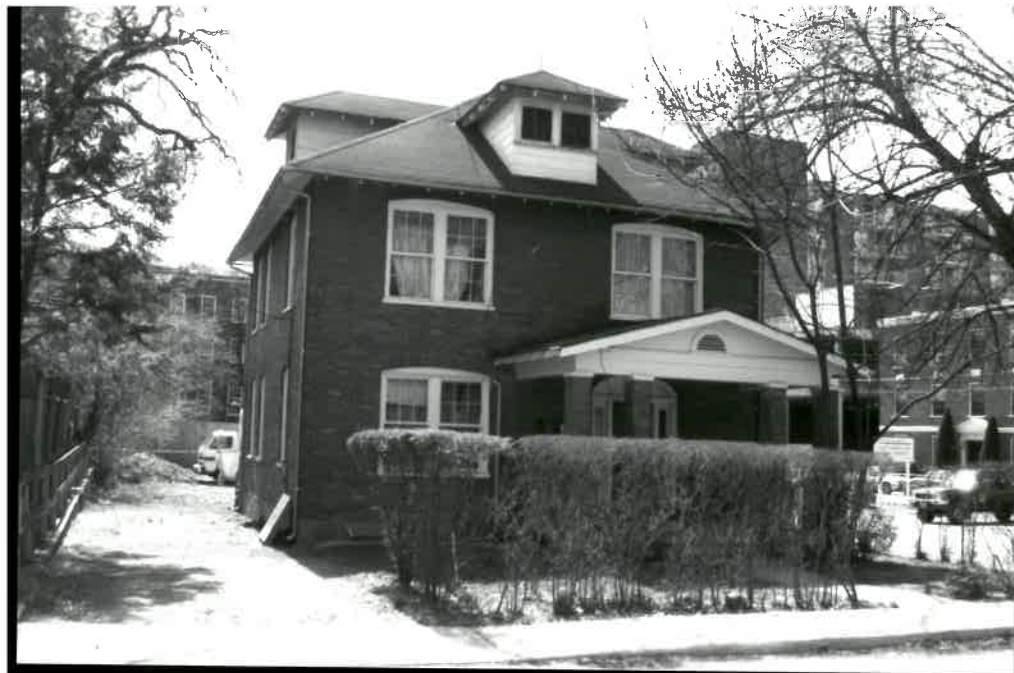
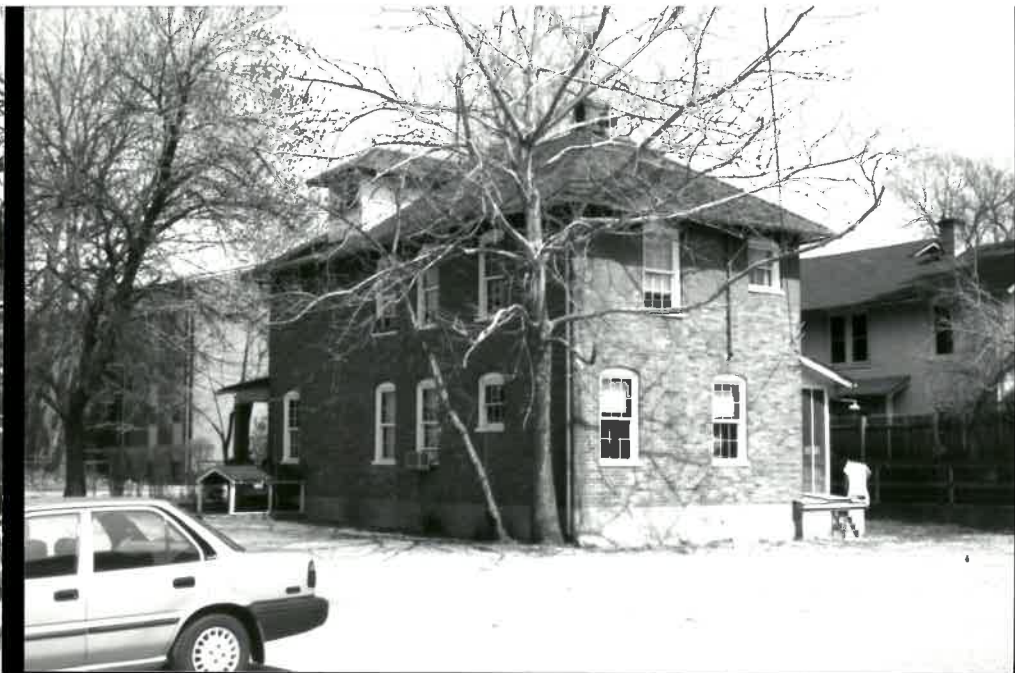
Name House (1254 Westland St.)

Foursquare form, front porch supported by Craftsman brick columns and with a semicircular louvered vent in the porch gable, front entry with sidelights and elliptical fanlight, segmental-arched windows, exposed rafter tails, basement, brick flue.

Contents 2 ext. views
